Inspection Photos  
Location Name: LAMP 42-3  
API#: 05-071-06672  
INSP. #: 695101266

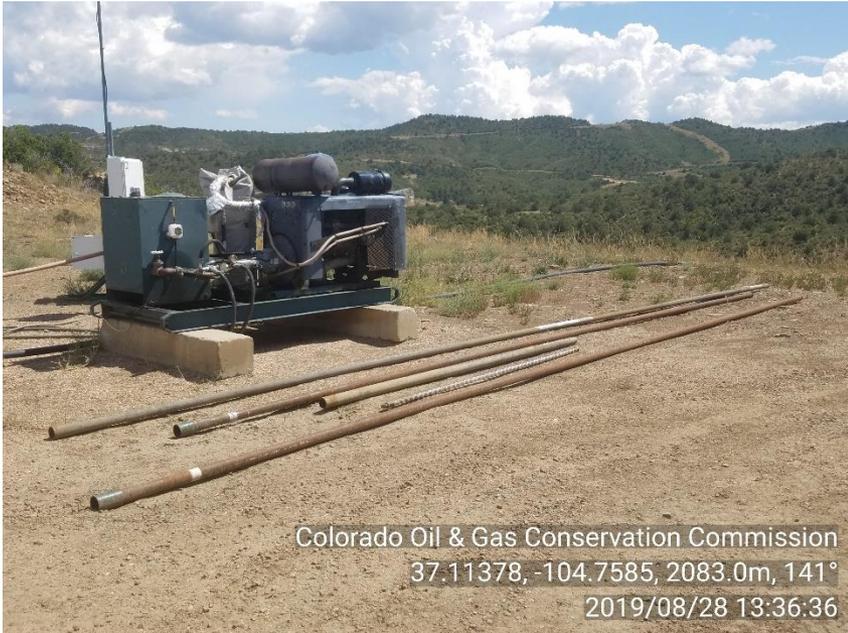
**PHOTO 3: UNUSED EQUIPMENT (TBG & RODS). REMOVE  
UNUSED EQUIPMENT, COMPLY WITH RULE 603.f. CA DATE 9-  
28-9.**

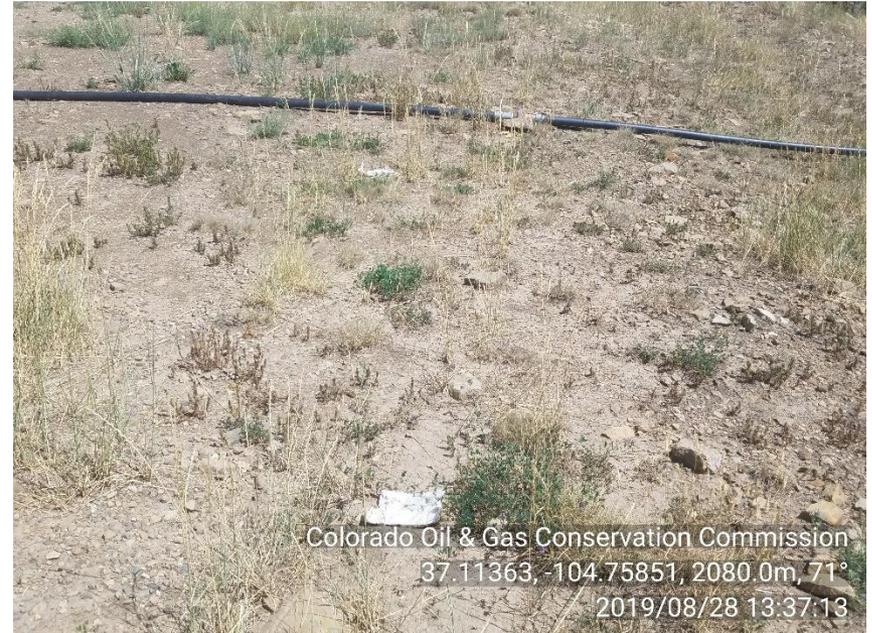
**PHOTO 4: TRASH ON LOCATION SOUTH OF WELLHEAD.  
POLICE LOCATION FOR TRASH AND DEBREE AT REGULAR  
INTERVALS, COMPLY WITH RULE 603.f. CA DATE 9-28-19**

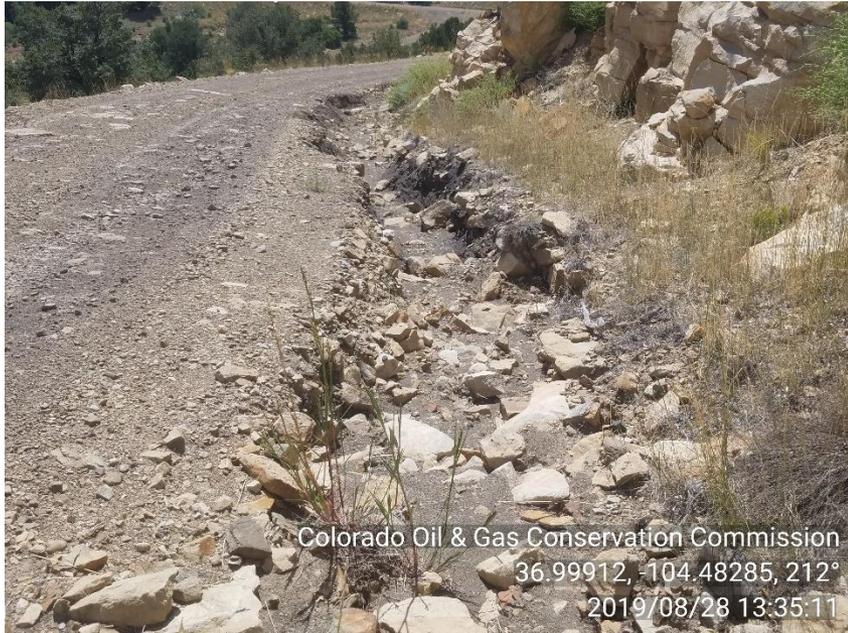
**PHOTO 5: STORMWATER EROSION ON UP GRADE SIDE OF  
ROW SOUTH OF LOCATION. **INSTALL OR REPAIR BMP'S**  
**COMPLY WITH RULE 1002.f. CA DATE 9-28-19****
