# Inspection Photos

Operator: FOUNDATION ENERGY  
MANAGEMENT LLC # 10112

Location ID: 447525  
Weld County, CO

Aaron Trujillo  
NE Reclamation Specialist  
COGCC

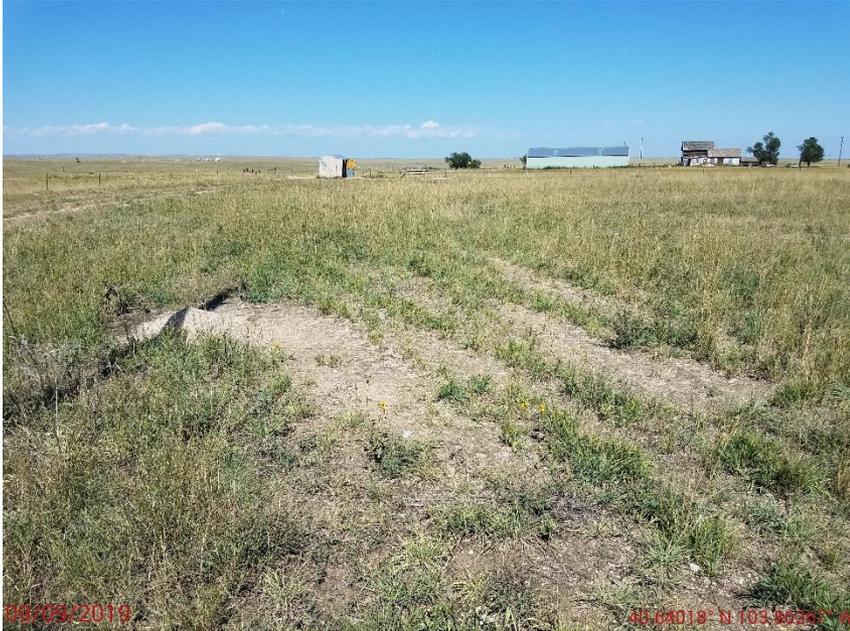
**Photo 1:** Photo taken from the southwest end of the location, facing south. Photo provides an overview of the location.

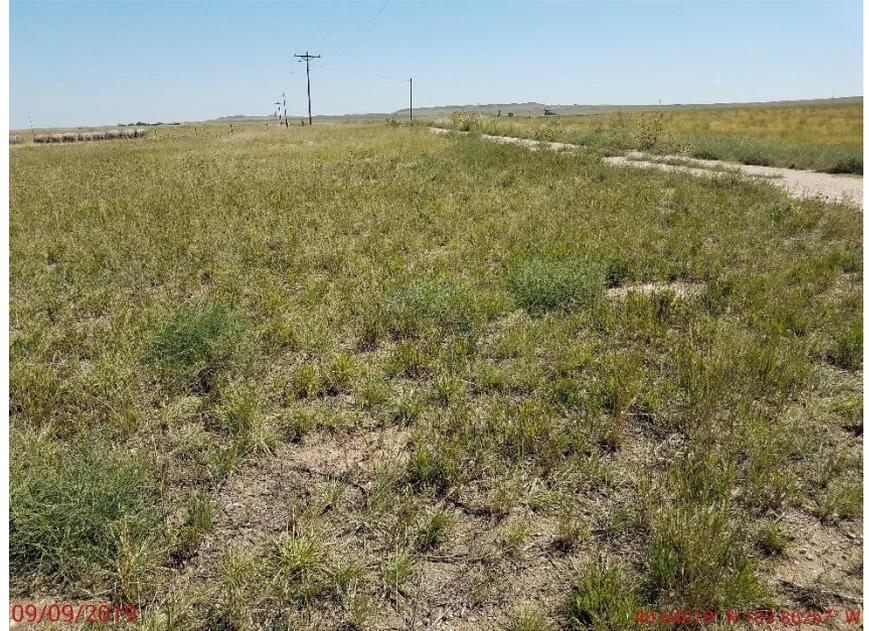
**Photo 2:** Photo taken from the southwest end of the location, facing east. Photo provides an overview of the location.

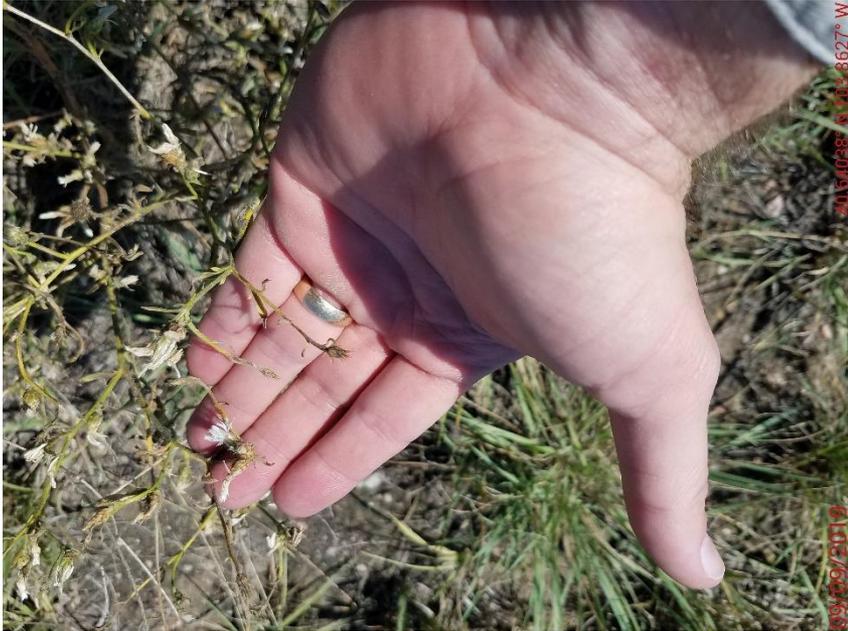
**Photo 3:** Photo taken from the location. Photo shows white flowers of a mature Diffuse Knapweed plant. Many mature plants remain on the location. Many other plants were observed to have already dispersed their seed.

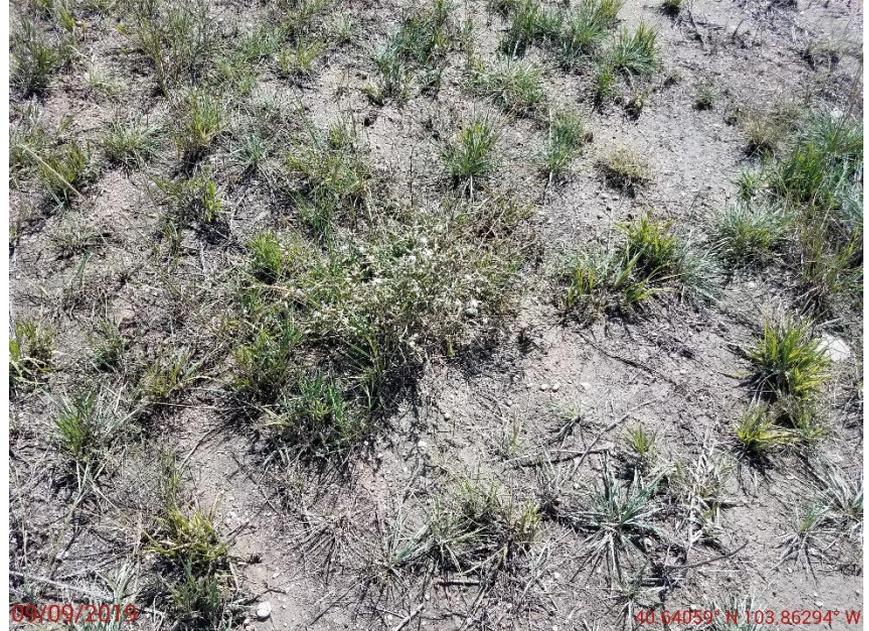
**Photo 4:** Photo of Diffuse Knapweed observed on location (White flowered plant). Knapweed was observed throughout entire location.

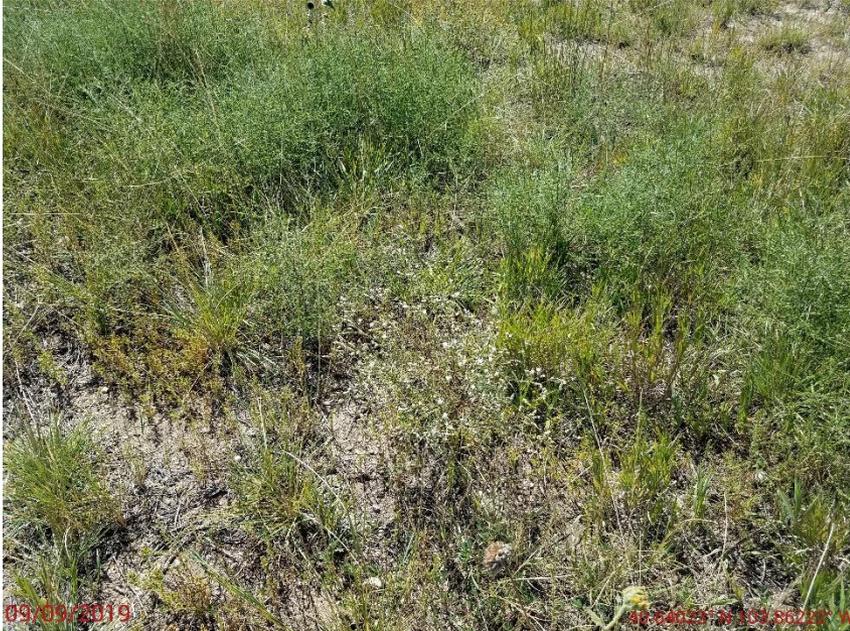
**Photo 5:** Photo of Diffuse Knapweed observed on location (White flowered plant). Knapweed was observed throughout entire location.

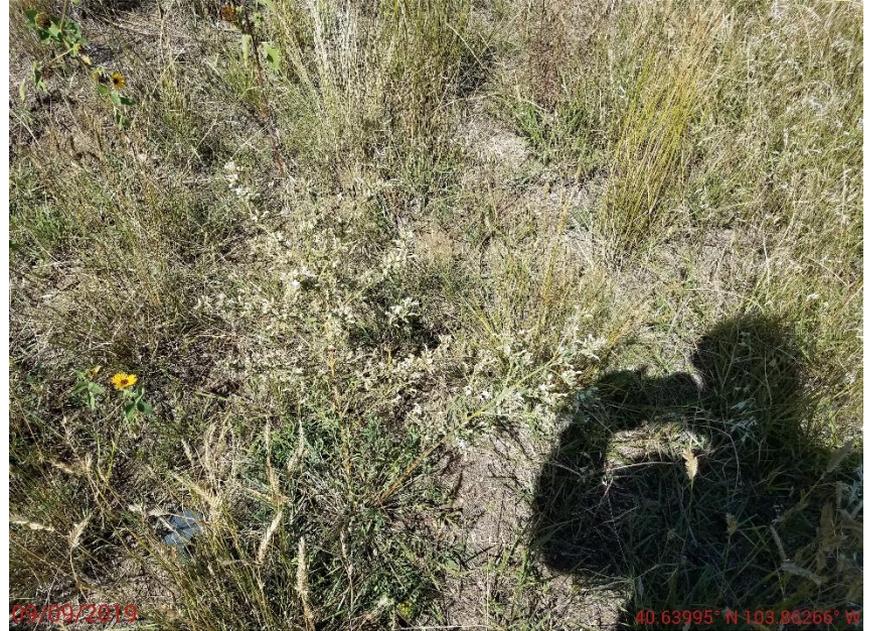
**Photo 6:** Photo of Diffuse Knapweed observed on location (White flowered plant). Knapweed was observed throughout entire location.
