Inspection Photos

09/09/2019

Operator: FOUNDATION ENERGY
MANAGEMENT LLC # 10112

Location ID: 447523
Weld County, CO

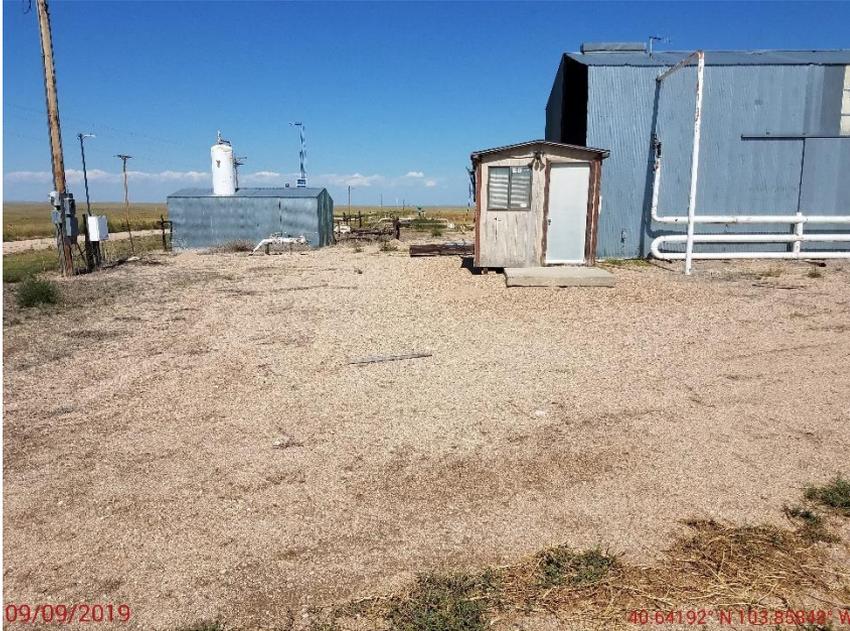
Photo 1: Photo taken from the southwest end of the location, facing north. Photos 1-3 provide an overview of the location. Photos also show equipment remaining on location and final reclamation has not been conducted.

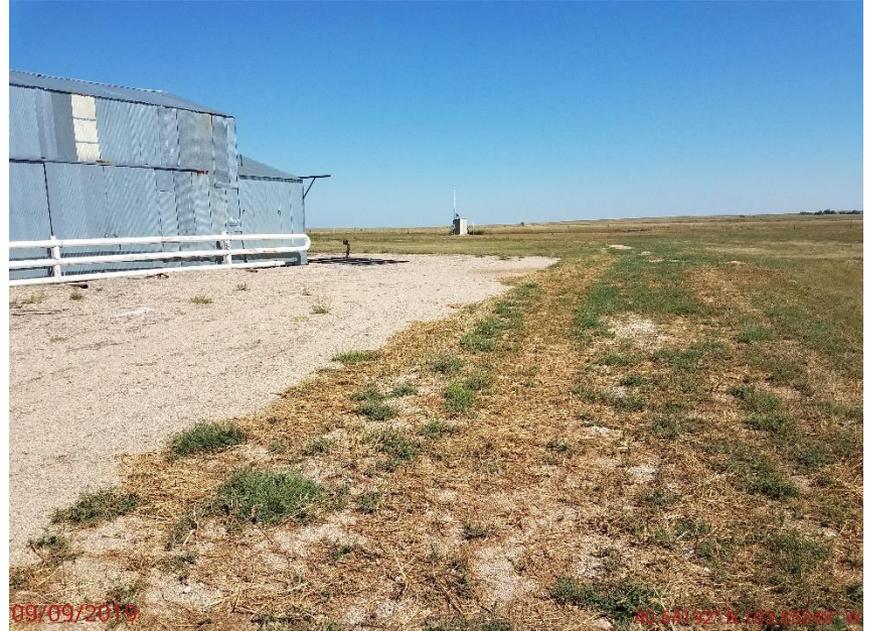
Photo 2: See comments under photo 1.

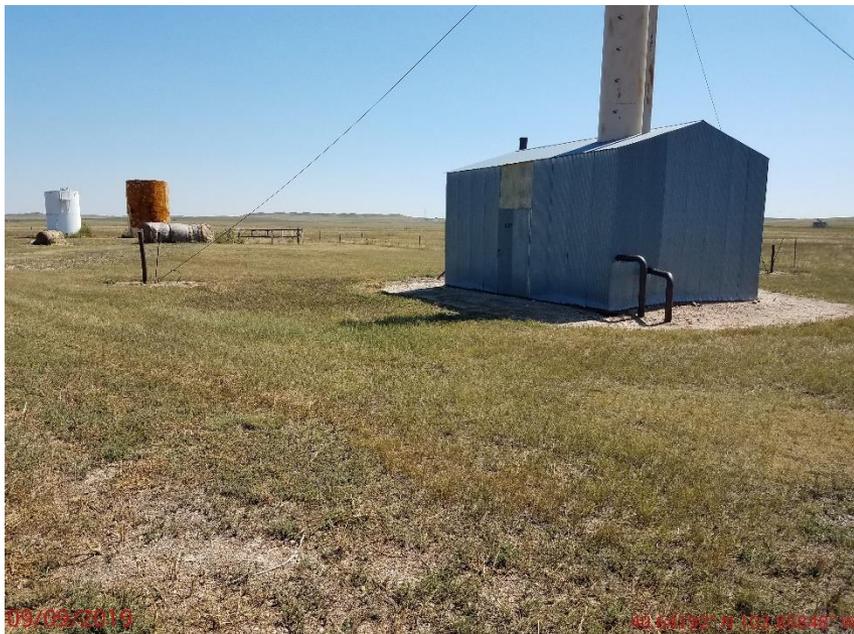
Photo 3: See comments under photo 1.

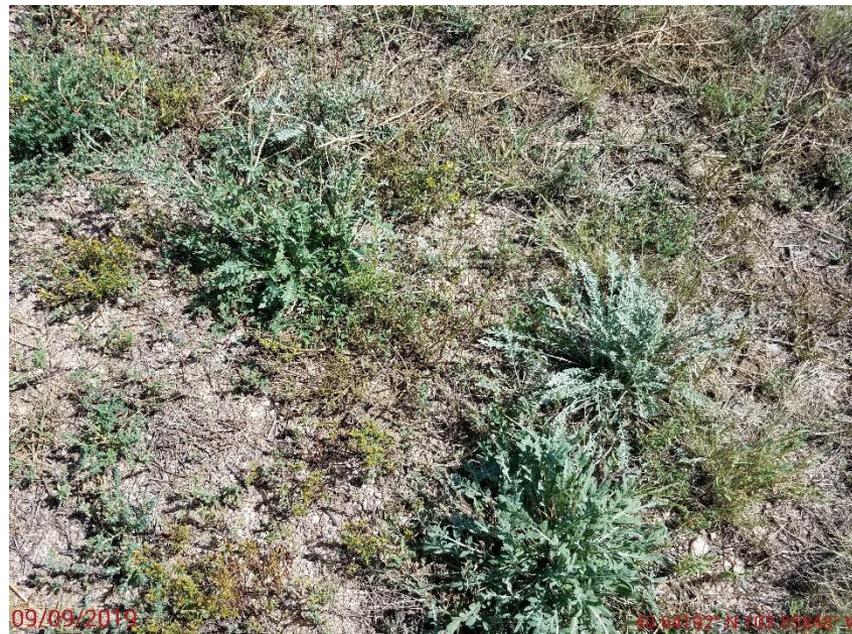
Photo 4: Photo taken from the south end of the location. Photo shows Diffuse Knapweed rosettes on location. Operator appears to have conducted mowing operations. Mowing has not been a sufficient method in removing noxious weeds from location.

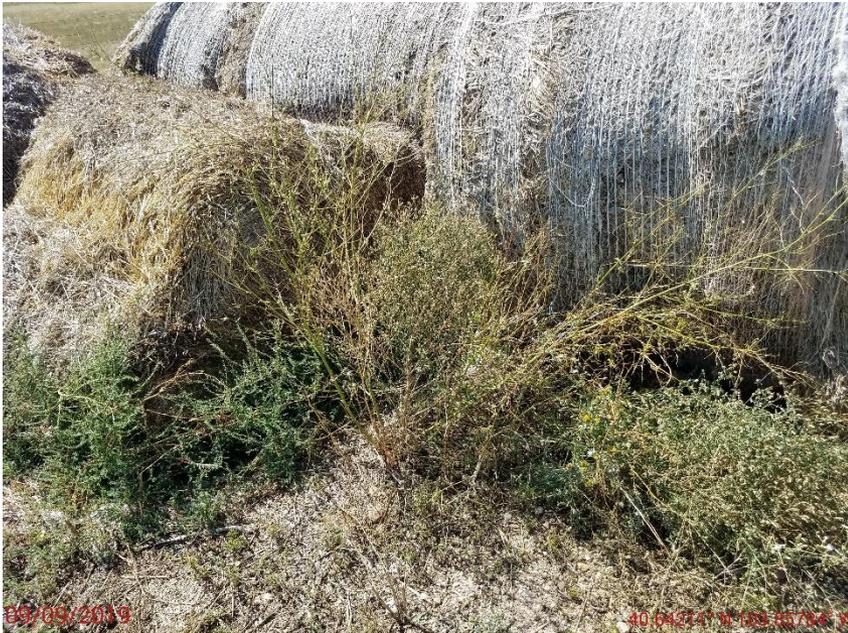
Photo 5: Photo taken from the south end of the location. Photo shows Diffuse Knapweed on location. Diffuse knapweed as observed throughout location.

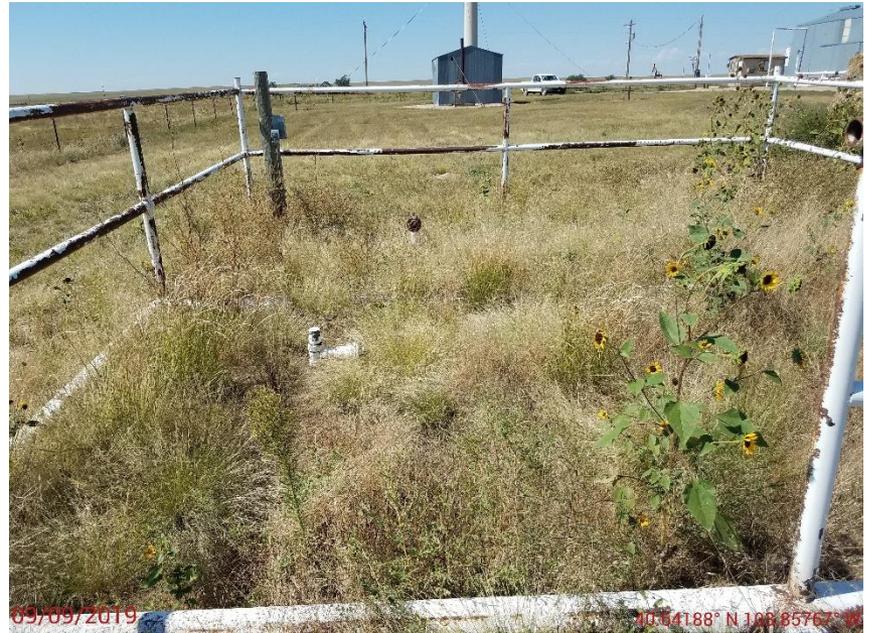
Photo 6: Photo taken from the south end of the location, facing west. Photo shows equipment has not been removed and location reclaimed.

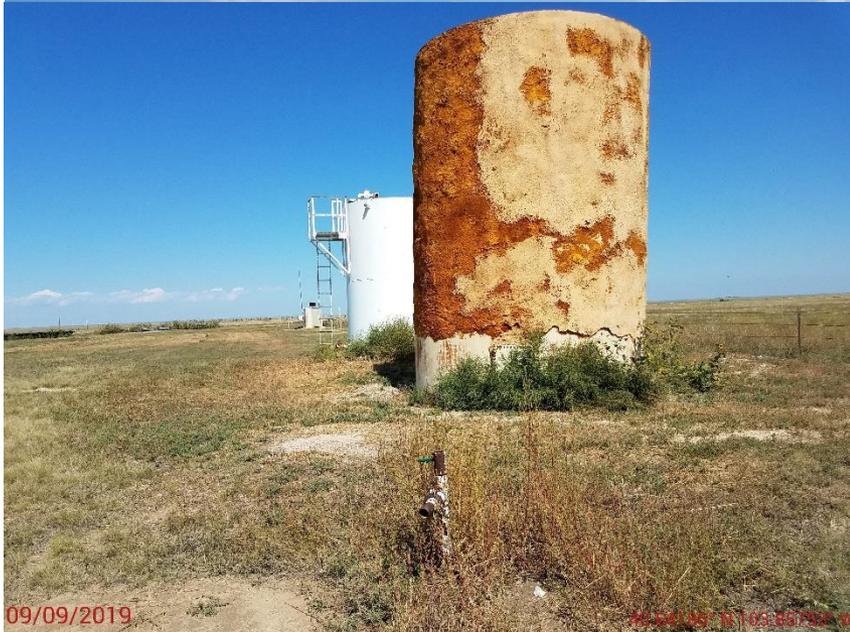
Photo 7: Photo taken from the south end of the location, facing north. Photo shows equipment has not been removed and location reclaimed.

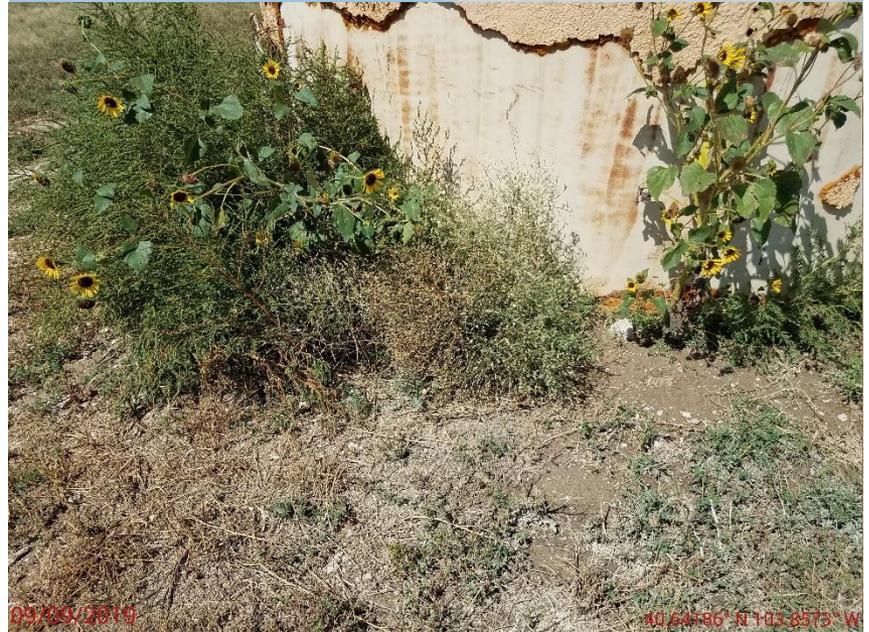
Photo 8: Photo of Diffuse Knapweed observed on location.

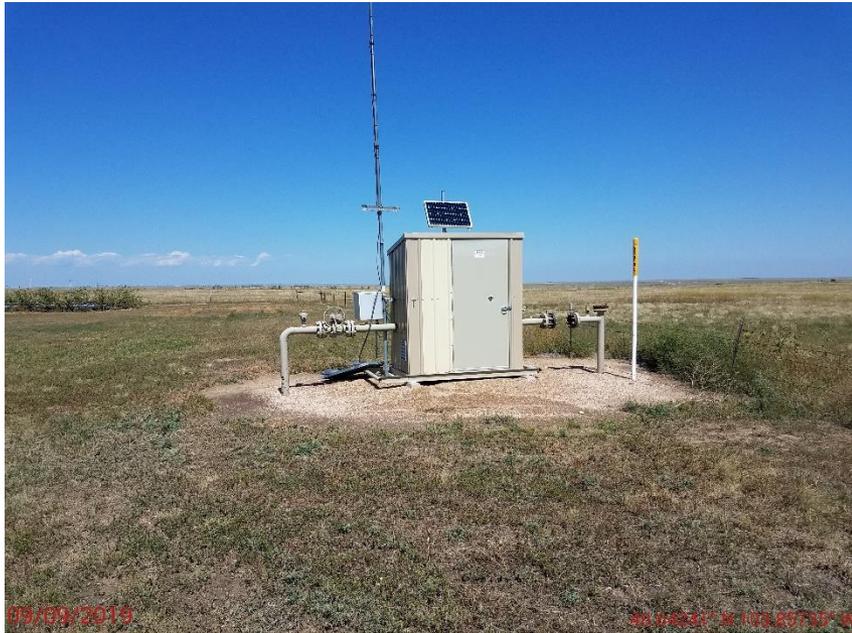
Photo 9: Photo taken from the east end of the location, facing north. Photo shows equipment has not been removed and location reclaimed.

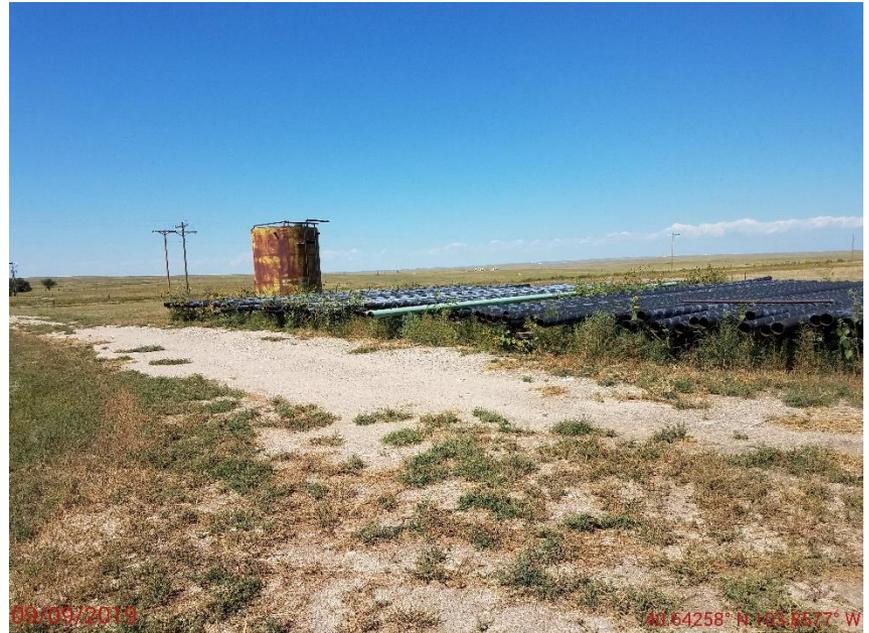
Photo 10: Photo taken from the north end of the location, facing northwest. Photo shows equipment has not been removed and location reclaimed.

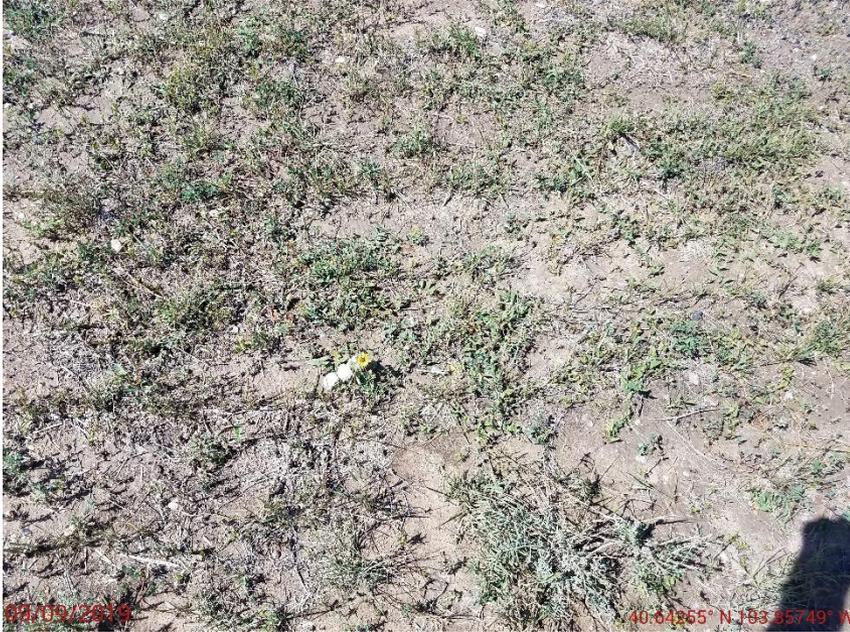
Photo 11: Photo taken from the northeast end of the location. Photo shows Bindweed remains evident on location

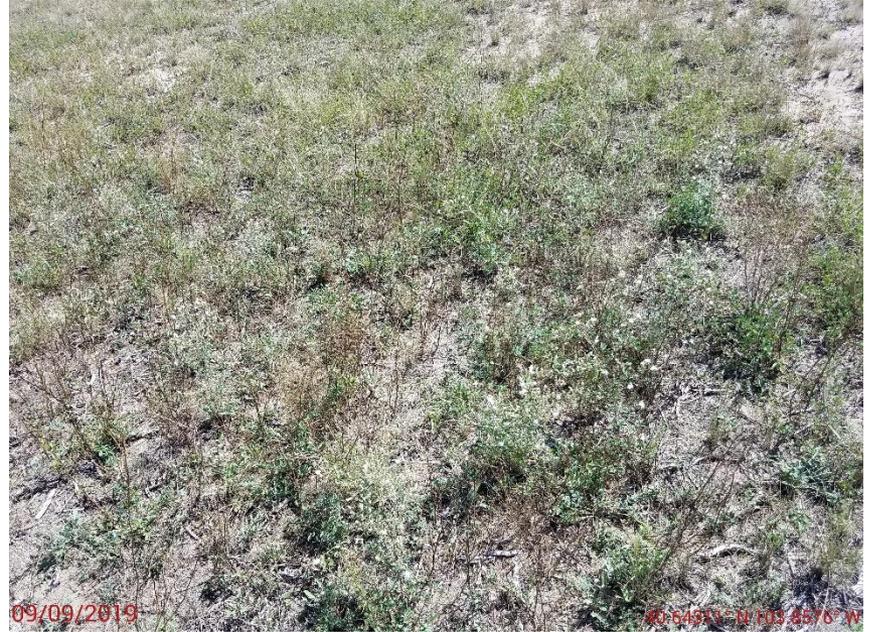
Photo 12: Photo taken from the central area of the location. Photo shows diffuse knapweed (white flowers) remains evident on location.

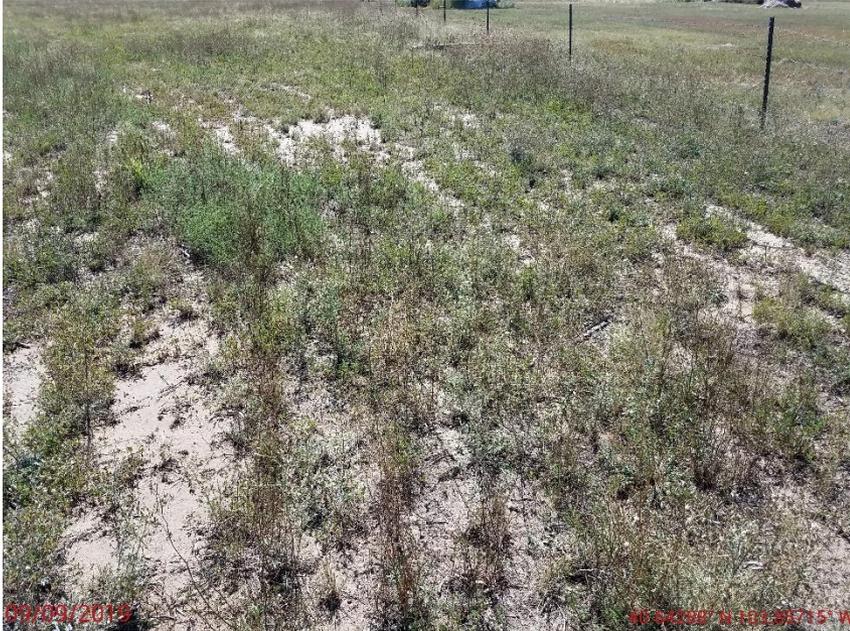
Photo 13: Photo taken from the adjacent reference area. Previous inspections required operator to conduct noxious weed management on the adjacent lands due to weeds spreading from the location. Noxious weeds remain evident on the surrounding adjacent lands.

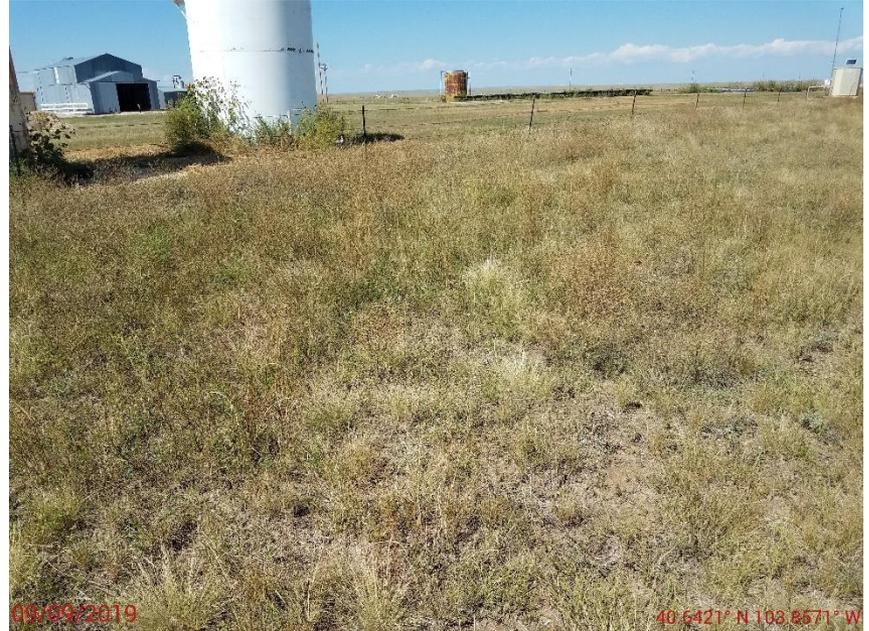
Photo 14: Photo taken from the adjacent reference area, facing northwest. Previous inspections required operator to conduct noxious weed management on the adjacent lands due to weeds spreading from the location. Noxious weeds remain evident on the surrounding adjacent lands.
