# Inspection Photos

09/09/2019

Operator: FOUNDATION ENERGY  
MANAGEMENT LLC # 10112

Location ID: 330359  
Weld County, CO

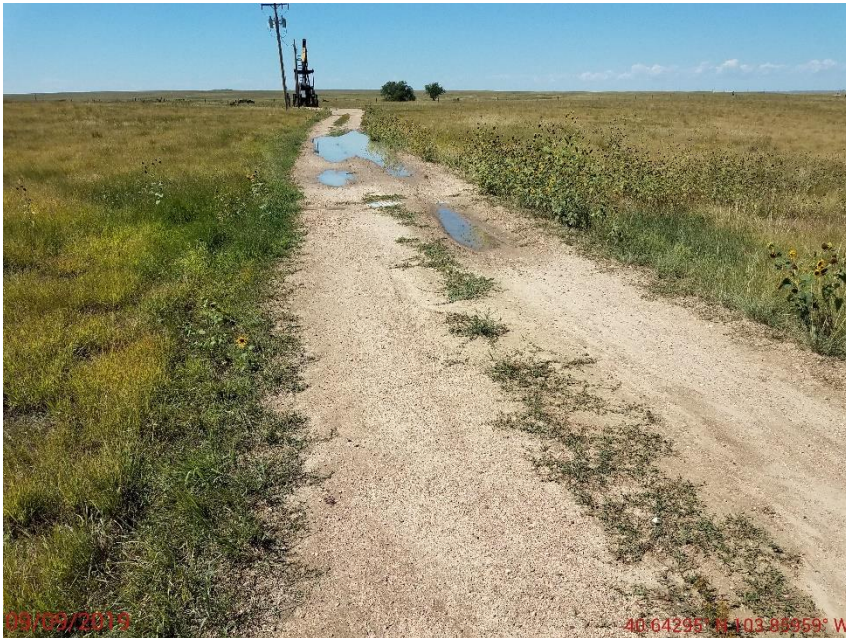
**Photo 1:** Photo taken from the access road, facing west. Photo shows that access road has not been constructed or sufficient BMPs installed to allow for proper stormwater discharge to ensure existing access road remains in proper functioning condition.

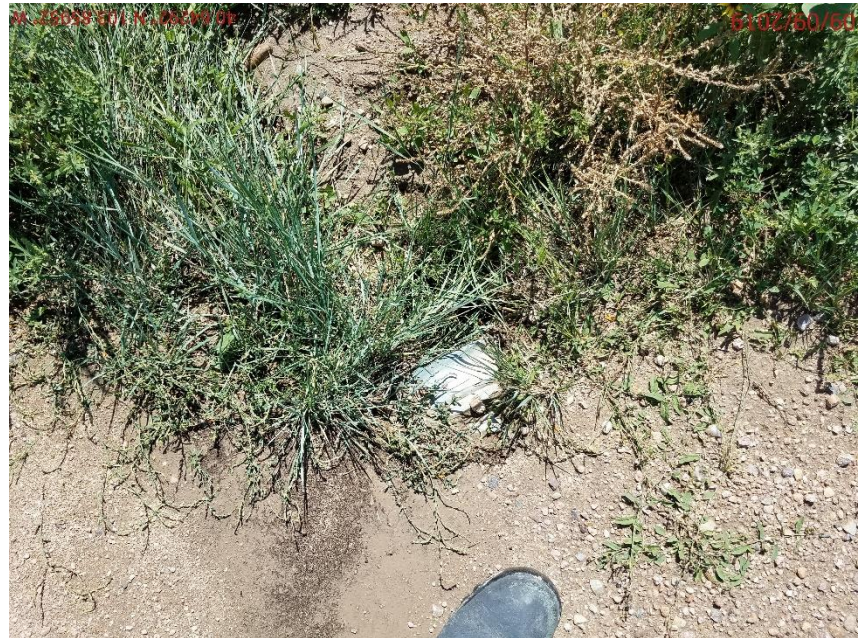
**Photo 2:** Photo shows culvert at access road is not longer in proper functioning condition.

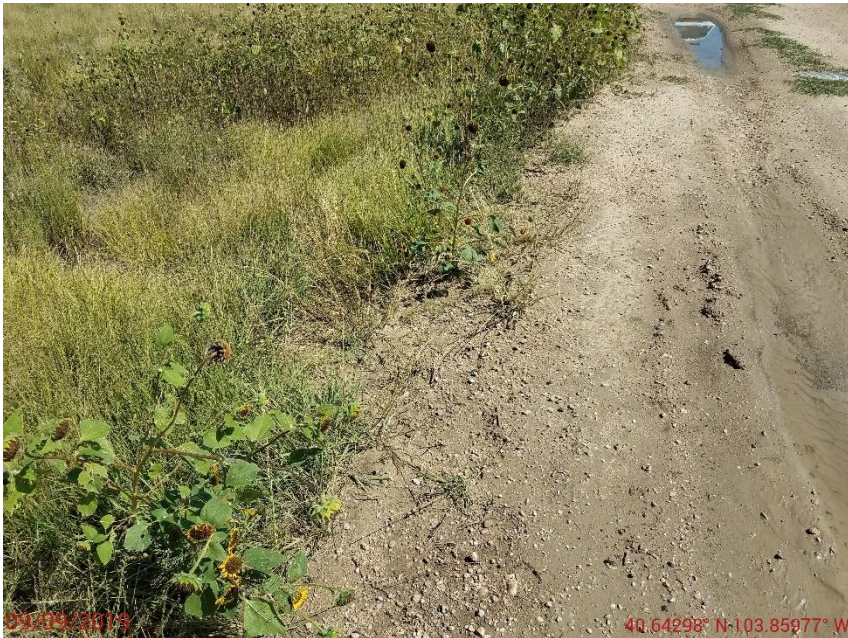
**Photo 3:** Photo shows areas where stormwater from the access road is discharging onto the adjacent lands. Sediment deposition evident.

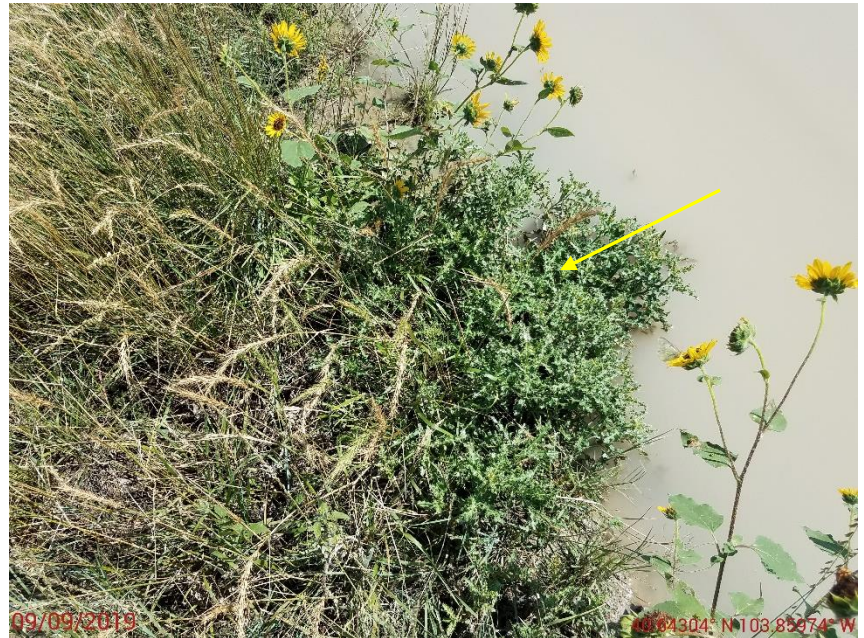
**Photo 4:** Photo taken from the access road. Photo shows what appear to be Canada thistle is establishing on location.

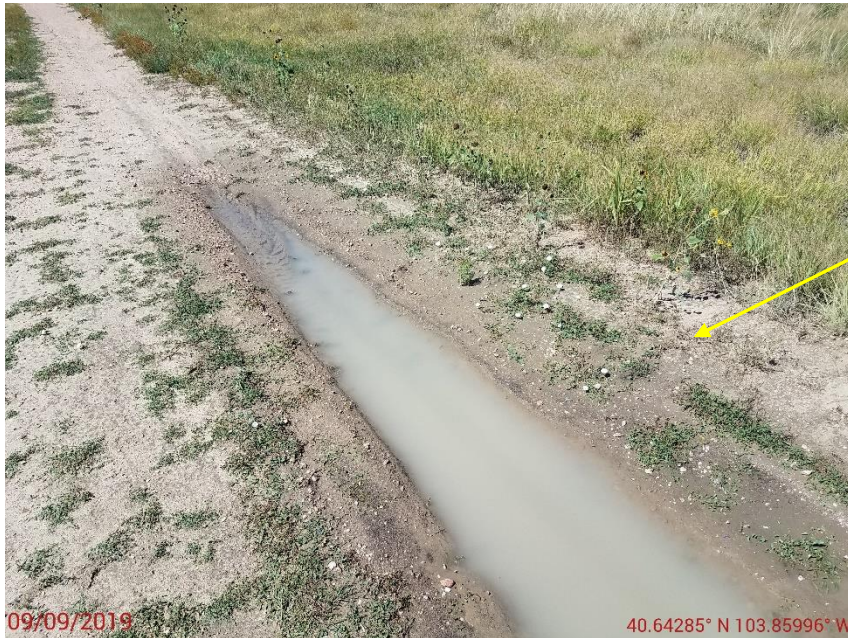
**Photo 5:** Photo shows bindweed on access road.

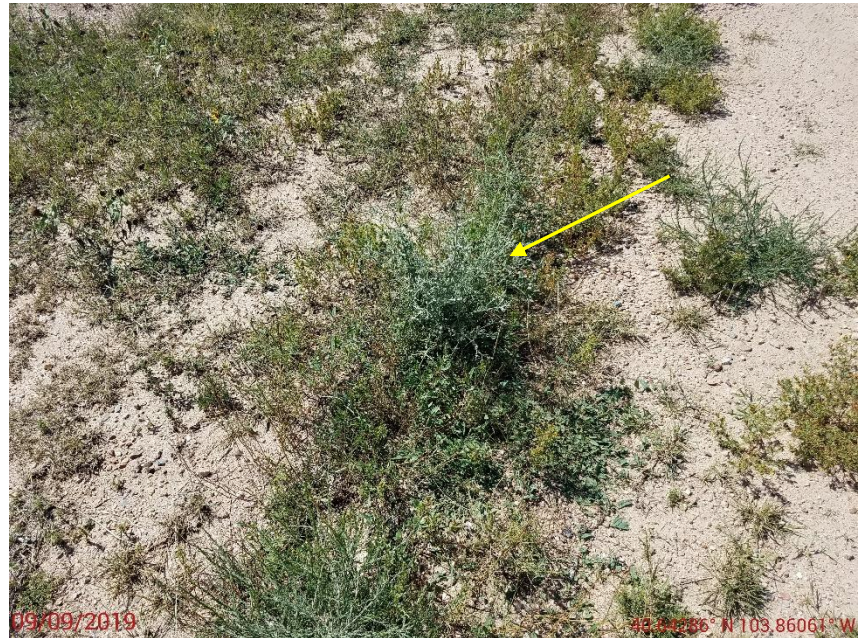
**Photo 6:** Photo taken from the southwest end of the location. Photo shows Diffuse Knapweed (Plants with white flowers in photo) remains established on the location.
