Final Reclamation Inspection

Operator: BAYSWATER EXPLORATION AND PRODUCTION LLC - #10261

Location ID: 306743

Inspection Photos
Location Name: HESTER #31-23
Location ID: 306743

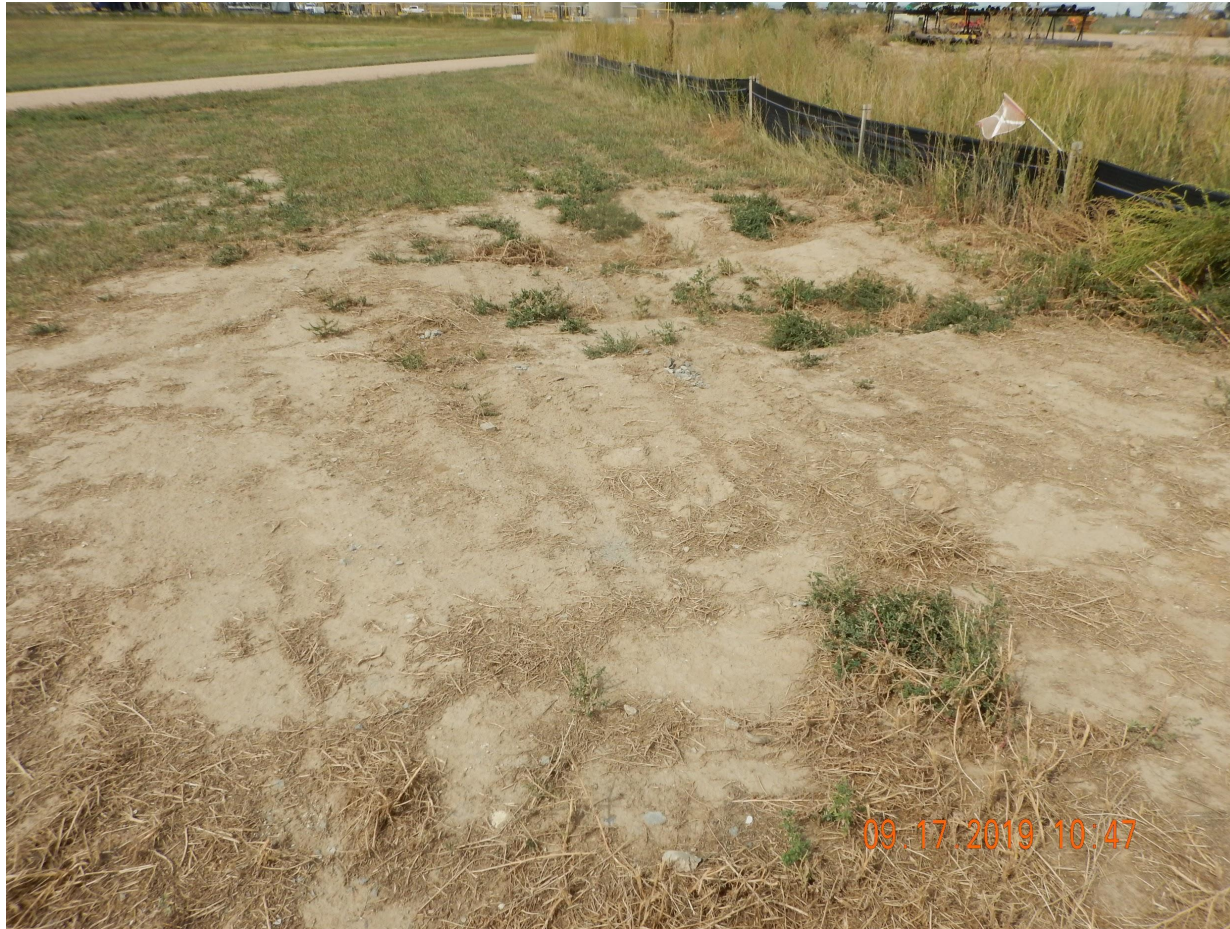
Photo 1. Photo taken from the well location, facing West. Photo illustrates Operator has failed to perform Final Reclamation activities at the well location, as there is no apparent vegetative growth which also has not been properly contoured. This PA well location is outside of the Hester Farms II 31-H Pad disturbance area.

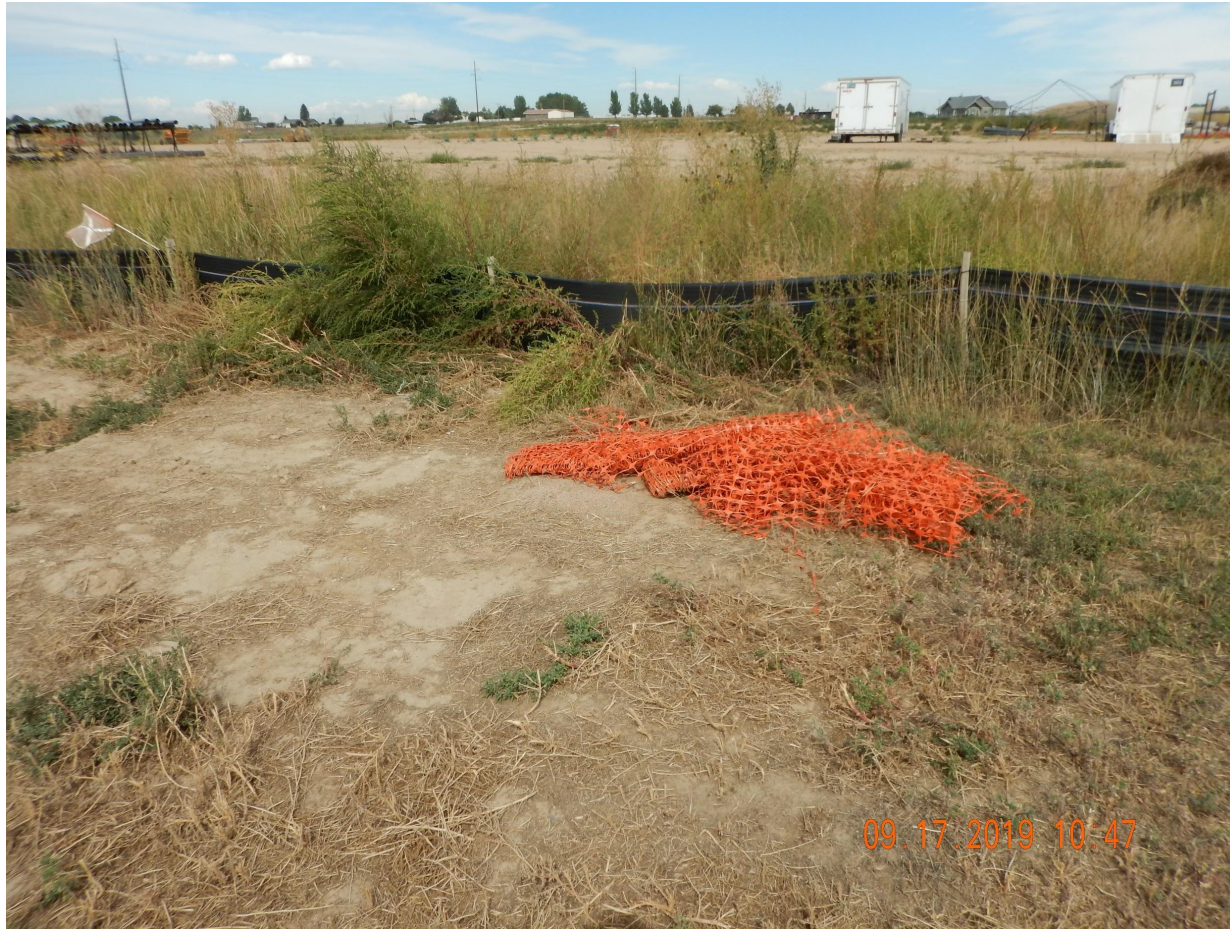
Photo 2. Photo taken from the well location, facing North. Photo illustrates unused equipment at the well location.
