Final Reclamation Inspection

Operator: SRC ENERGY INC- #10311

Location ID: 319090

Inspection Photos
Location Name: BUXMAN, D. #1-26
Location ID: 319090

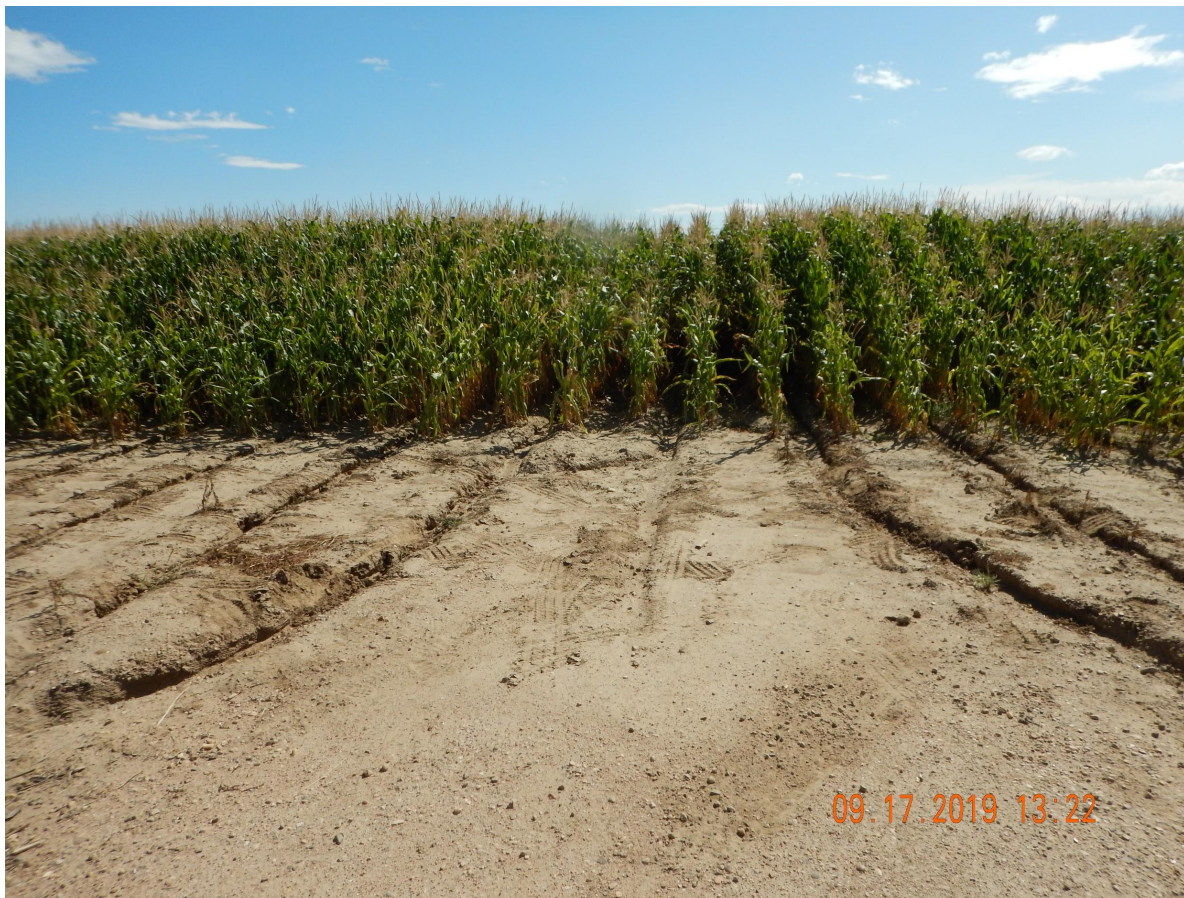
Photo 1. Photo taken from the well location entrance point, facing South. COGCC staff could not make a full assessment due to crop height and density, as the location was ~500' further south.

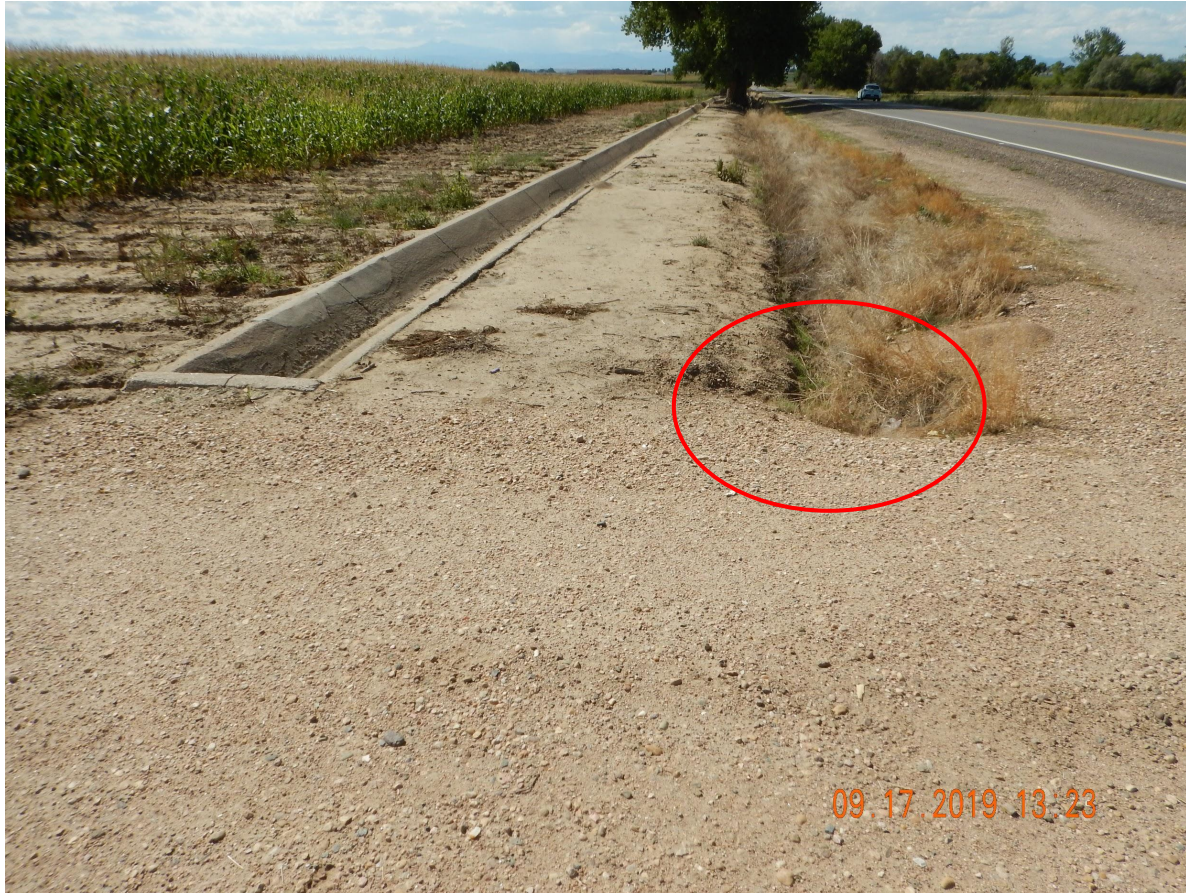
Photo 2. Photo taken from the well location entrance point, facing West. Photo illustrates the Operator has failed to remove the culvert. There is an access point for this crop field ~600 feet to the west of this point. This access point is no longer in use and was used for oil and gas operations.
