**Inspection Photos**  
**Operator: BP America**  
**Location/API #: 067-07246**  
**Date: 9-24-2019**

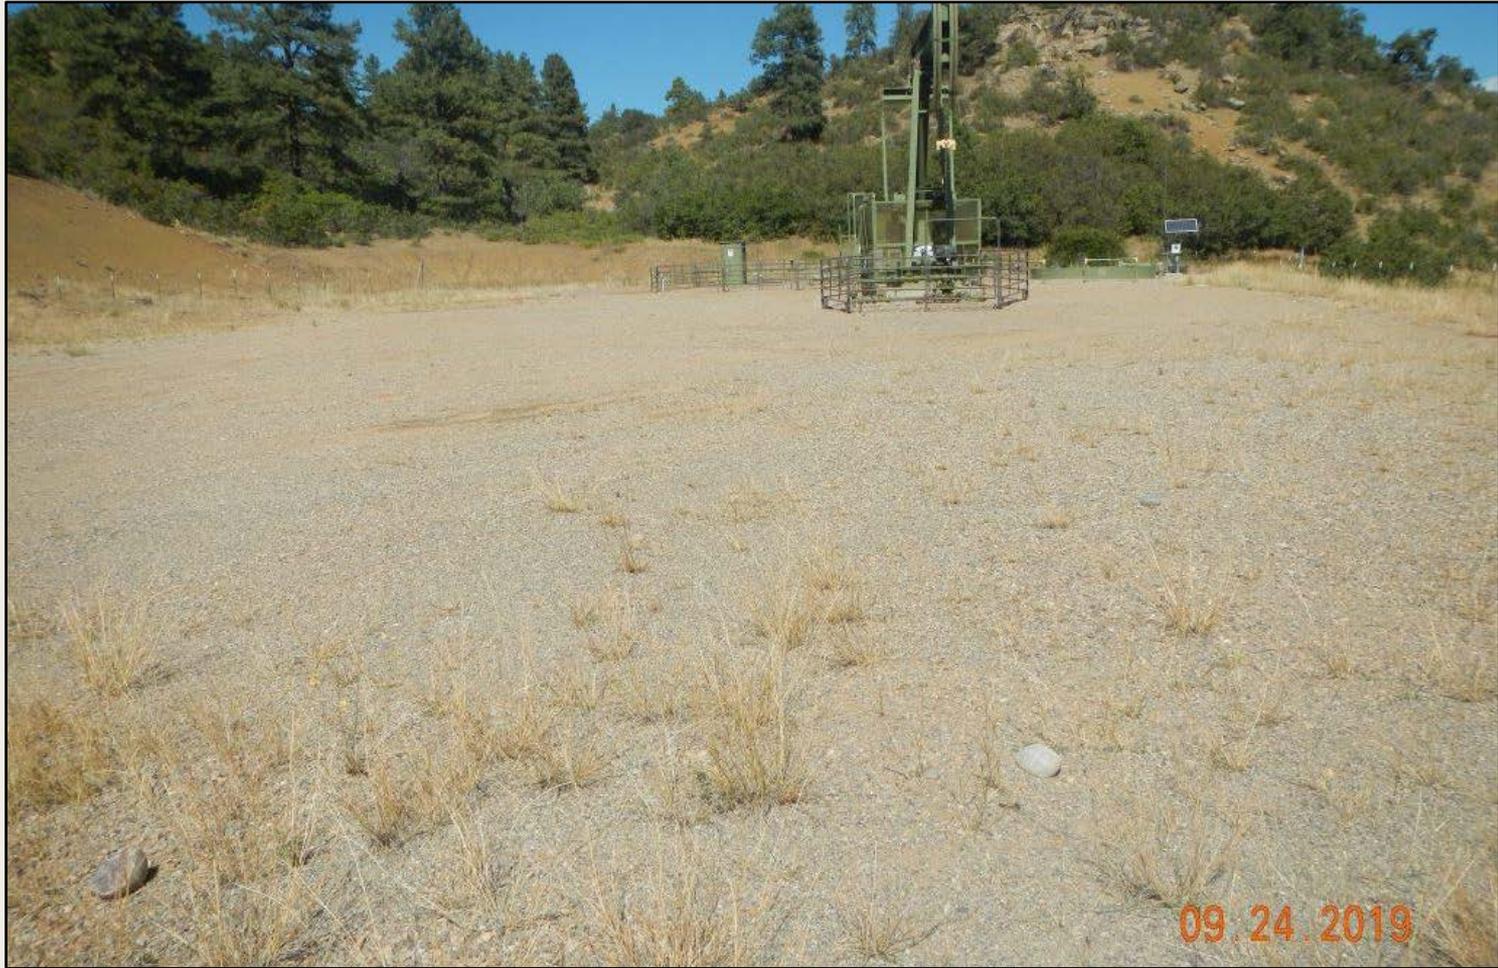
Photo 1. View of the project area from the well pad entrance facing center.

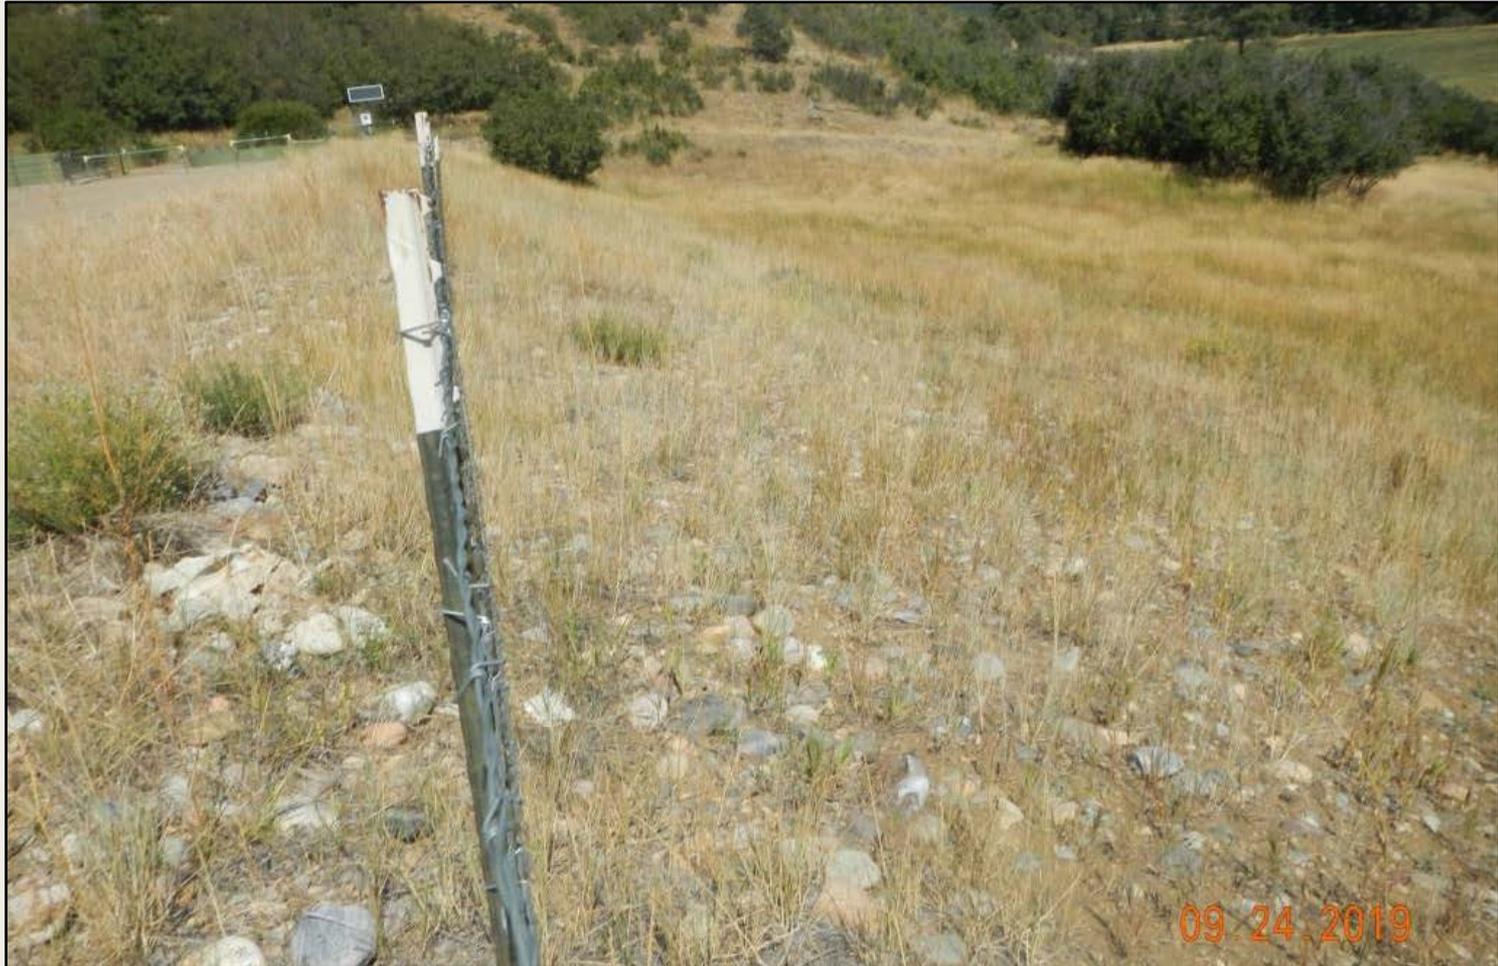
Photo 2. View of the eastern fill slope from the southeastern edge facing northward. Revegetation is progressing with western wheatgrass, sand dropseed, and smooth brome.

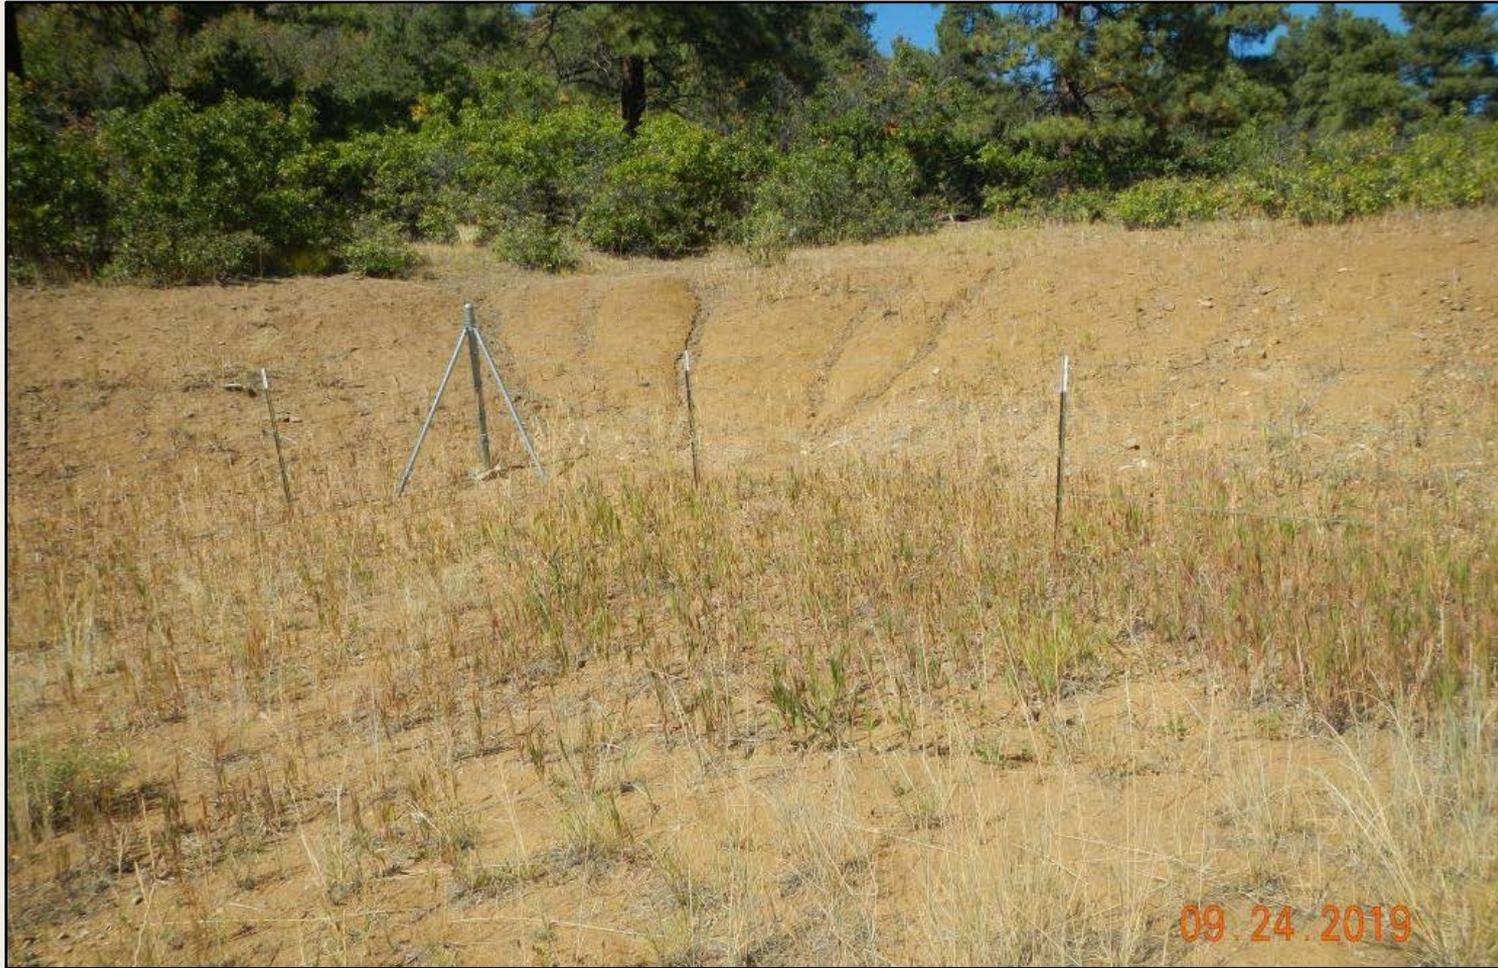
Photo 3. View of erosion occurring on the northwestern project area. Significant sediment deposition observed down-slope. Bare soils on slope are not stabilized.

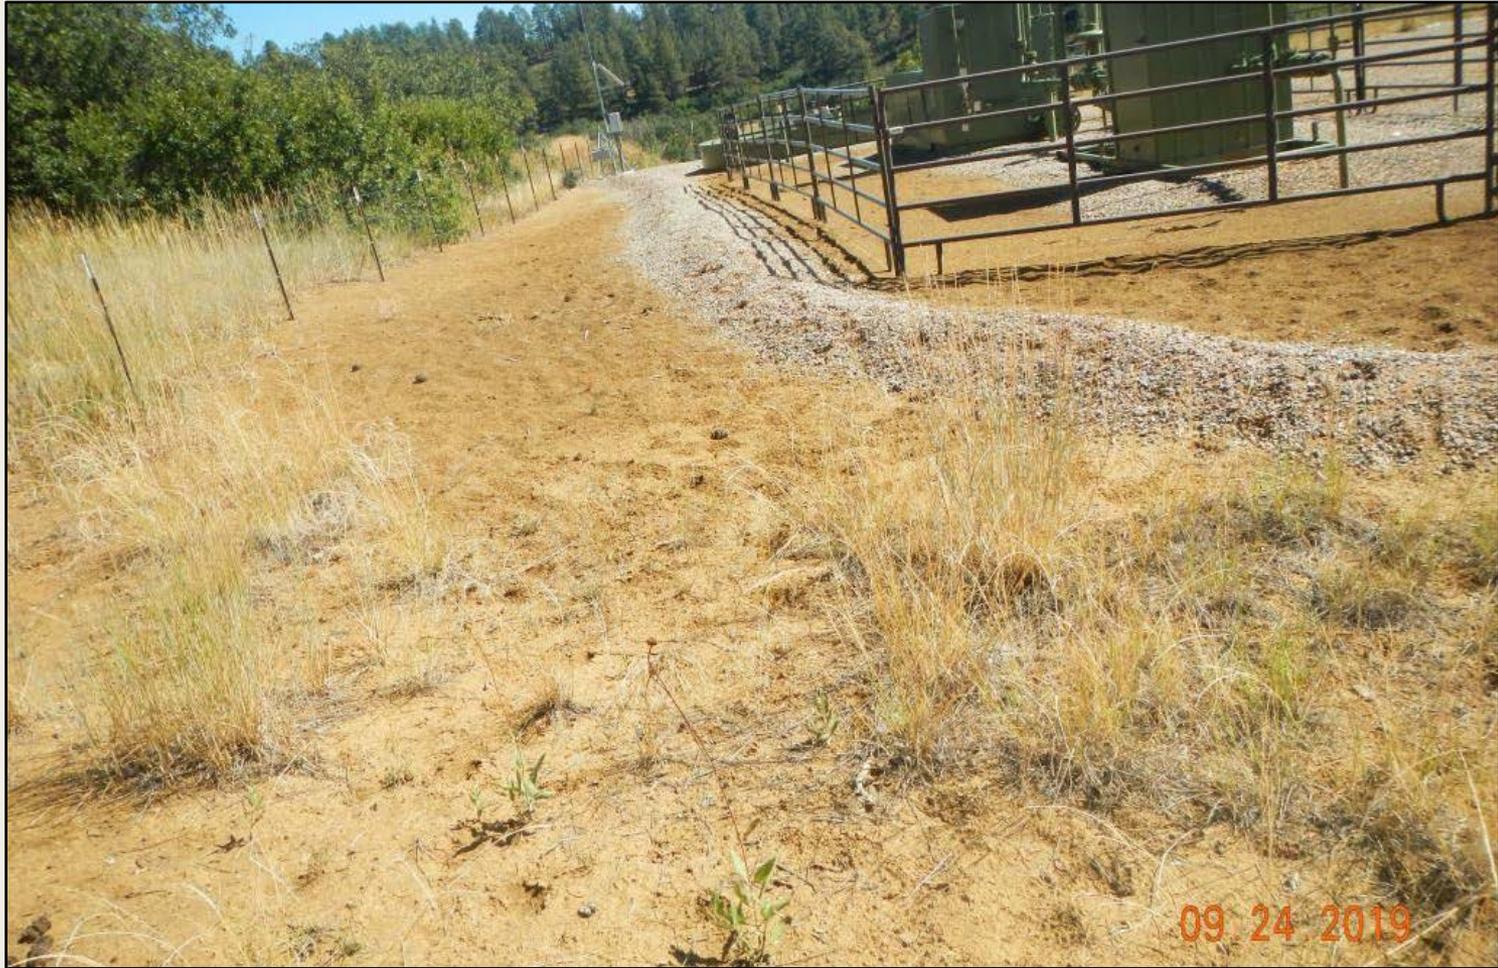
Photo 4. Downstream view of sediment accumulation in the northwestern project area.

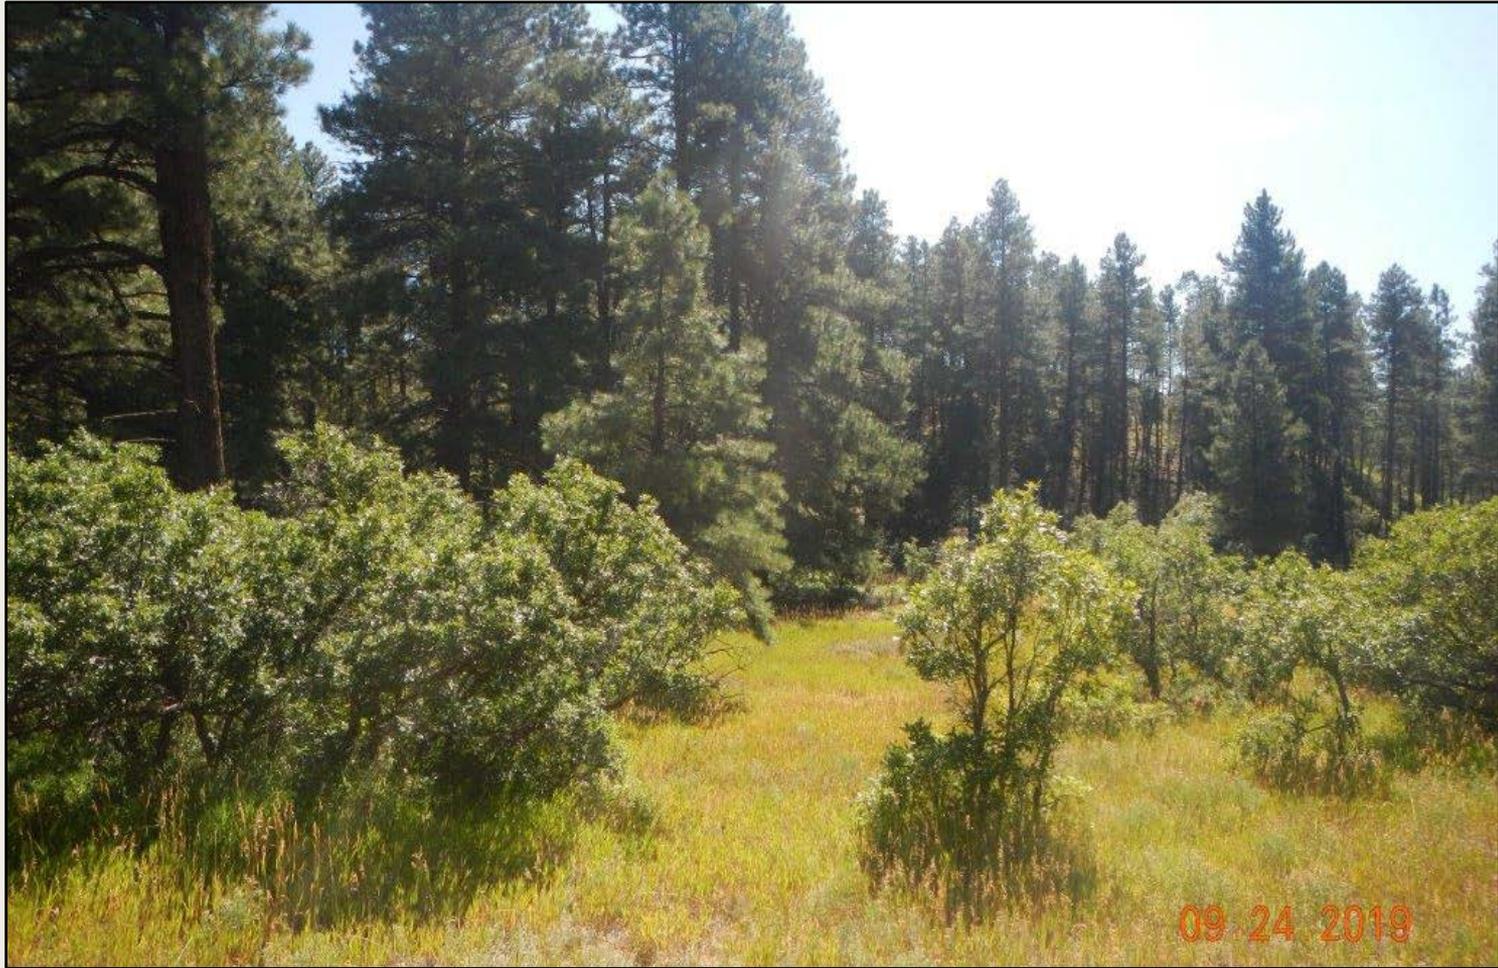
Photo 5. View of reference area vegetation, comprised of mixed ponderosa pine and gambel oak woodland with grass field in openings.
