Inspection Photos

API: 05-071-09451

Operator: NATURAL RESOURCE GROUP

Inspection Date: 10/1/2019

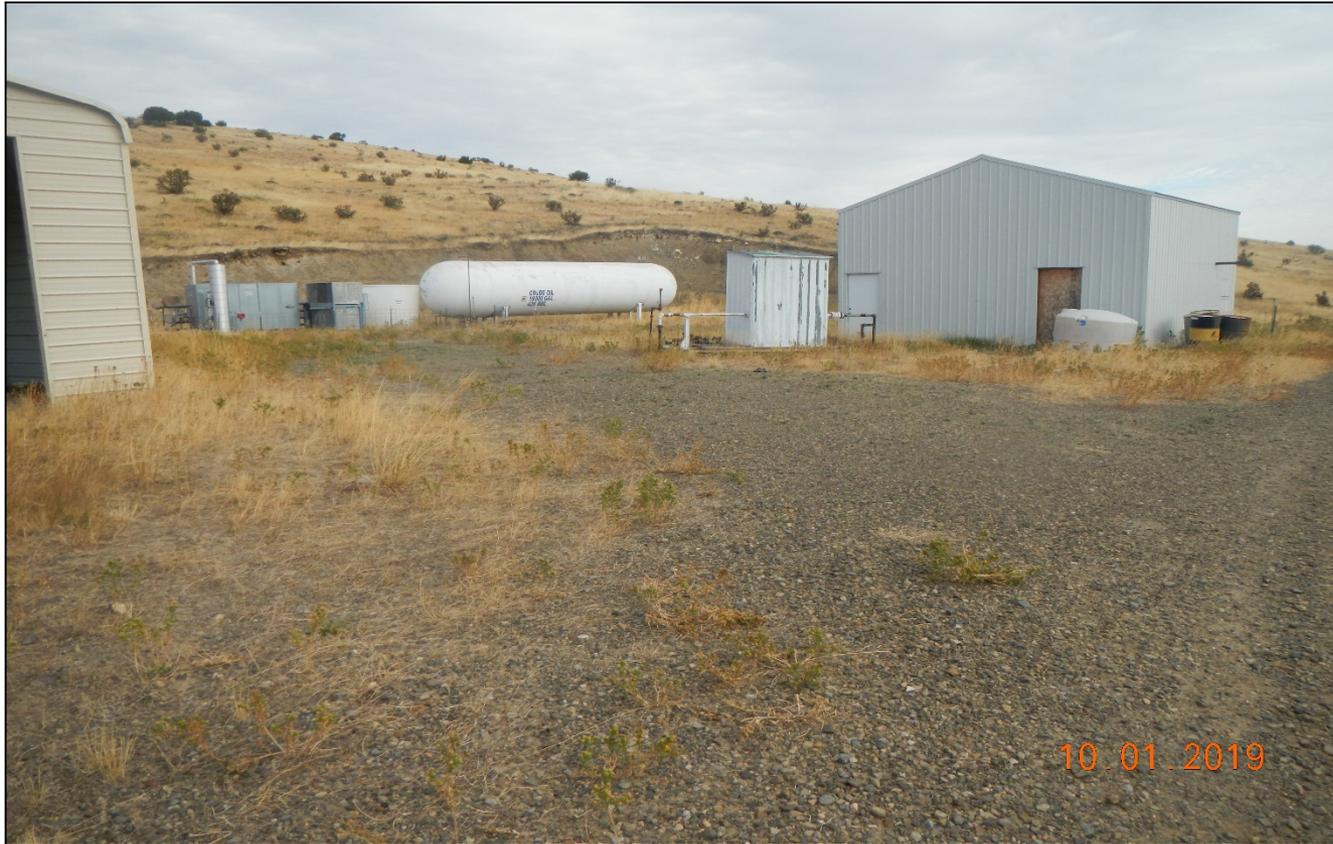
Photo 1. Facing north toward the location. There is various unused equipment at the location.

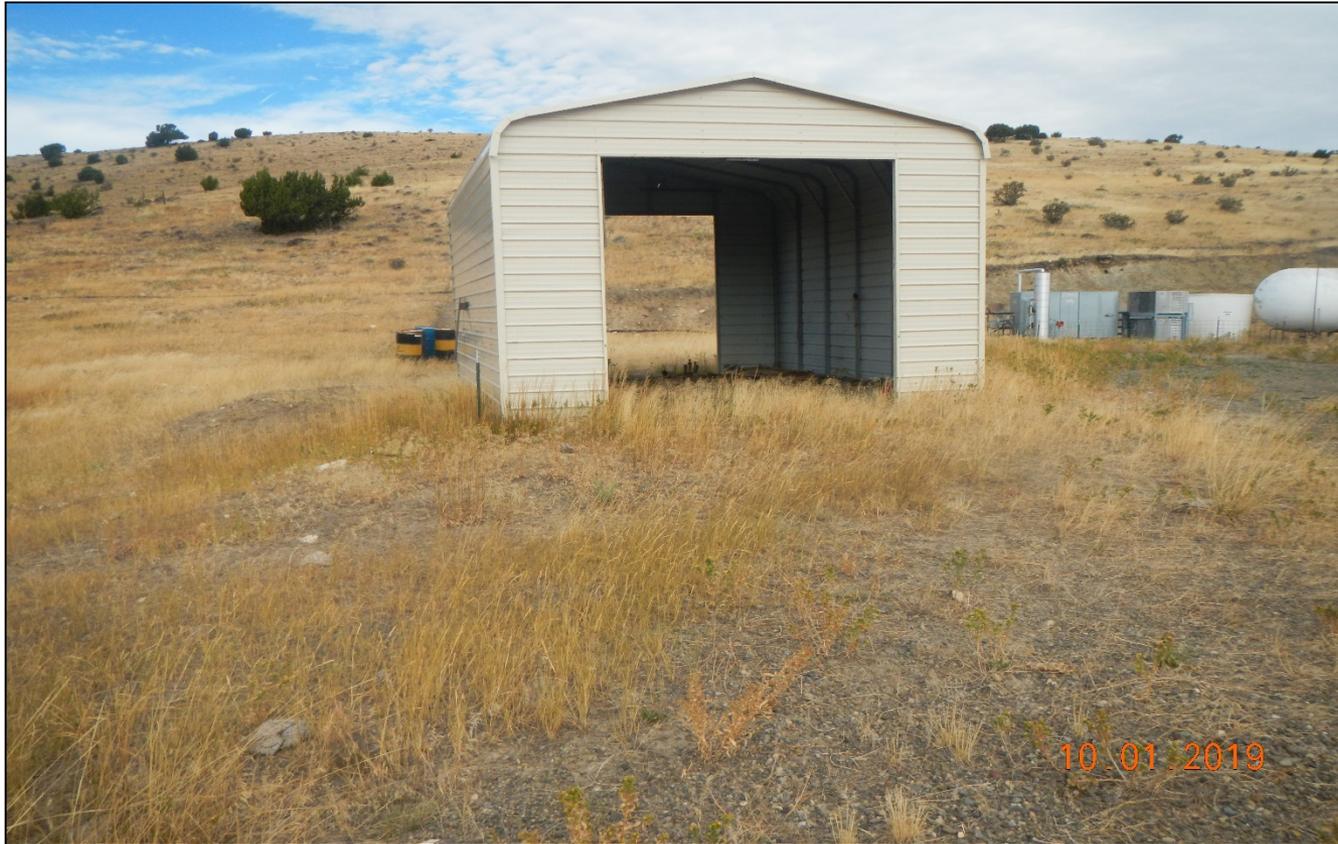
Photo 2. Facing northwest. There is an unused shed at the west side of the location.

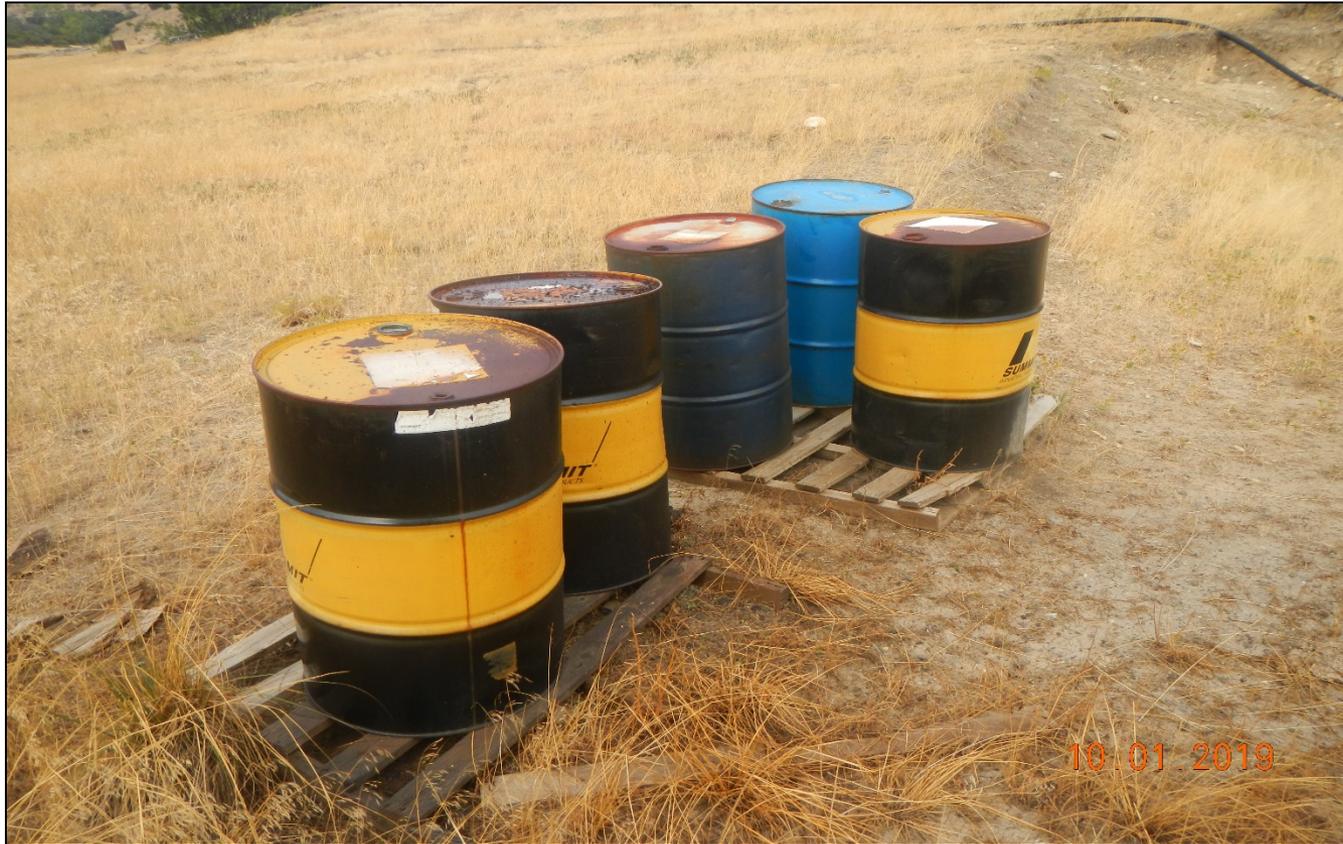
Photo 3. There are barrels stored at the west side of the location. Labels are not legible and contents unknown. Hydrocarbon odor near the barrels with stained soils.

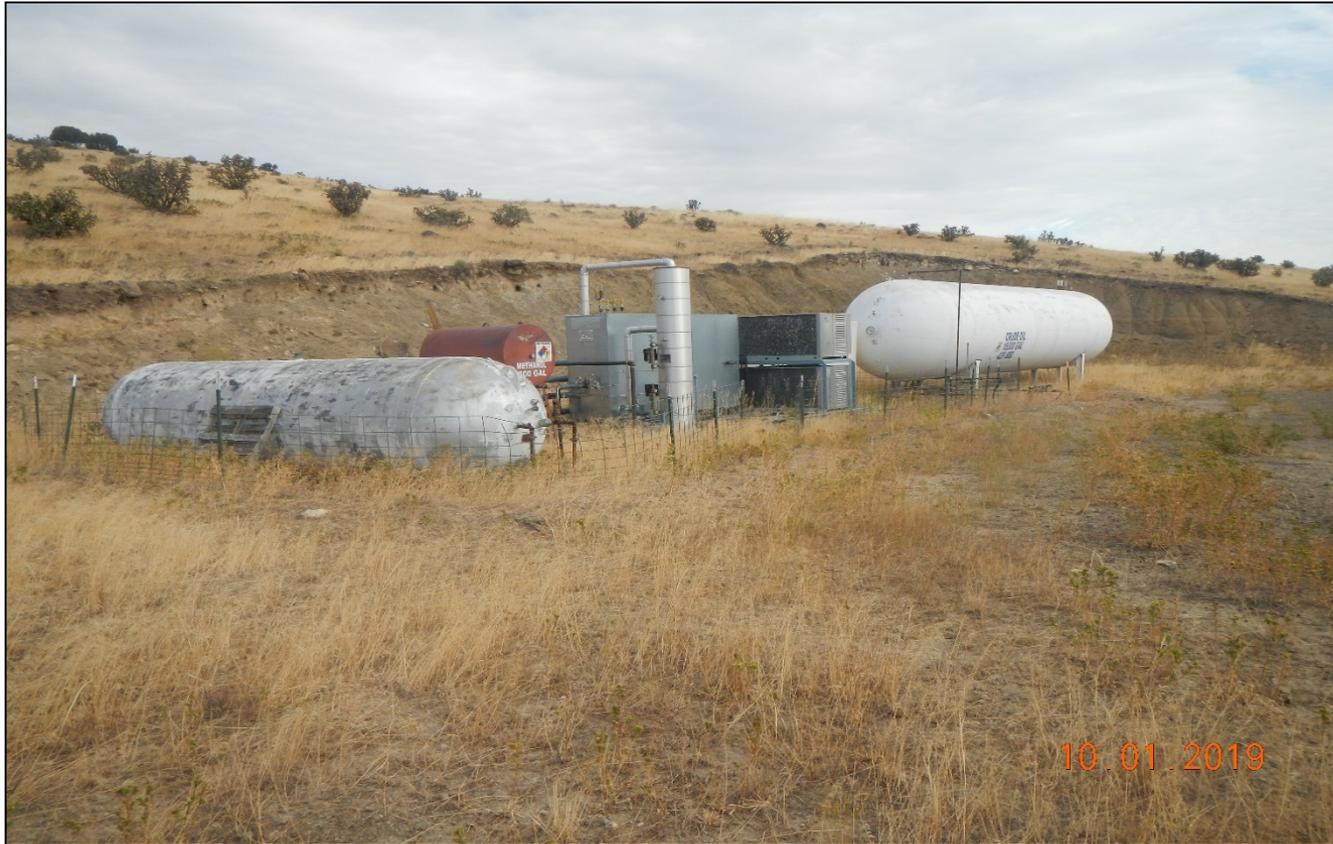
Photo 4. Facing towards the storage tanks. The berm appears to be inadequate and there is dry vegetation around the tanks which is a fire hazard.

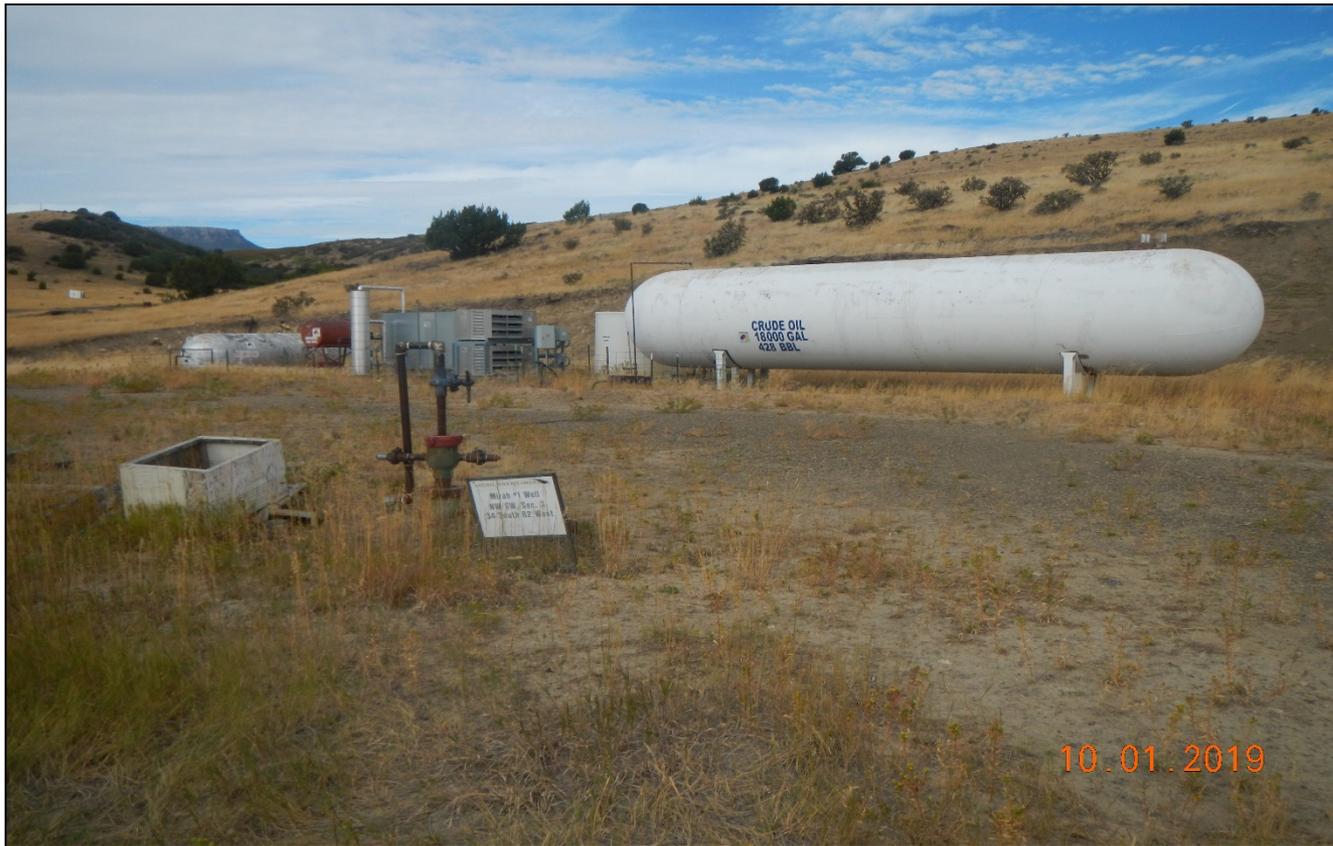
Photo 5. The sign at the well head does not display an emergency contact number, operator number, and public road description.

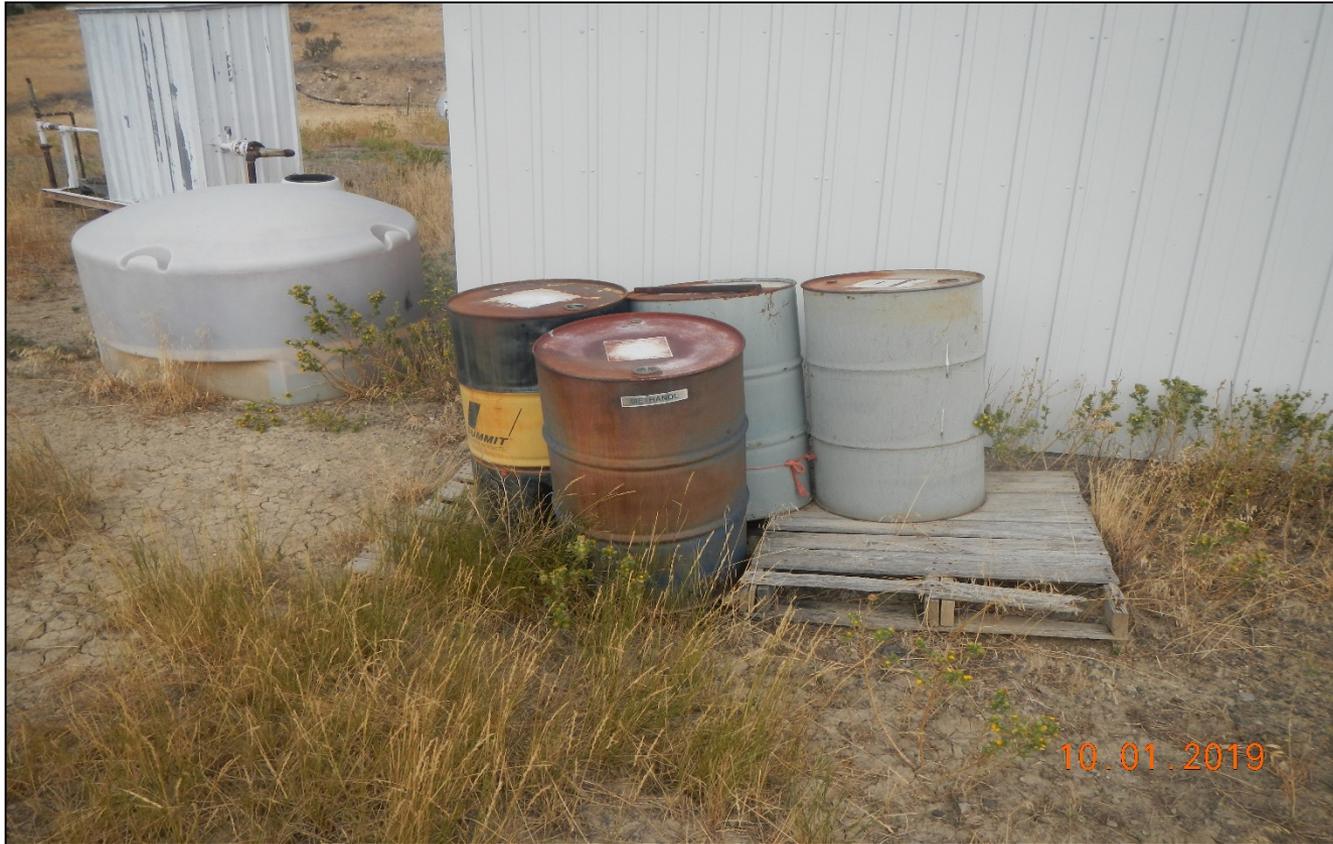
Photo 6. There are barrels stored near the building at the center of the location. Labels are not legible and contents unknown. There is various unused equipment.
