# Inspection Photos

10/09/2019

Operator: FRITZLER RESOURCES INC - 31257

Location ID: 316908

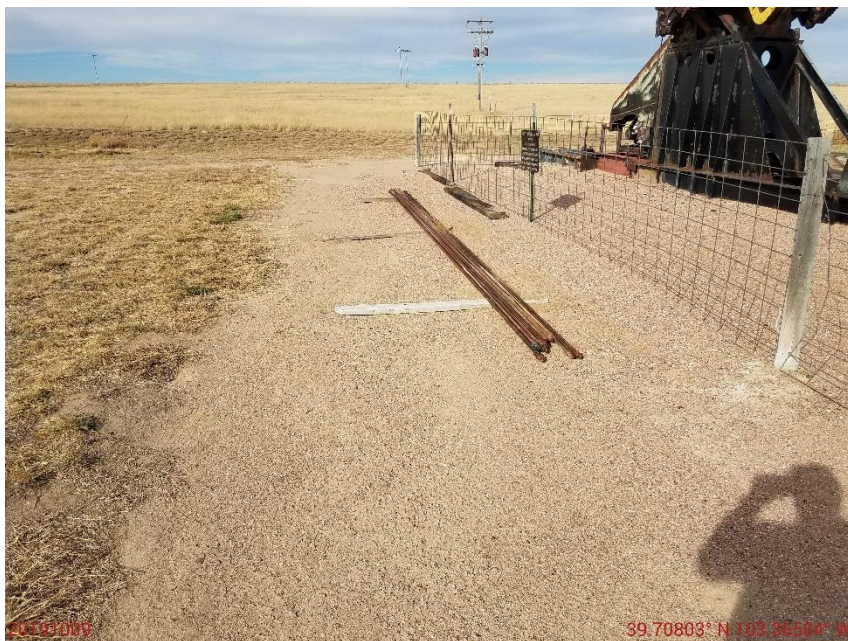
**Photo 1:** Photo taken from the south end of the pump unit, facing west. Photo shows equipment (pipe) not needed for production has not been removed from the location

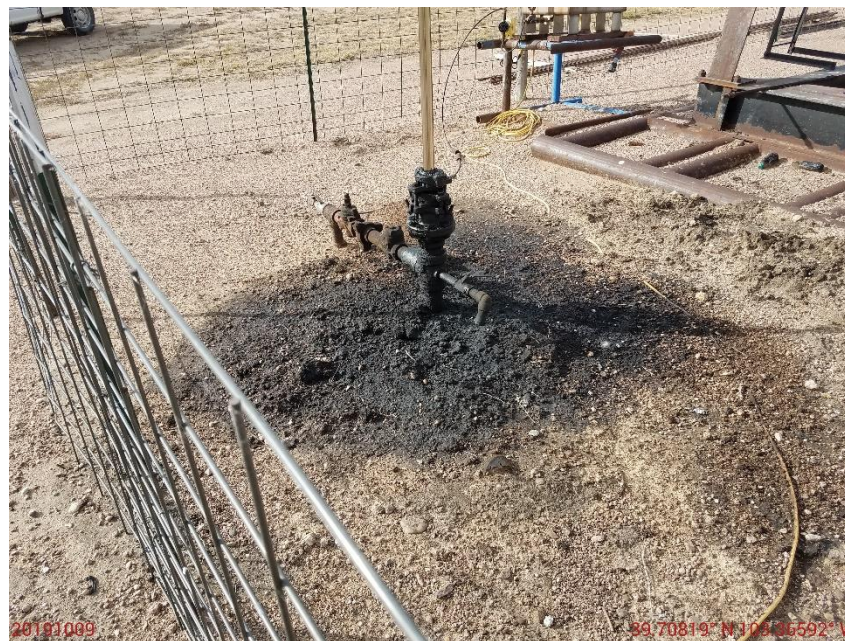
**Photo 2:** Photo taken from the well, facing south. Photo shows stained soils have not been removed from wellhead. Area of contamination also appears to have expanded since previous inspection dated 5/20/2019.

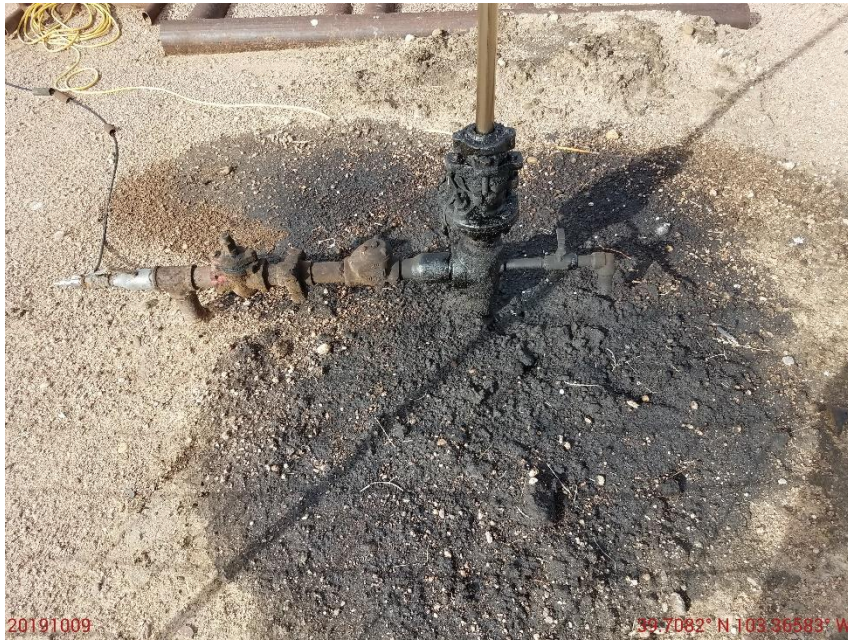
**Photo 3:** See comments under photo2.

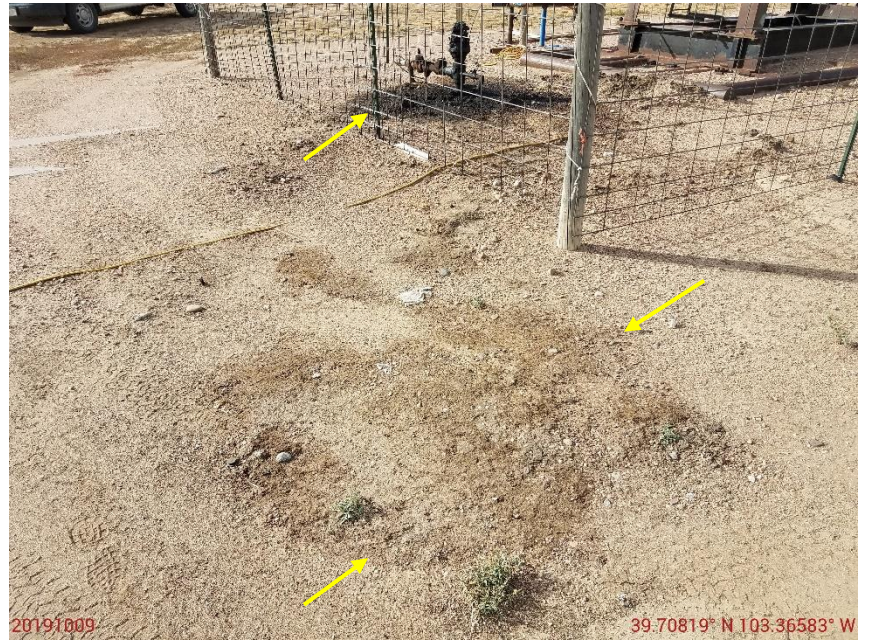
**Photo 4:** See comments under photo 2.

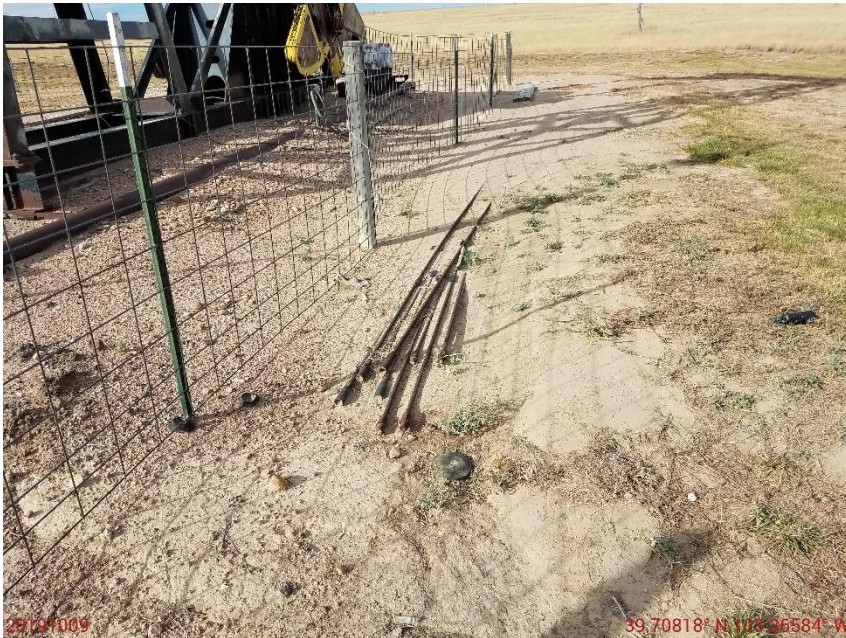
**Photo 5:** Photo taken from the north end of the pump unit, facing west. Photo shows equipment (pipe) not needed for production has not been removed from the location

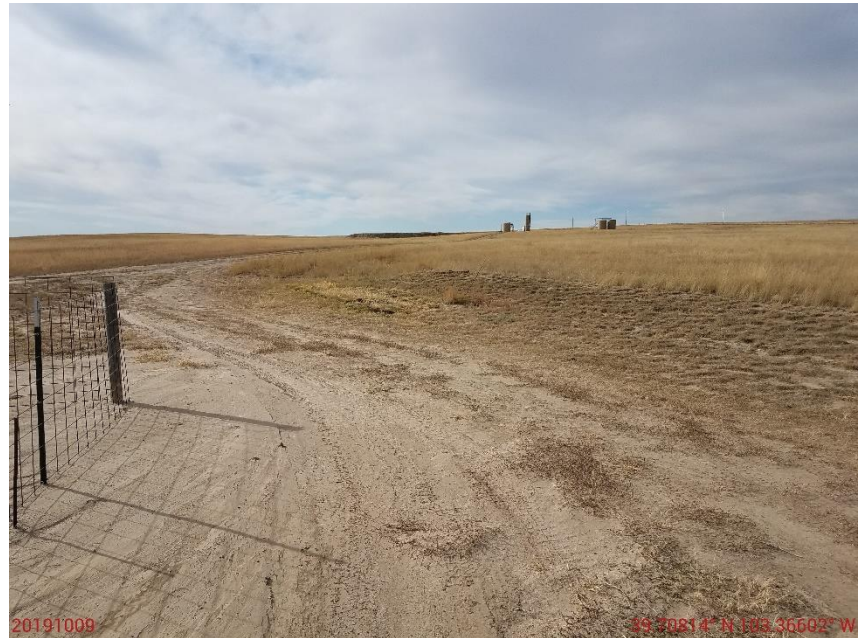
**Photo 6:** Photo taken from the west end of the location. Photo shows equipment observed stored on the west end of the location has been removed.

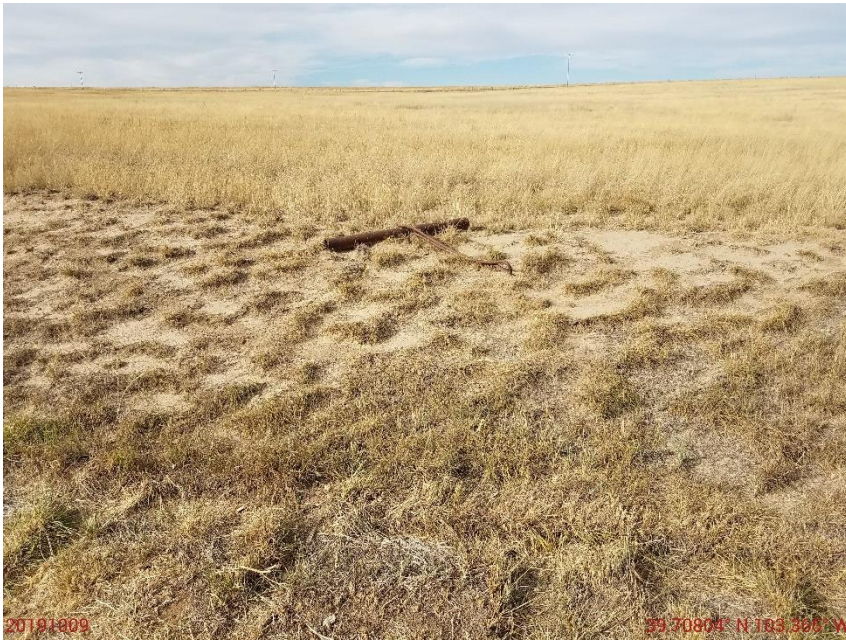
**Photo 7:** Photo taken from the southwest (Southwest anchor). Photo shows trash debris, or equipment, remaining on location.

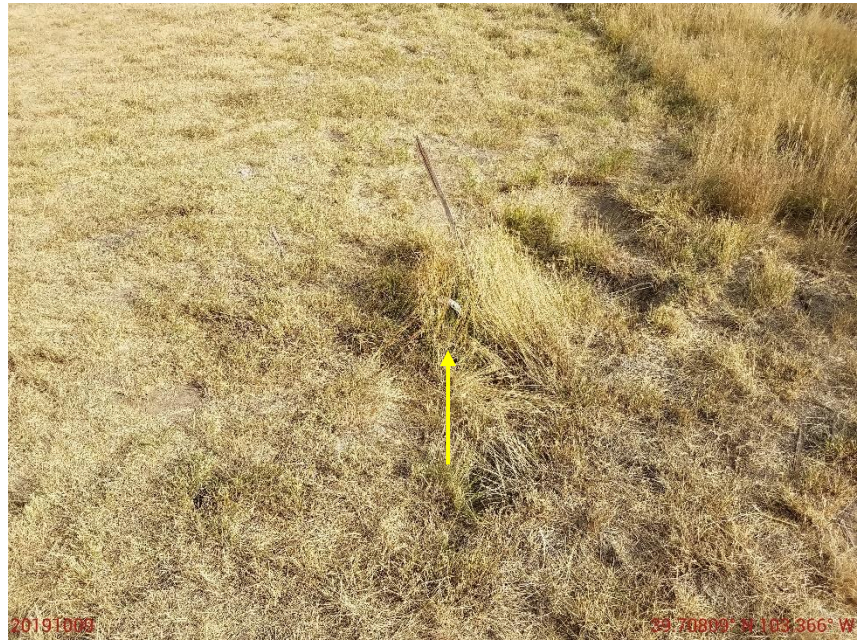
**Photo 8:** Photo taken from the southeast corner of the well location. Previous inspections required operator to comply with rule 1003 and mark anchors. Photo shows anchor on the southeast end of the location has not been marked in accordance with 1003 rules.

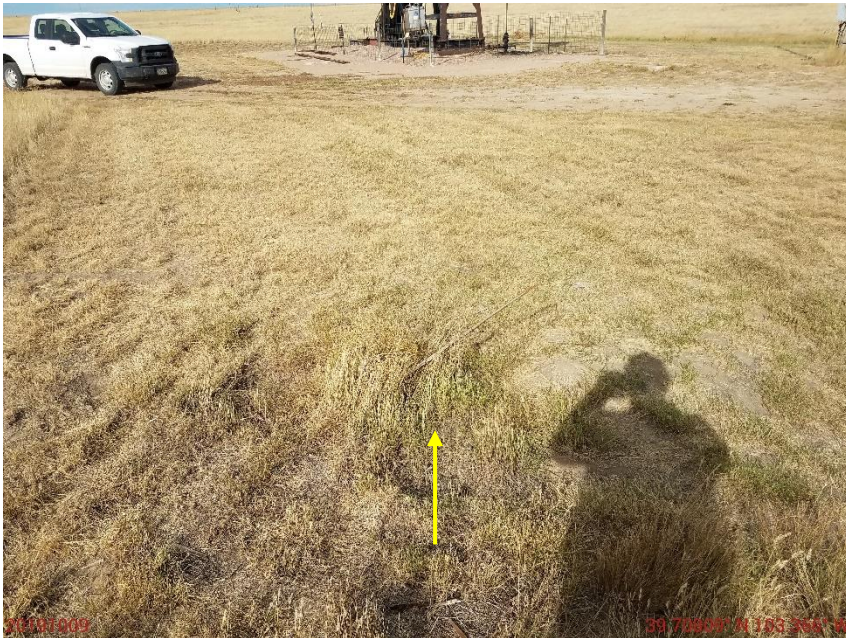
**Photo 9:** See comments under photo 8.

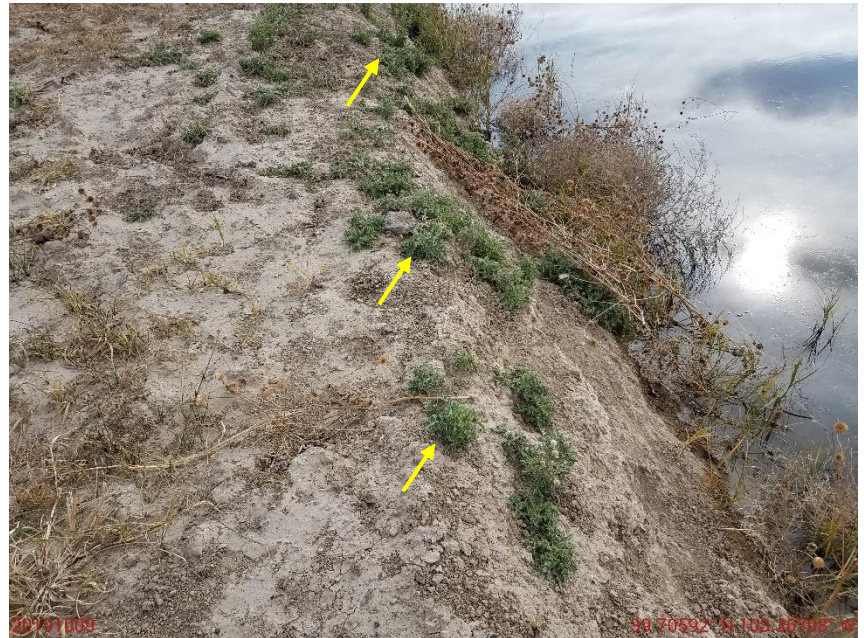
**Photo 10:** Previous inspections documented noxious weed establishment, and required operator to comply with Rule 1003.f.

Photo shows noxious weeds (Canada Thistle) remains established on location/pits.

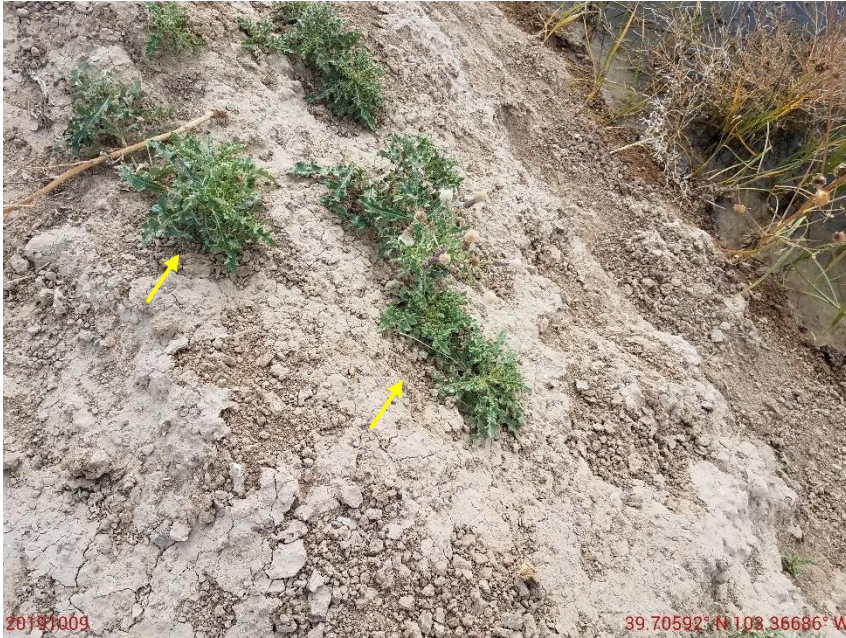
**Photo 11:** See comments under photo 10.

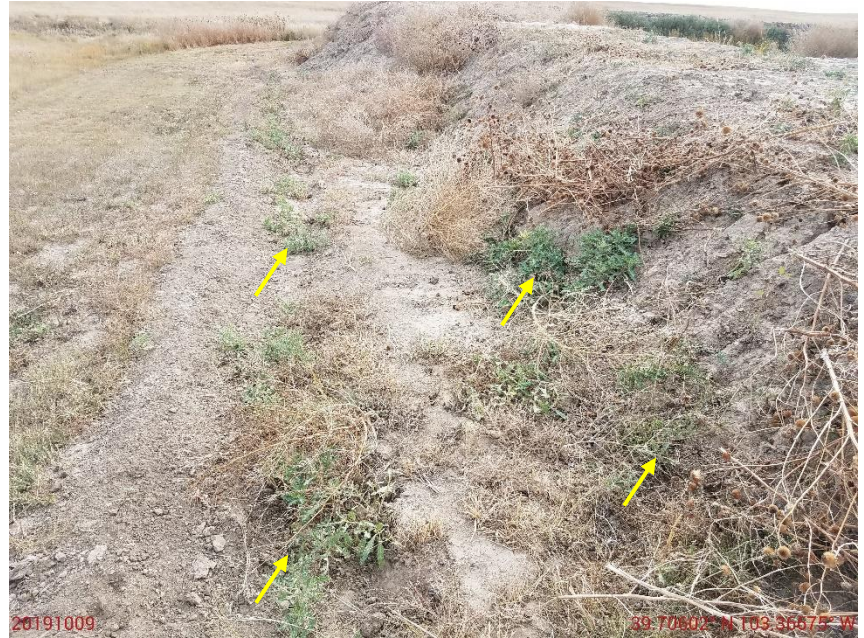
**Photo 12:** See comments under photo 10.
