Inspection Photos

Location Name: OUTPOST 22-24 TR FOLLOWUP

API#: 05-071-09193

INSP. #: 695101544

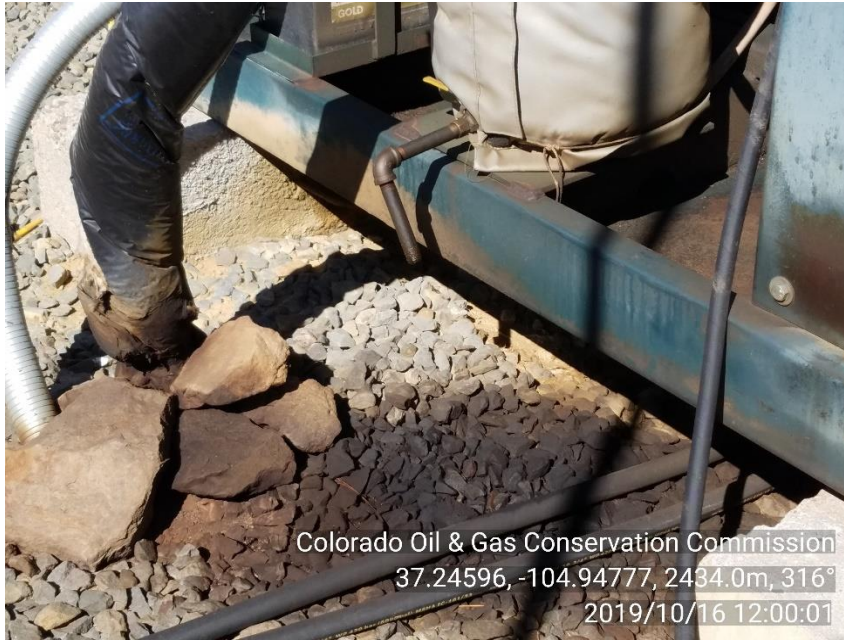
Colorado Oil & Gas Conservation Commission
37.24596, -104.94777, 2434.0m, 316°
2019/10/16 12:00:01

PHOTO 3: AREA OF IMPACTED SOIL NEAR DRAIN ON ENGINE SKID FOR ORIGINAL WELL EQUIPMENT. IT APPEARS THAT A DRAIN ON UNIT IS BEING DRAINED ON THE GROUND.

IMMEDIATELY STOP DRAINING FLUIDS ON THE GROUND, Properly treat or dispose of oily waste in accordance with 907.e. CA DATE 11-16-19.

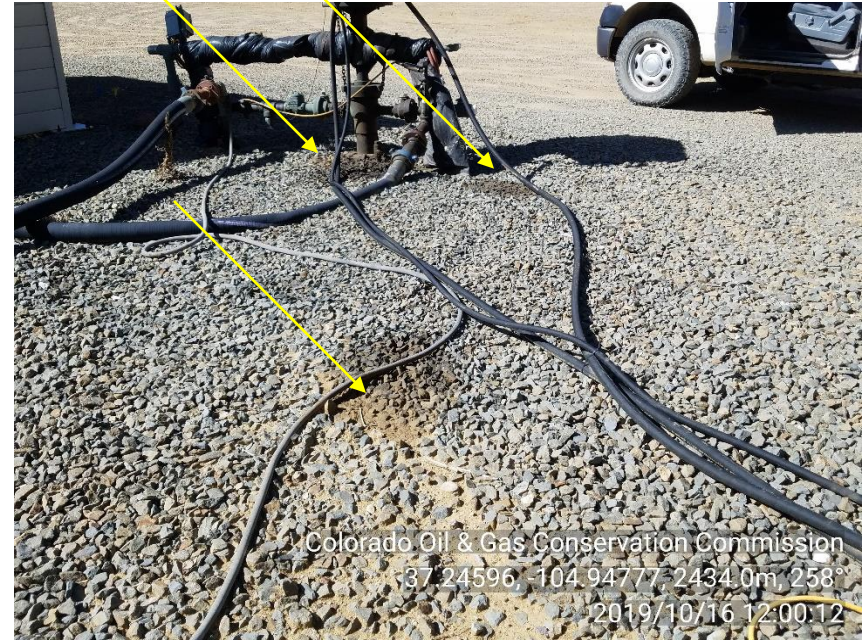
Colorado Oil & Gas Conservation Commission
37.24596, -104.94777, 2434.0m, 258°
2019/10/16 12:00:12

PHOTO 4: SEVERAL SPOTS OF IMPACTED SOIL BETWEEN ORIGINAL WELLHEAD AND ENGINE SKID. Properly treat or dispose of oily waste in accordance with 907.e. CA DATE 11-16-19.

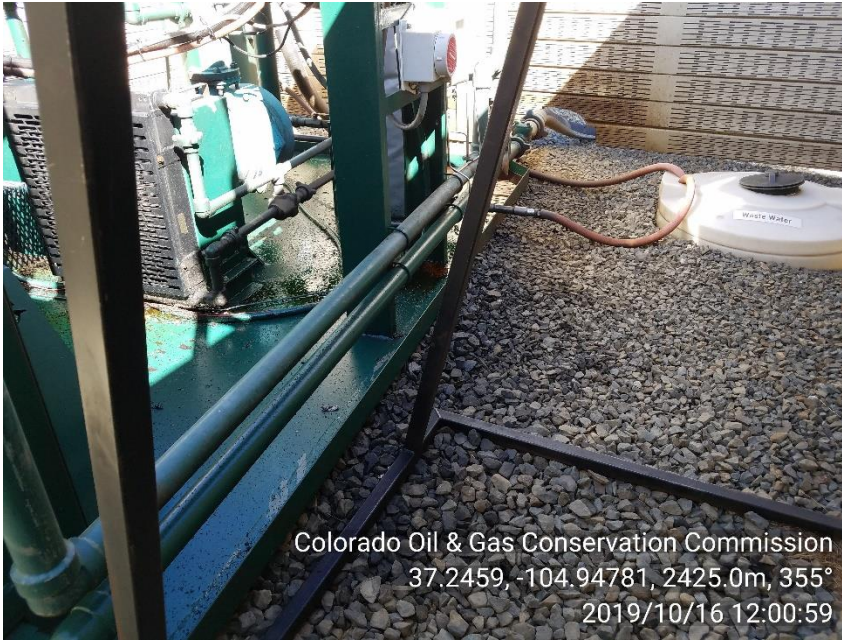
Colorado Oil & Gas Conservation Commission
37.2459, -104.94781, 2425.0m, 355°
2019/10/16 12:00:59

PHOTO 5: AREA OF IMPACTED SOIL AROUND COMPRESSOR SKID. Properly treat or dispose of oily waste in accordance with 907.e. CA DATE 11-16-19.

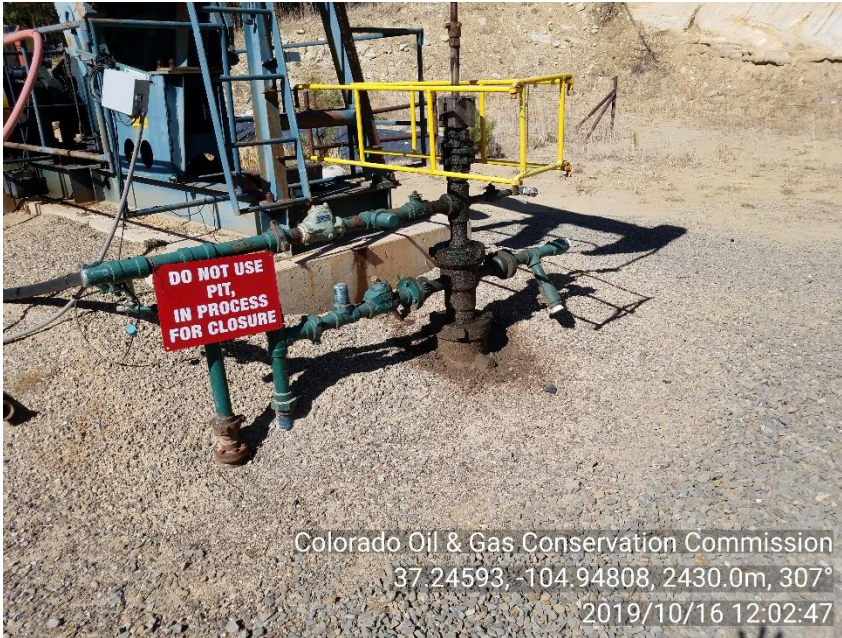
PHOTO 7: AREA OF IMPACTED SOIL AROUND TR WELLHEAD.
Properly treat or dispose of oily waste in accordance with 907.e. CA DATE 11-16-19.

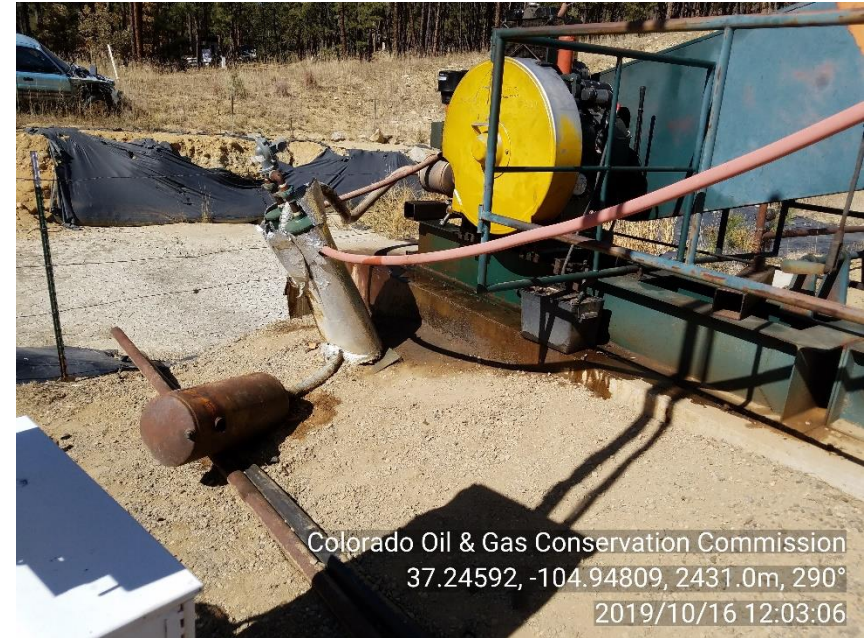
PHOTO 8: AREA OF IMPACTED SOIL AROUND TR WELLHEAD.
Properly treat or dispose of oily waste in accordance with 907.e. CA DATE 11-16-19.

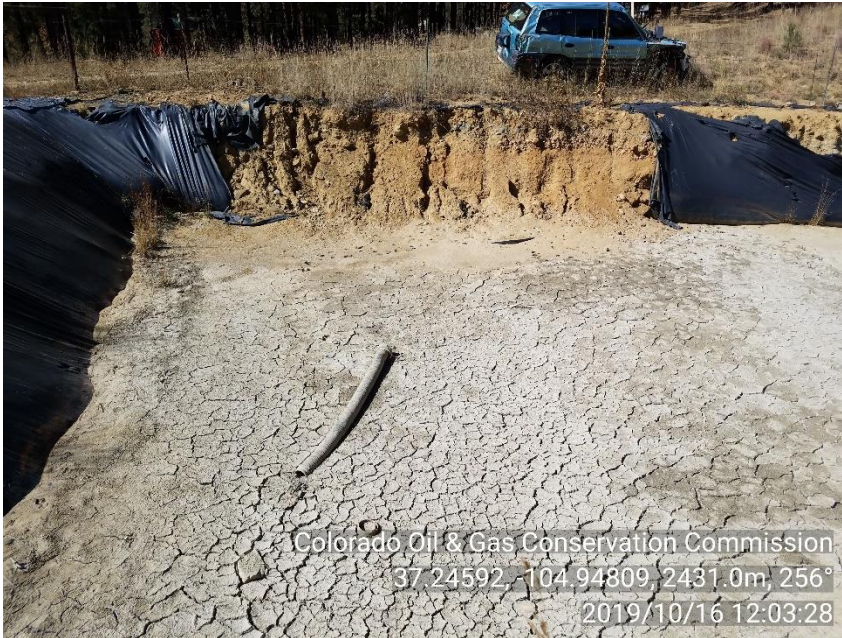
PHOTO 9: LINER ON TR WELL PIT, THIS IS THE SECOND WARNING ON CORRECTIVE ACTION. SIGN AT WELLHEAD STATES PIT IS IN PROCESS FOR CLOSURE. PIECES OF LINER ARE BEING SPREAD AROUND LOCATION AND OFF SITE.
COMPLY WITH RULE 603.f. CONCERNING TRASH ON AND AROUND LOCATION, REMOVE SOURCE OF TRASH PREADING.
