Interim Reclamation and Stormwater Inspection

Operator: BAYSWATER EXPLORATION AND PRODUCTION LLC - #10261

Location ID: 456151

Inspection Photos
Location Name: Hester Farms II /31-H Pad
Location ID: 456151

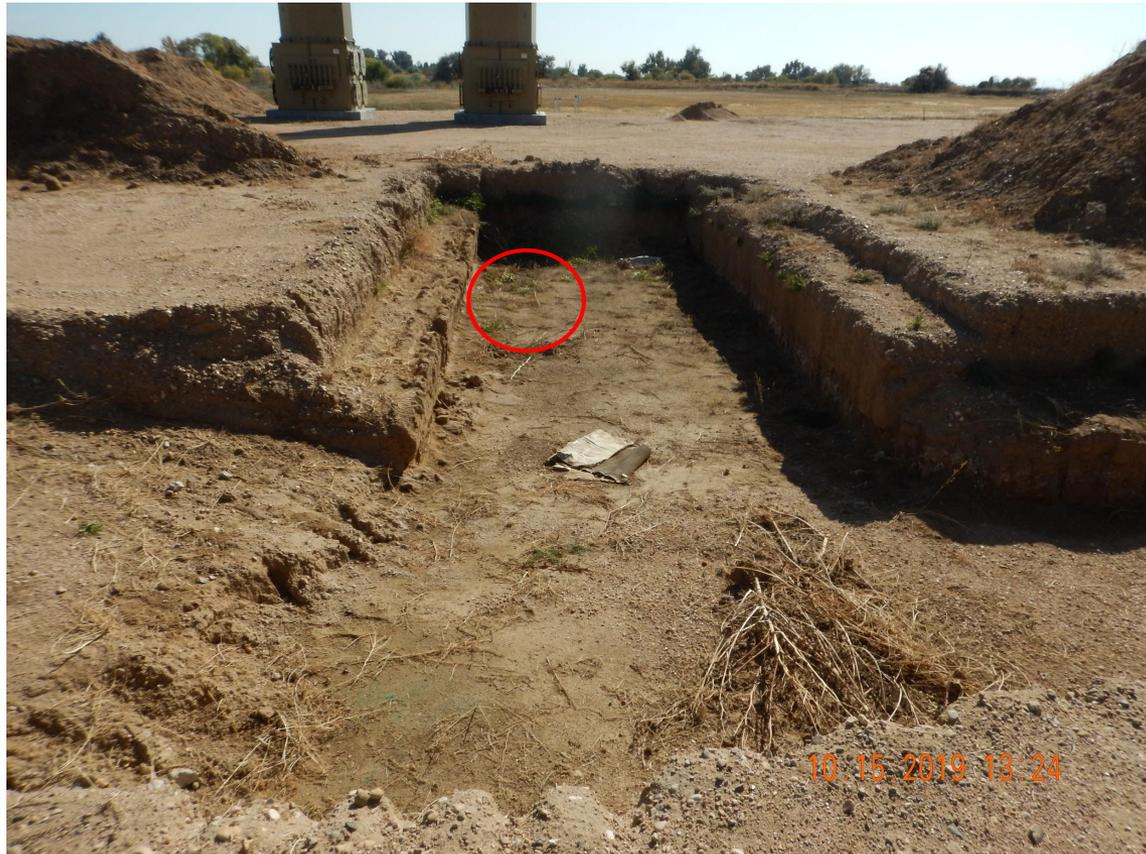
Photo 1. Photo taken on October 15, 2019 from the pit area, facing South. Photo illustrates the general location (red circle) of the wildlife bird mortality that still remains after approximately one month since discovery by COGCC staff.

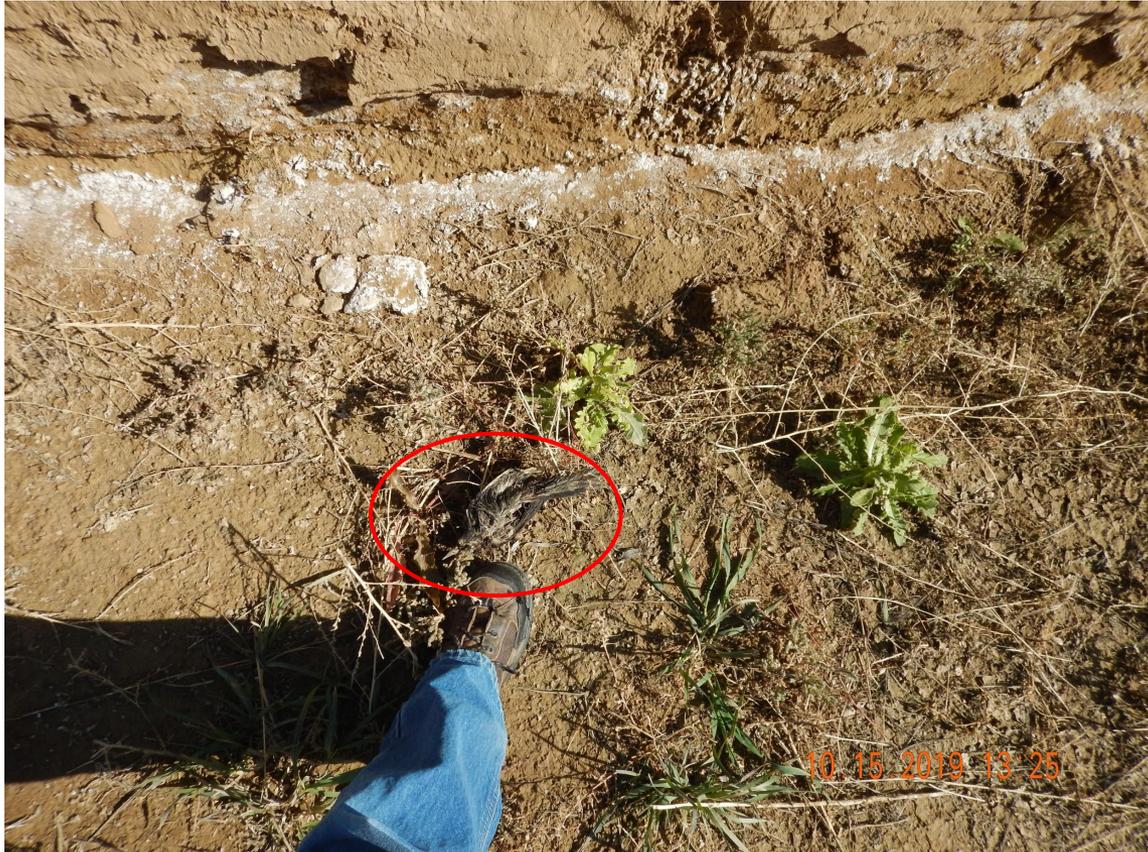
Photo 2. Close up photo taken on October 15, 2019 from the pit area illustrating the wildlife bird mortality that still remains.

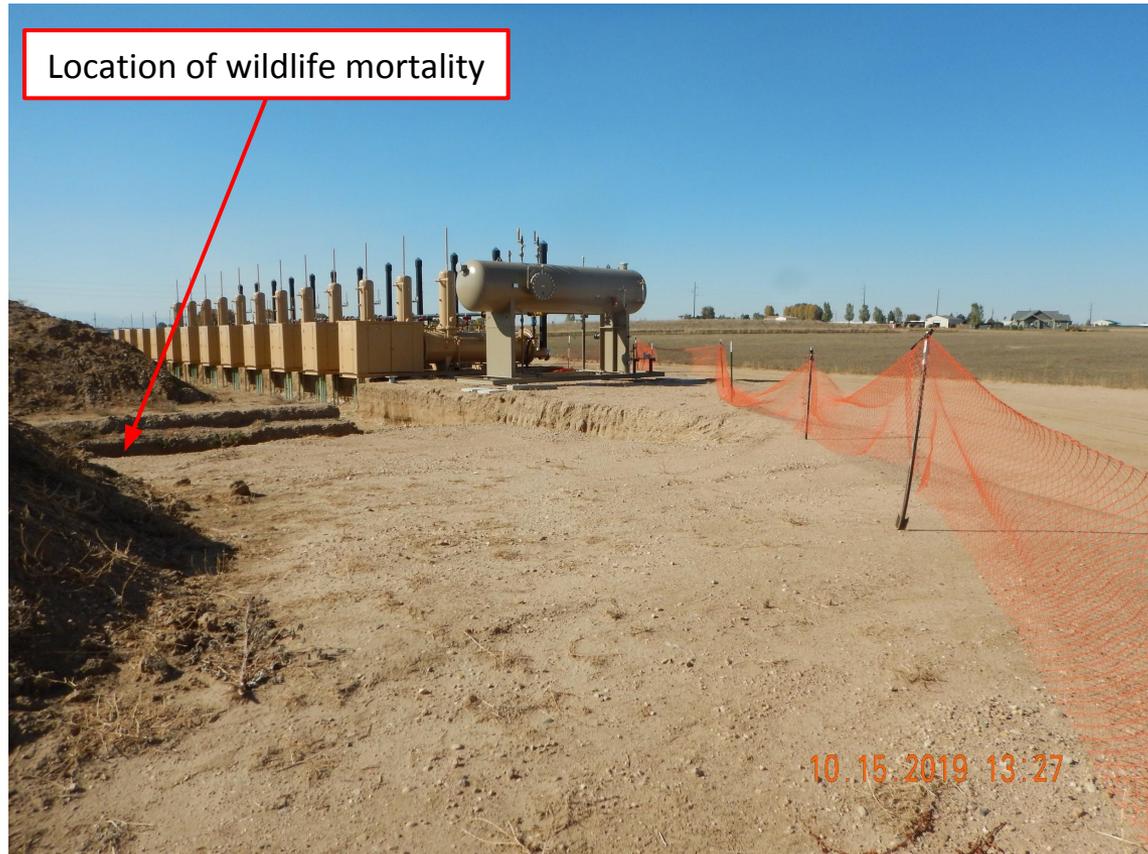
Photo 3. Photo taken on October 15, 2019 from the adjacent pit area, facing West. Photo illustrates the current BMPs which were also in place during the September 17, 2019 inspection.

Note: Operator has haphazardly installed safety fencing around portions of the pit area.

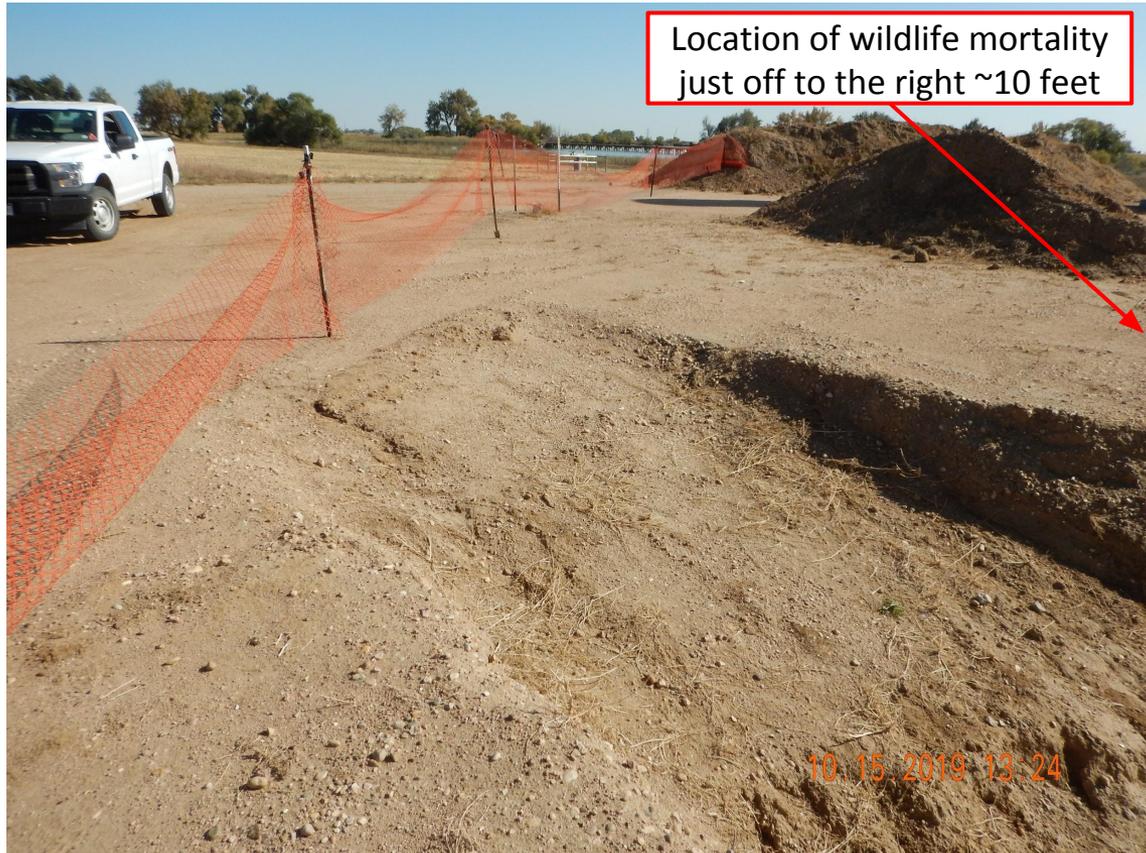
Photo 4. Photo taken on October 15, 2019 from the adjacent pit area, facing East. See comments under Photo 3.

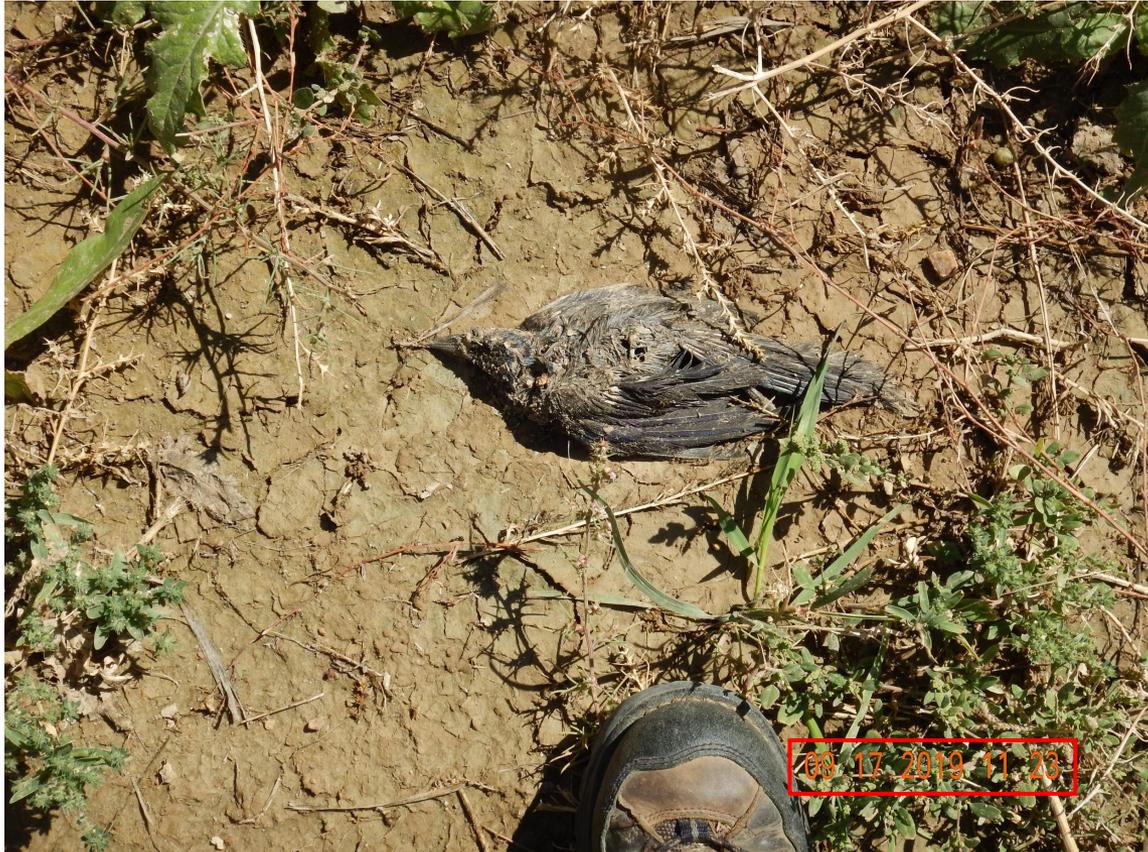
Photo 5. Photo taken on September 17, 2019 from the pit area illustrating a wildlife bird mortality.
