# Final Reclamation Inspection

Operator: SRC ENERGY INC- #10311

Location ID: 330604

Inspection Photos  
Location Name: STATE BEATRICE #32-16  
Location ID: 330604

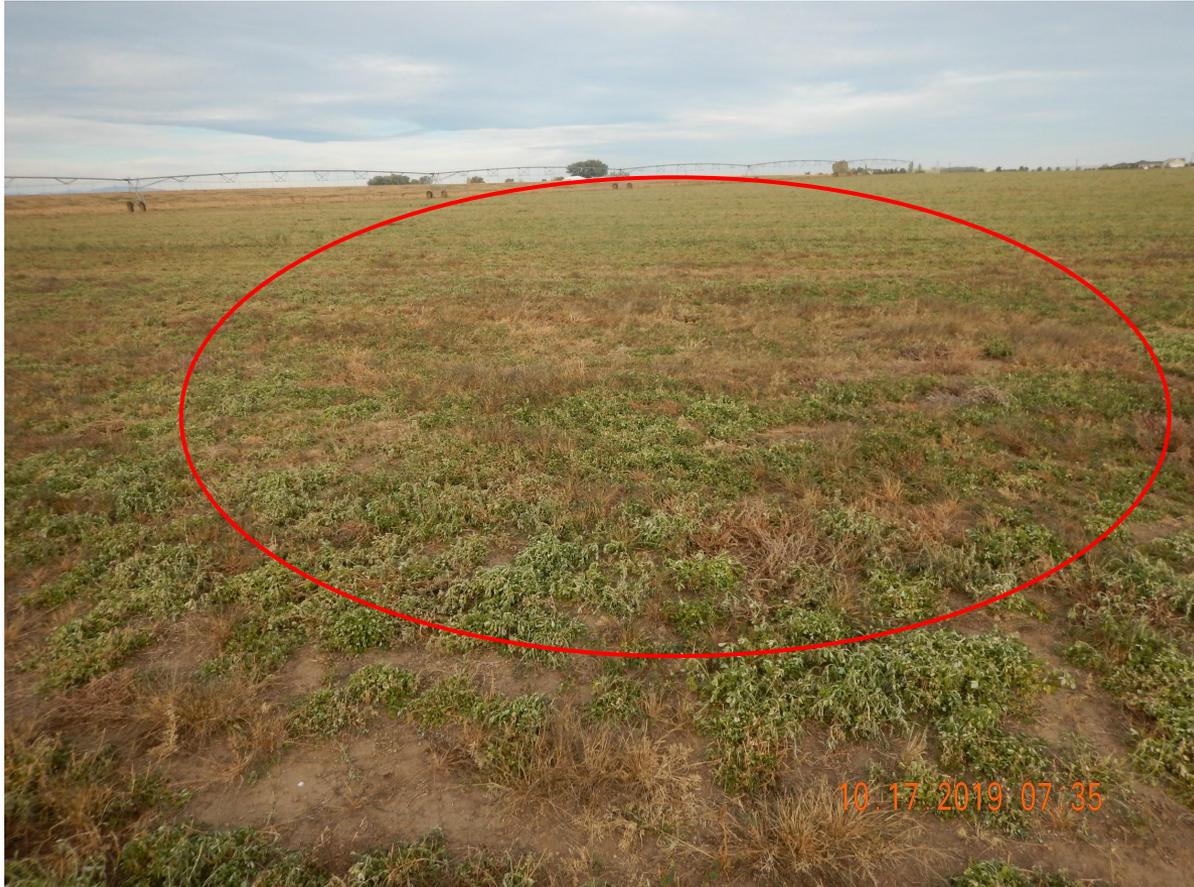
**Photo 1.** Photo taken from the well location, facing North. Photo illustrates the well location has not been properly re-contoured to match the surrounding landscape and/or potential subsidence occurred.

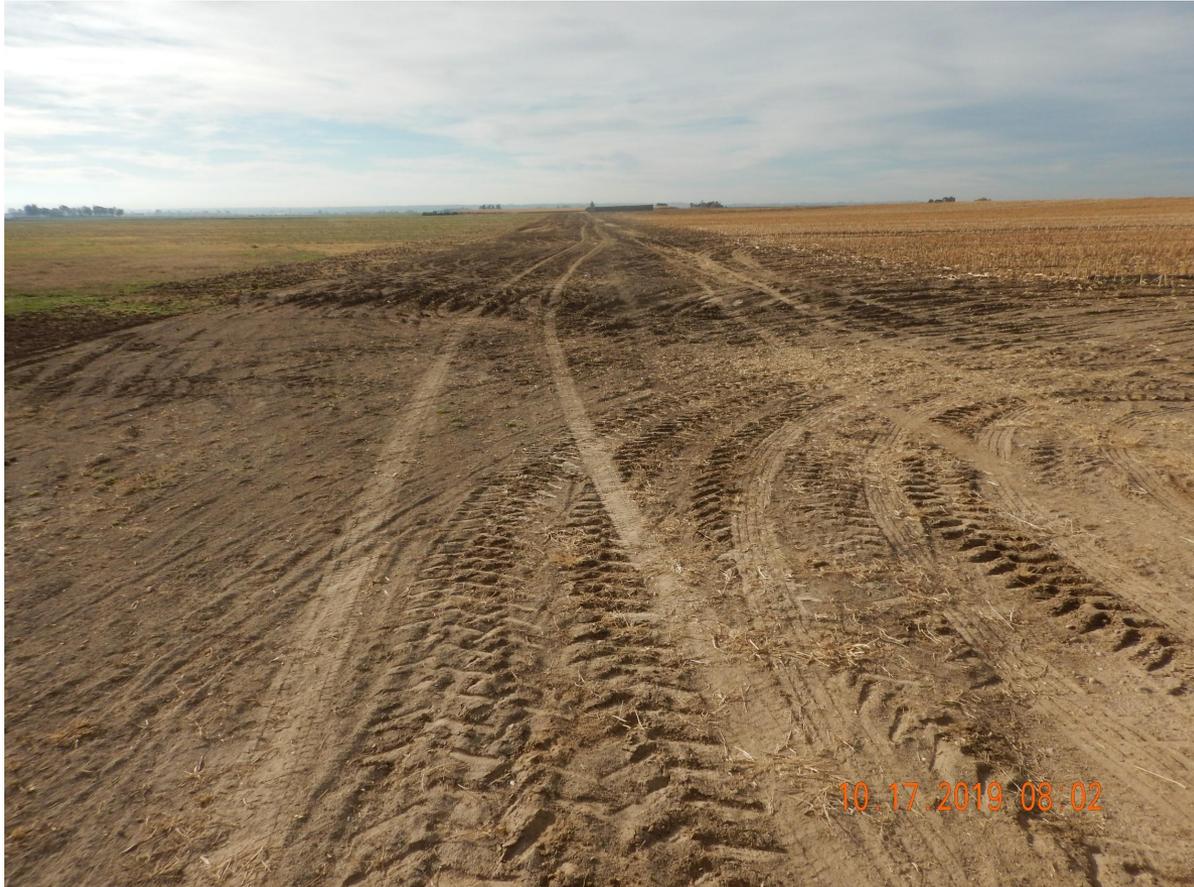
**Photo 2.** Photo taken from the tank battery location, facing South. Appears a recent disturbance has taken place and crop have already been harvested; therefore, COGCC staff could not make a vegetative assessment.

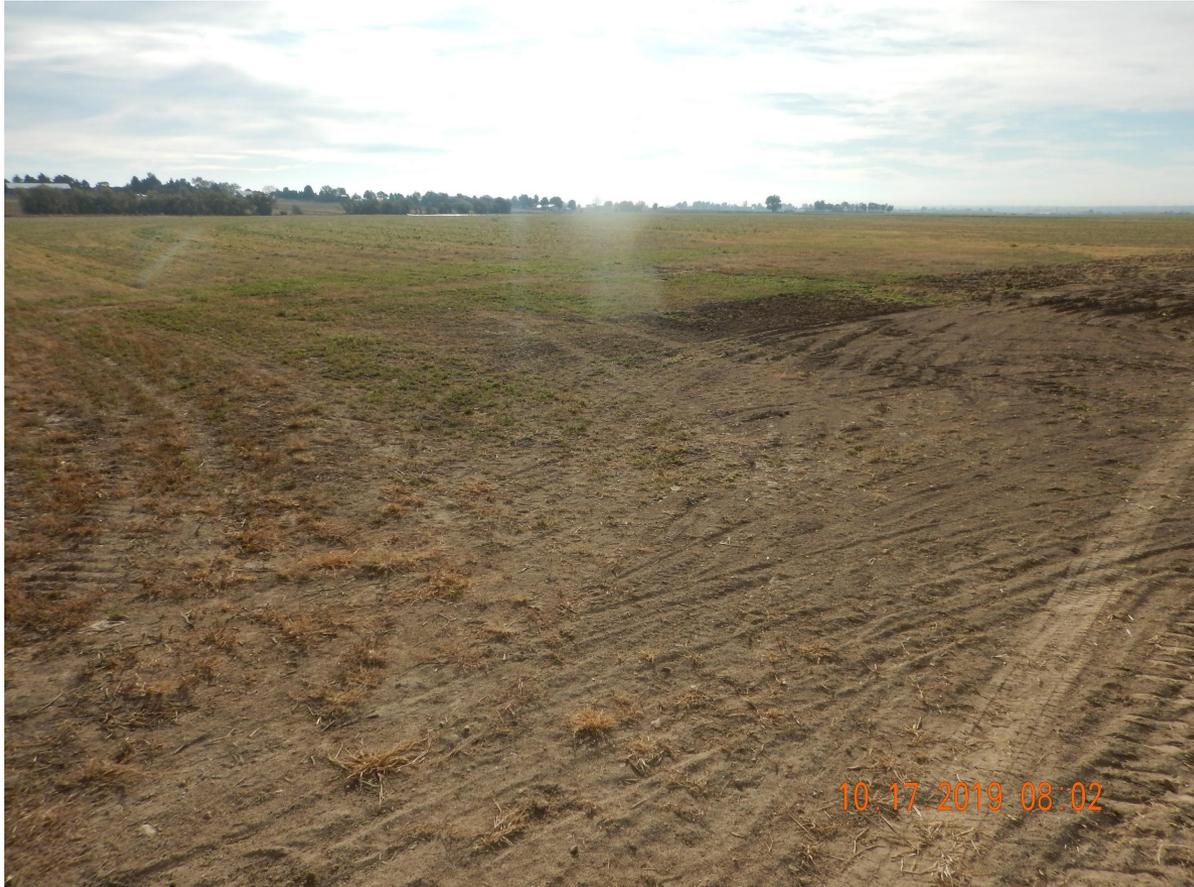
**Photo 3.** Photo taken from the tank battery location, facing Southeast. See comments under Photo 2.
