Final Reclamation Inspection

Operator: SRC ENERGY INC- #10311

Location ID: 310710

Inspection Photos
Location Name: SENA #15-24
Location ID: 310710

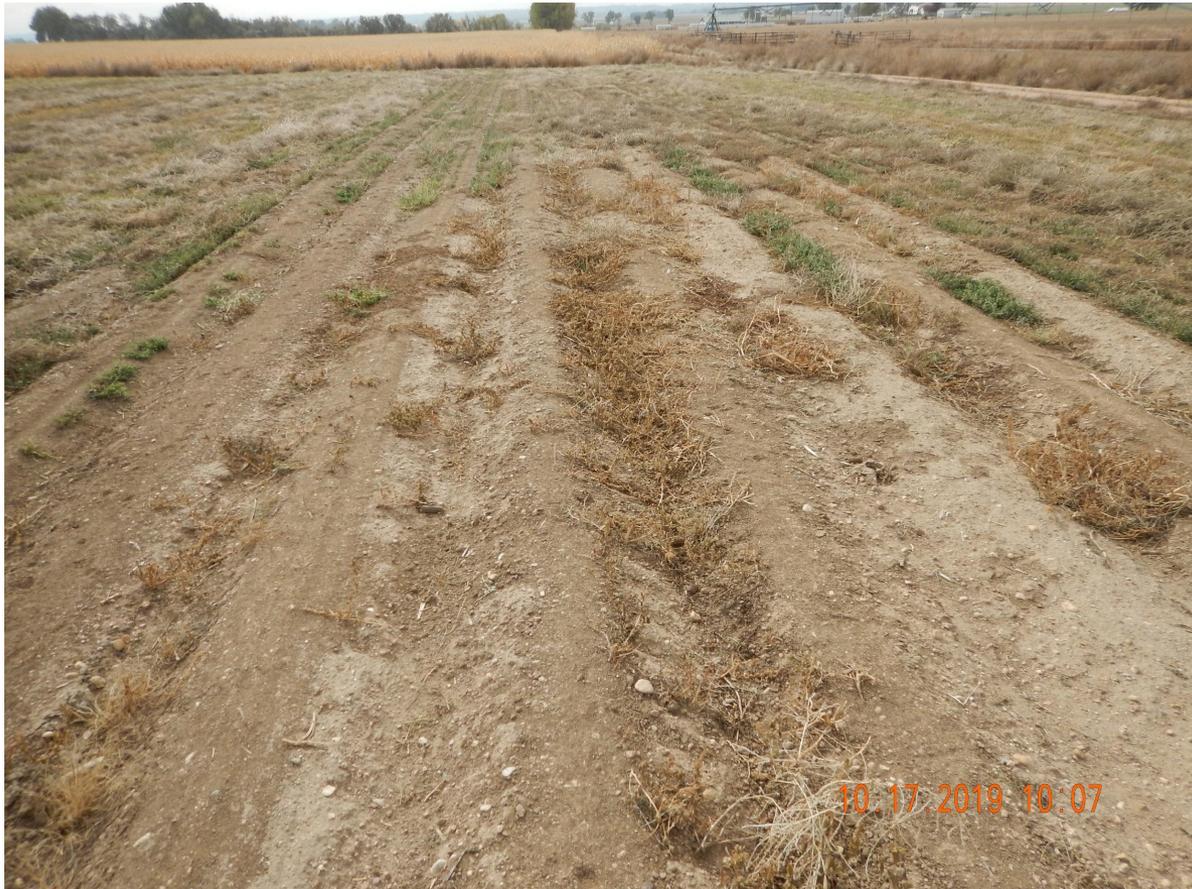
Photo 1. Photo taken from the tank battery location, facing South. There appears to be a lack of crop growth throughout portions of the tank battery.

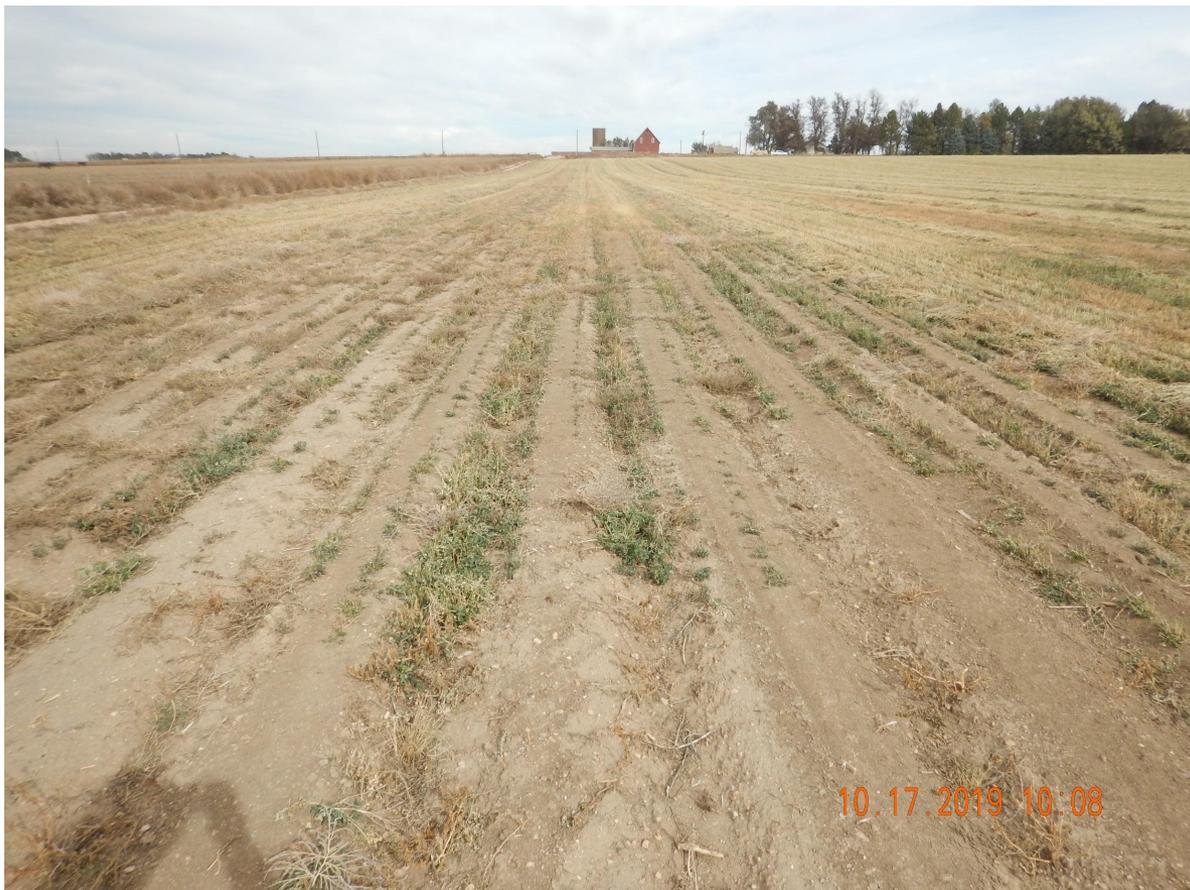
Photo 2. Photo taken from the tank battery location, facing North. See comments under Photo 1.

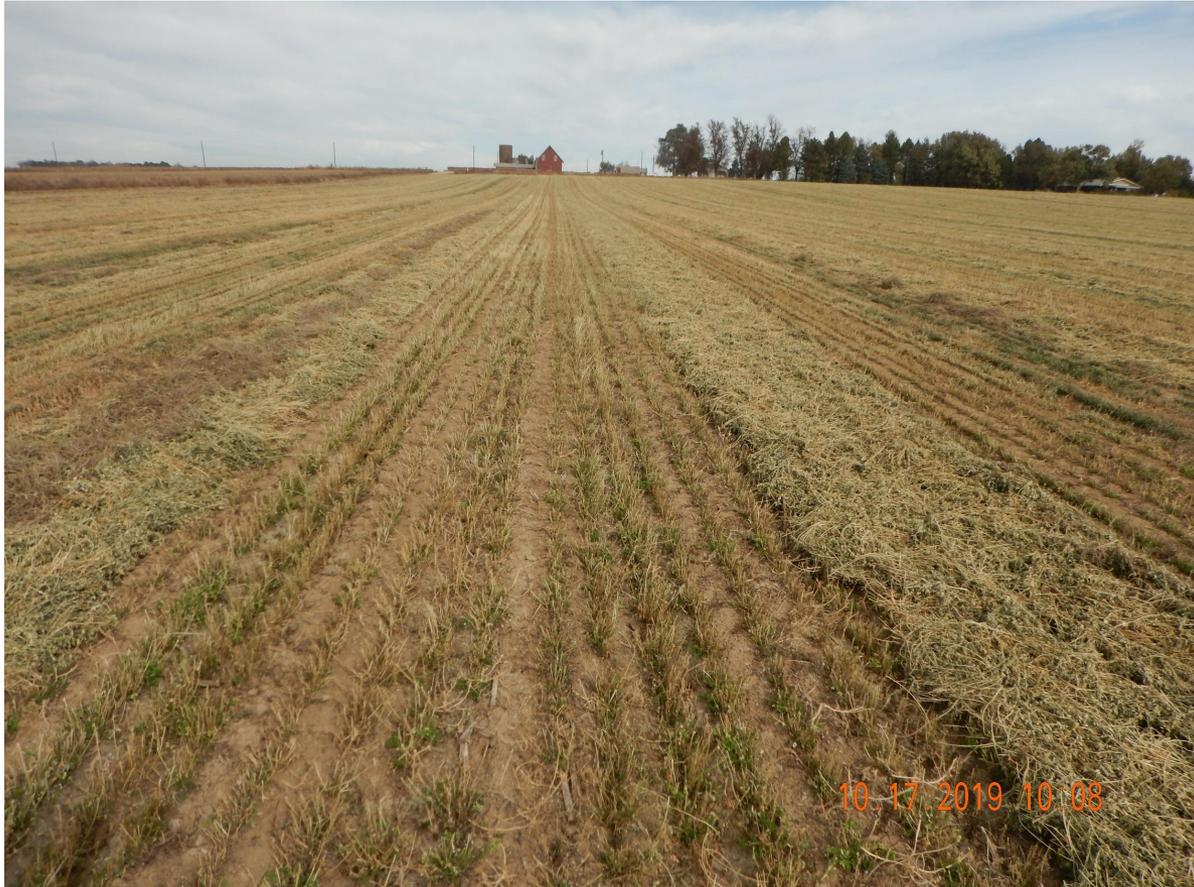
Photo 3. Reference photo taken east of the tank battery location, facing North. Photo illustrates the vegetative difference from a reference crop area vs the lack of growth observed at the tank battery.

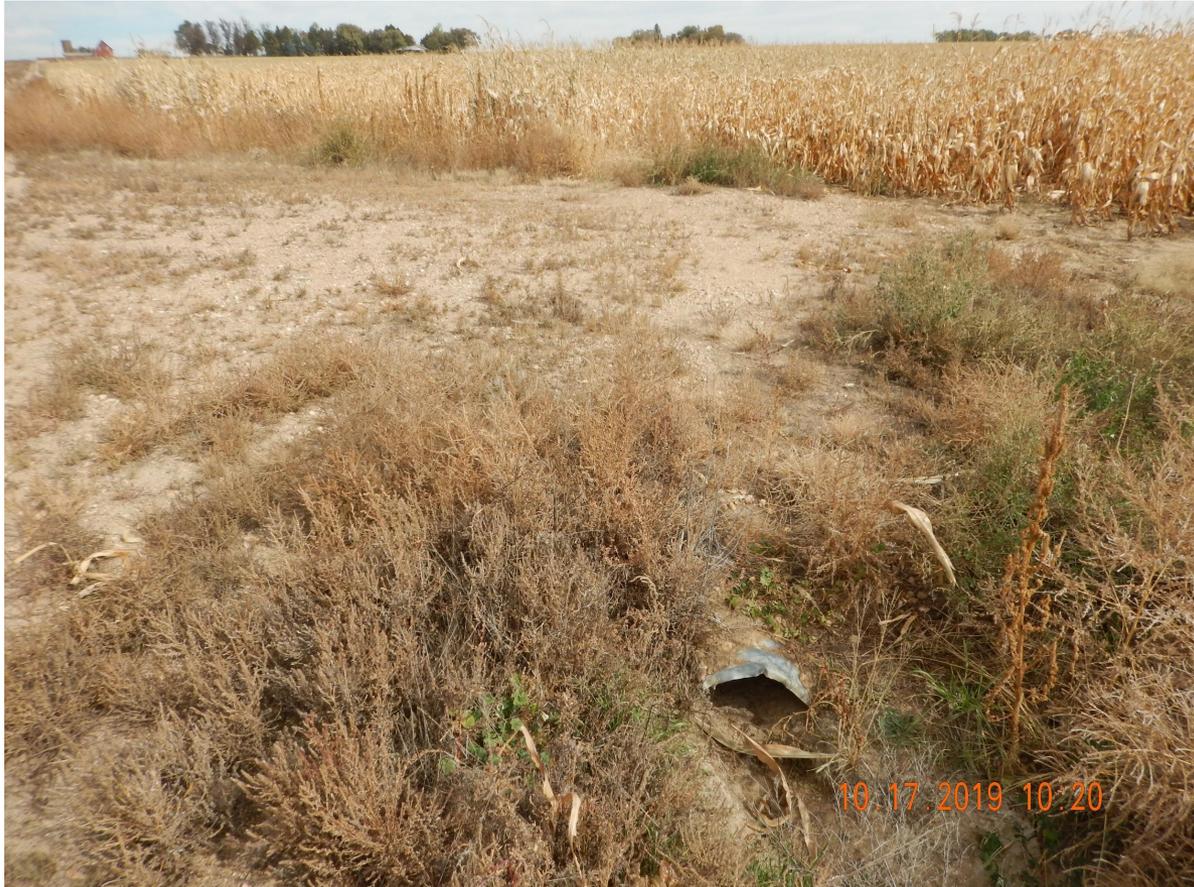
Photo 4. Photo taken from the well location access road, facing North. Operator has failed to remove the access point and culvert.

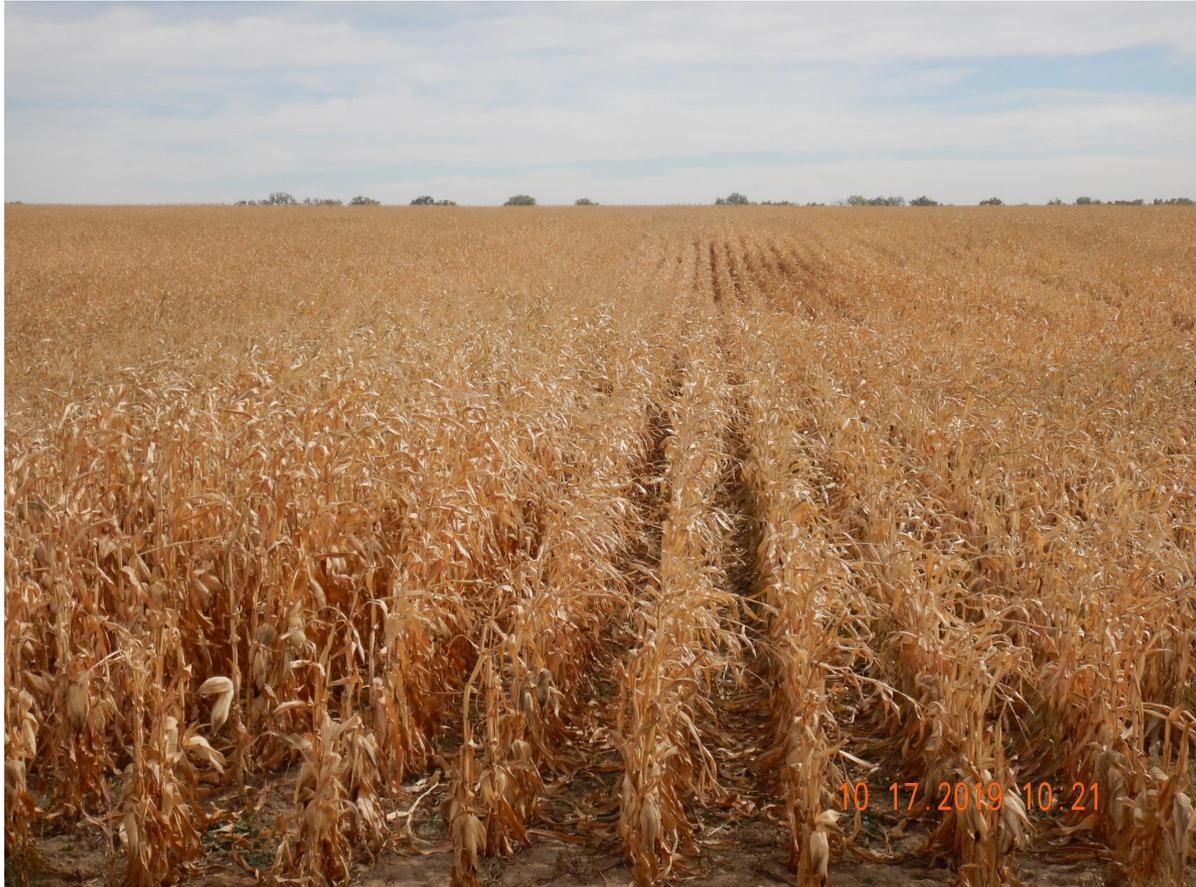
Photo 5. Photo taken from the well location access road, facing East. Well location and well location access road, minus the access point, appear reflective of reference areas.
