Inspection Photos
Location Name: VICTORY 12-14
API#: 05-071-08332
INSP. #: 695101573

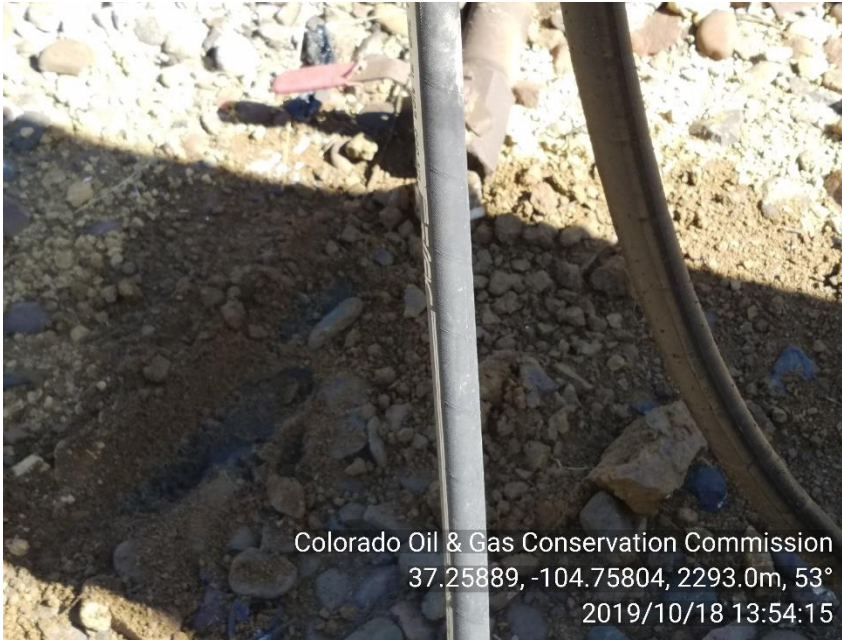
PHOTO 3: AREA OF IMPACTED SOIL NEAR ORIGINAL WELLHEAD APPEARS TO HAVE LEAKING HYDRAULIC HOSE OR QUICK FITTINGS. Properly treat or dispose of oily waste in accordance with 907.e. CA DATE 11-18-19

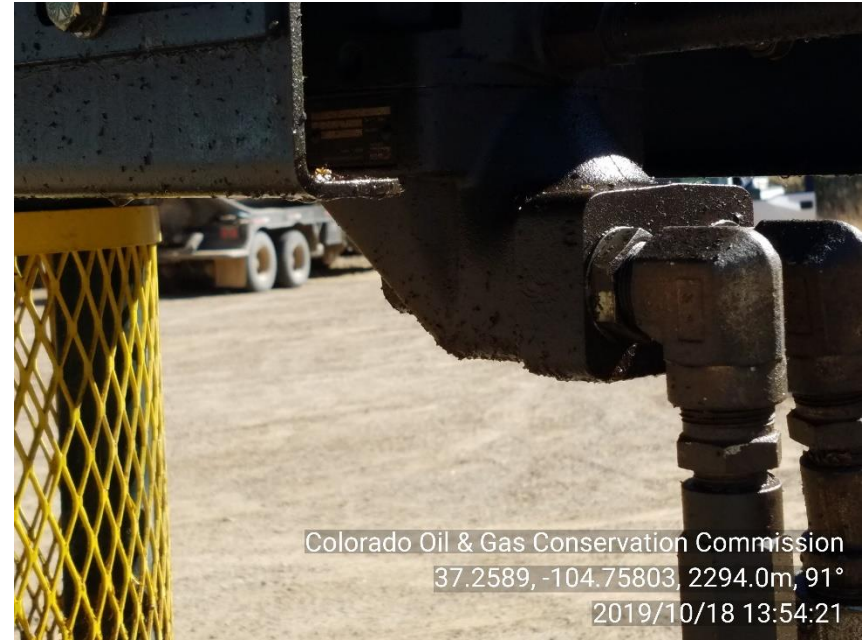
PHOTO 4: FITTING APPEAR TO ME LEAKING
