Inspection Photos
Location Name: MANVILLE 42-14
API#: 05-071-08385
INSP. #: 695101577

Inspection Photos

Location Name: MANVILLE 42-14

API#: 05-071-08385

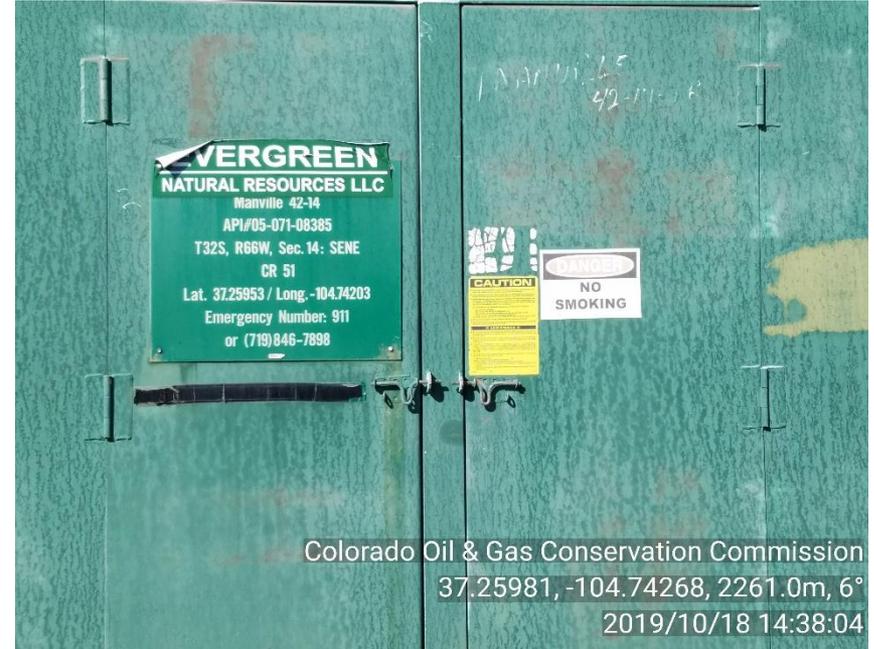
PHOTO 2: WELL SIGN

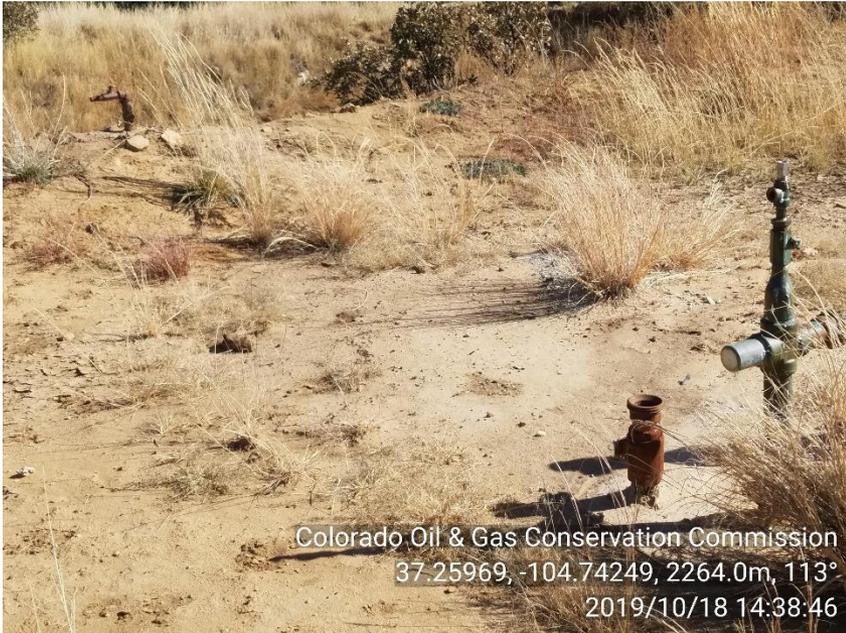
PHOTO 3: 3 UNMARKED UNUSED RISERS, ONE 1" AND TWO 2" RISERS NEAR ORIGINAL WELLHEAD. REMOVE RISER COMPLY WITH NTO. CA DATE 11-18-19

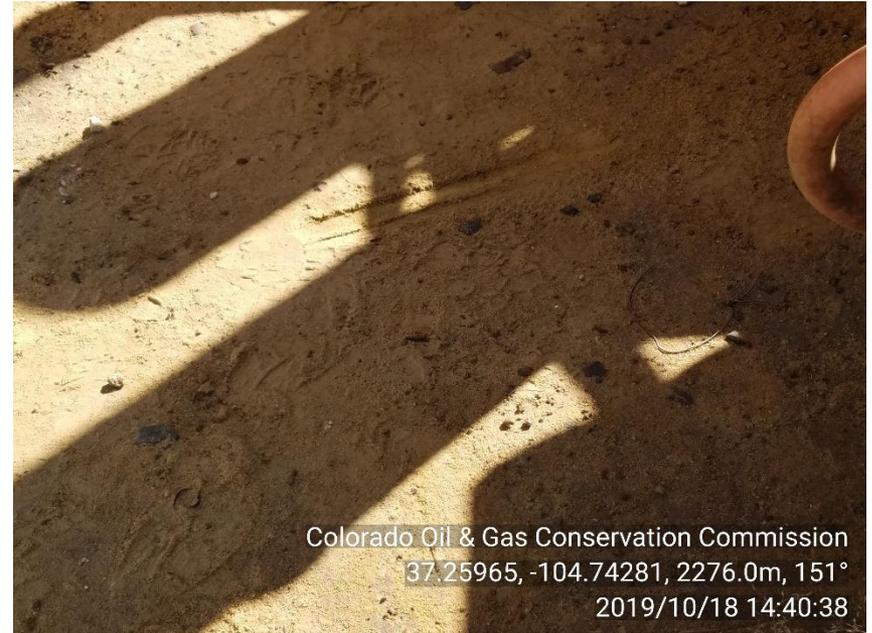
PHOTO 4: IT HARD TO SEE IN PHOTO BUT THERE IS AN AREA OF IMPACTED SOIL NEAR FULL GAS DRAIN ON COMPRESSOR. Properly treat or dispose of oily waste in accordance with 907.e. CA DATE 11-18-19
