**Inspection Photos**  
**Operator: BP America**  
**Location/API #: 067-08862**  
**Date: 10-16-2019**

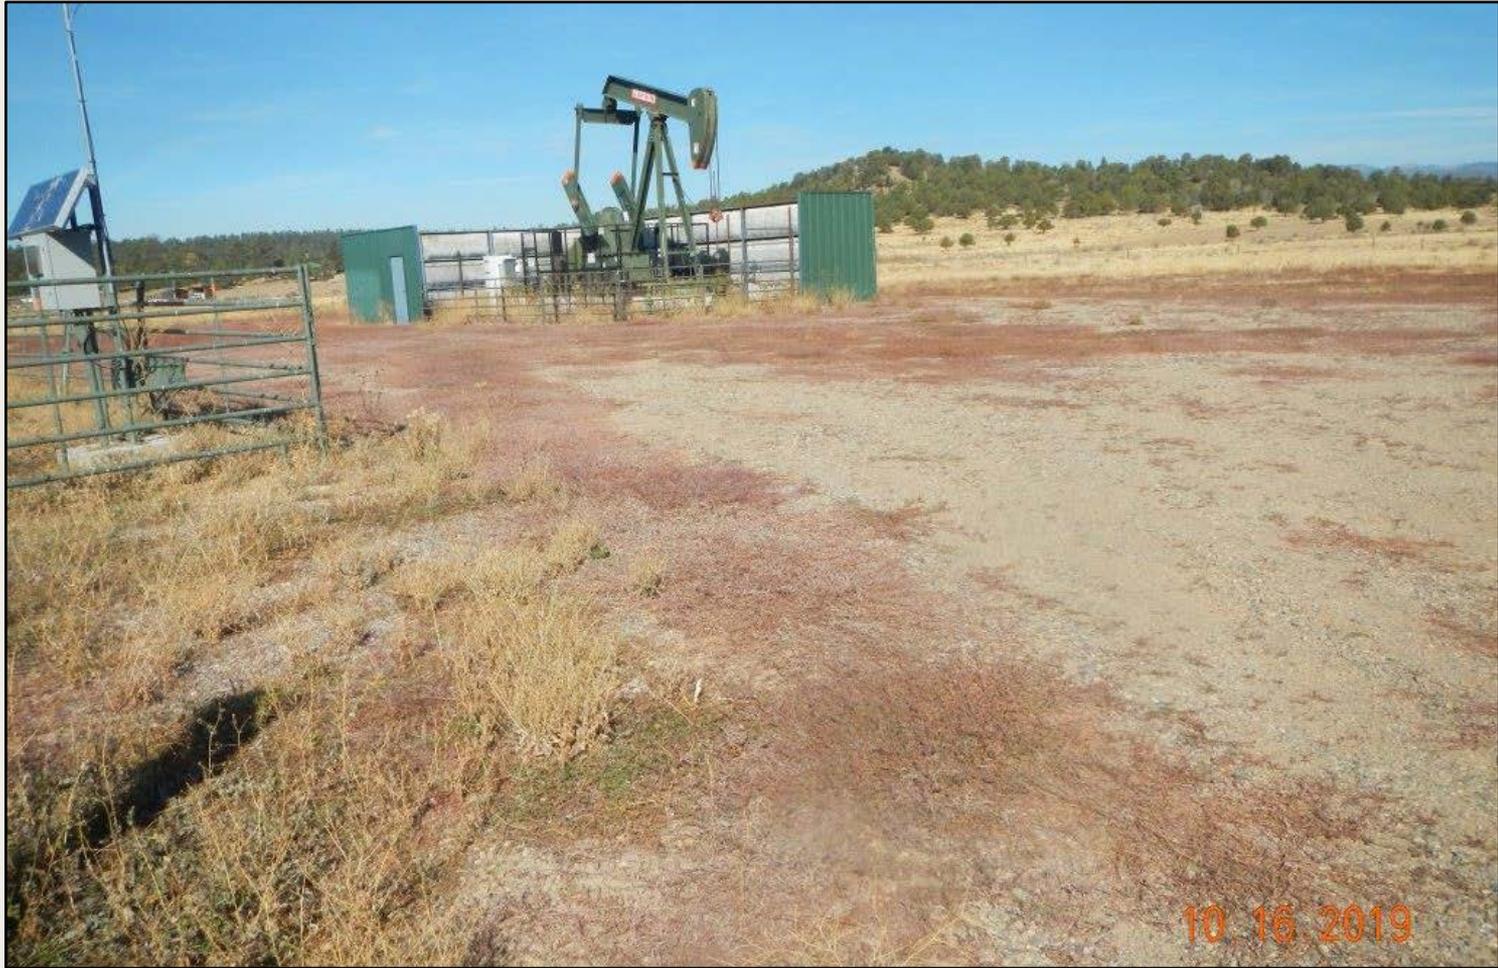
Photo 1. View of the project area from the northern well pad entrance facing center.

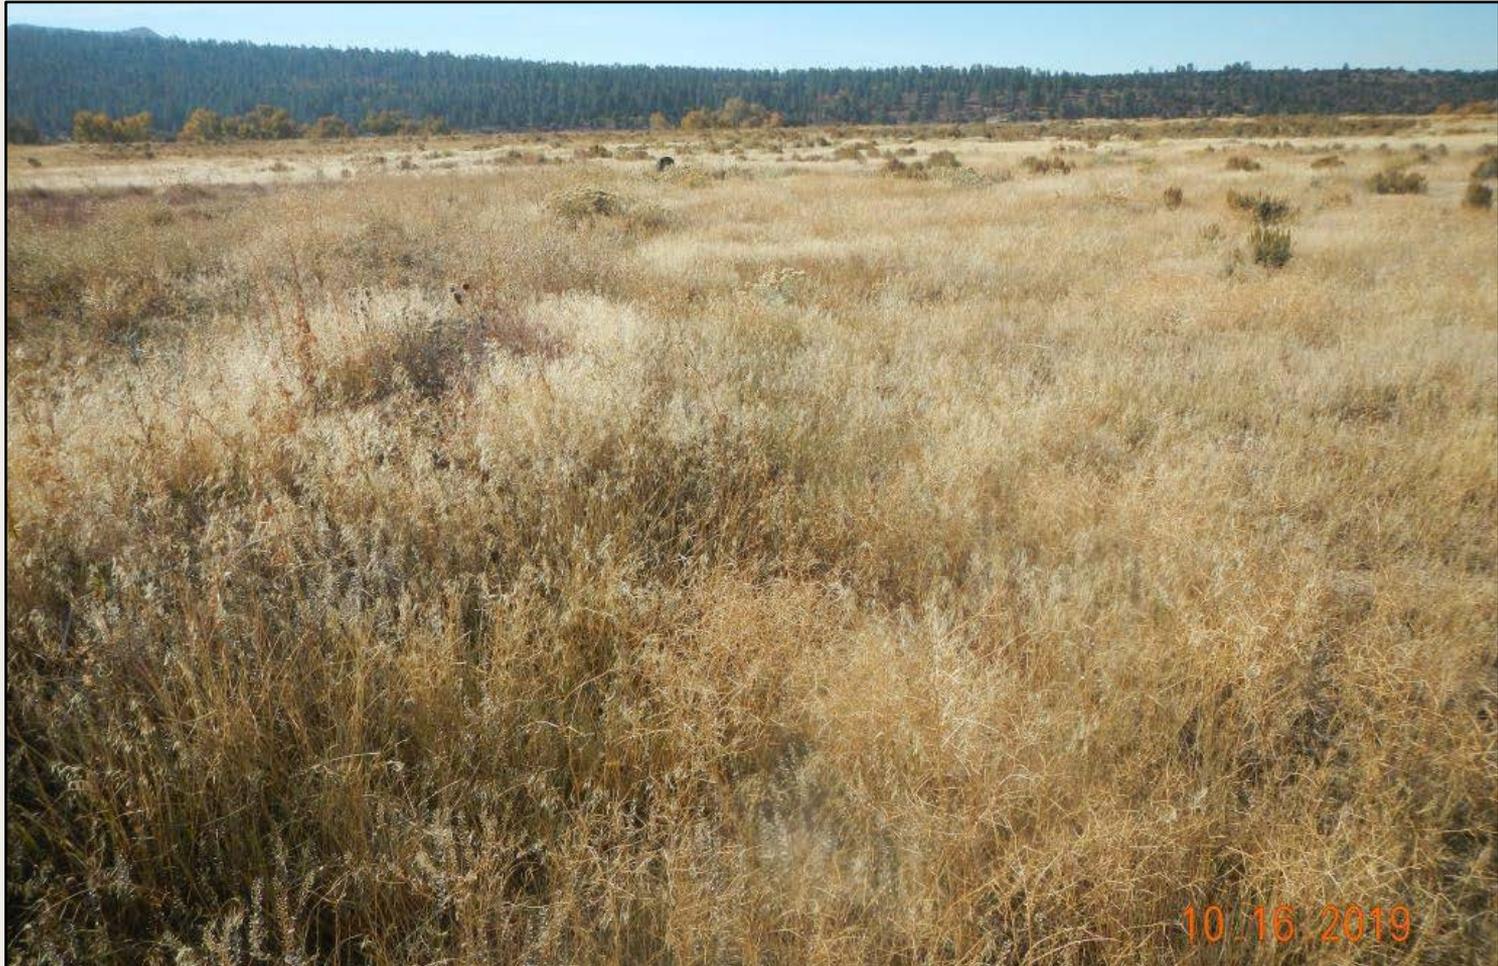
Photo 2. View of the western project area from the northwestern corner facing southward. Vegetation is well established, and comprised largely with perennial grasses such as western wheatgrass and shrubs such as rubber rabbitbrush.

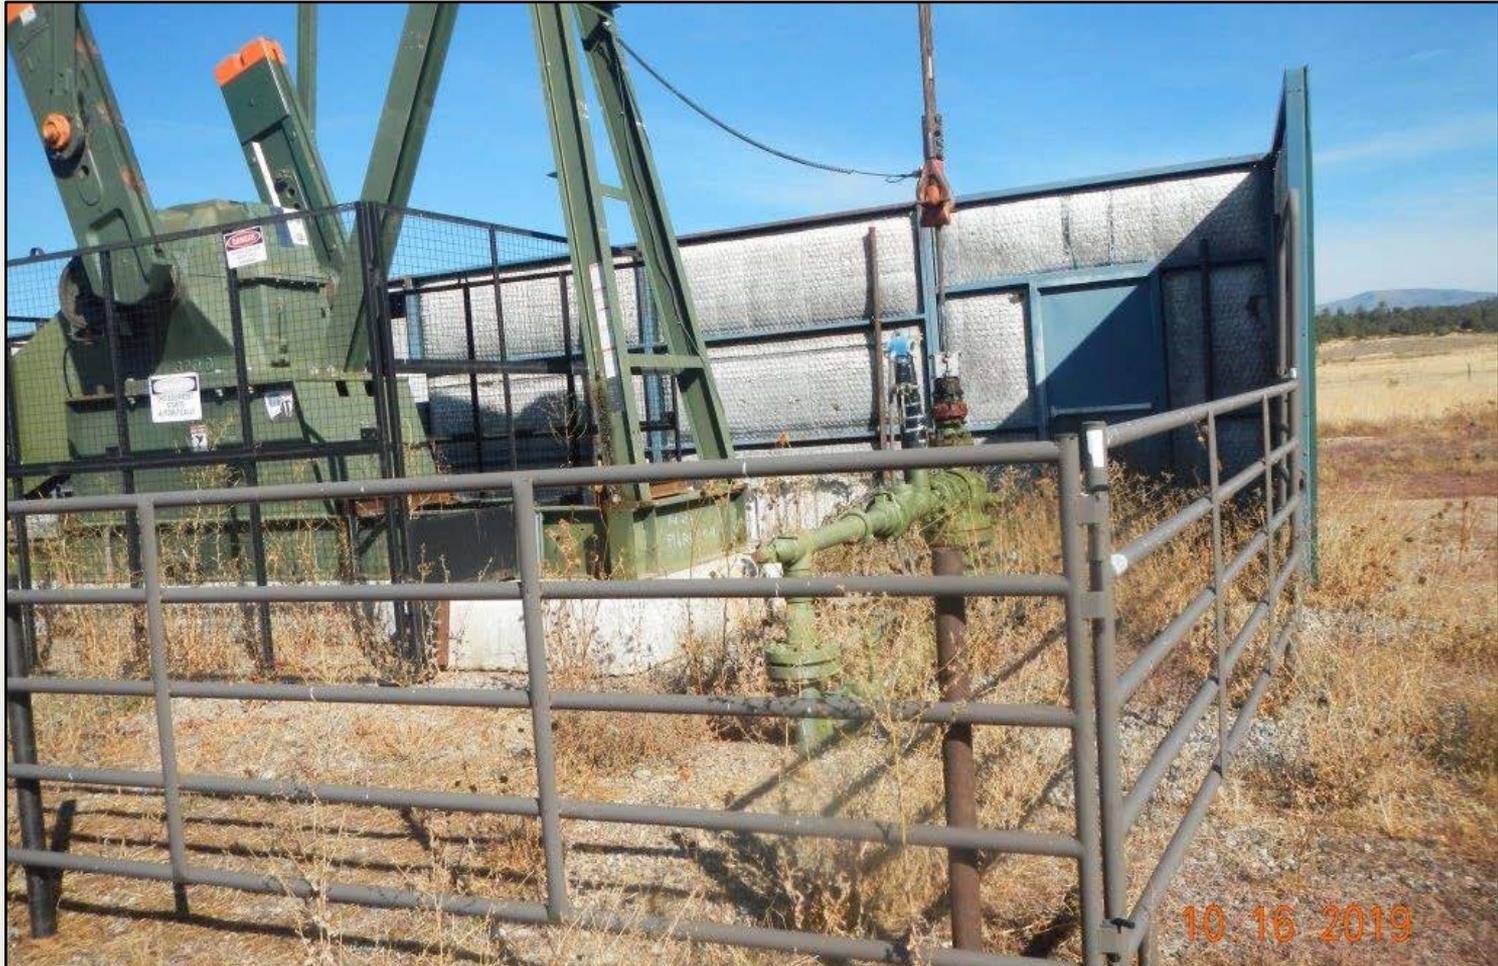
Photo 3. View of vegetation growing around wellhead, needing management. Noxious musk thistles are scattered within these weedy areas.

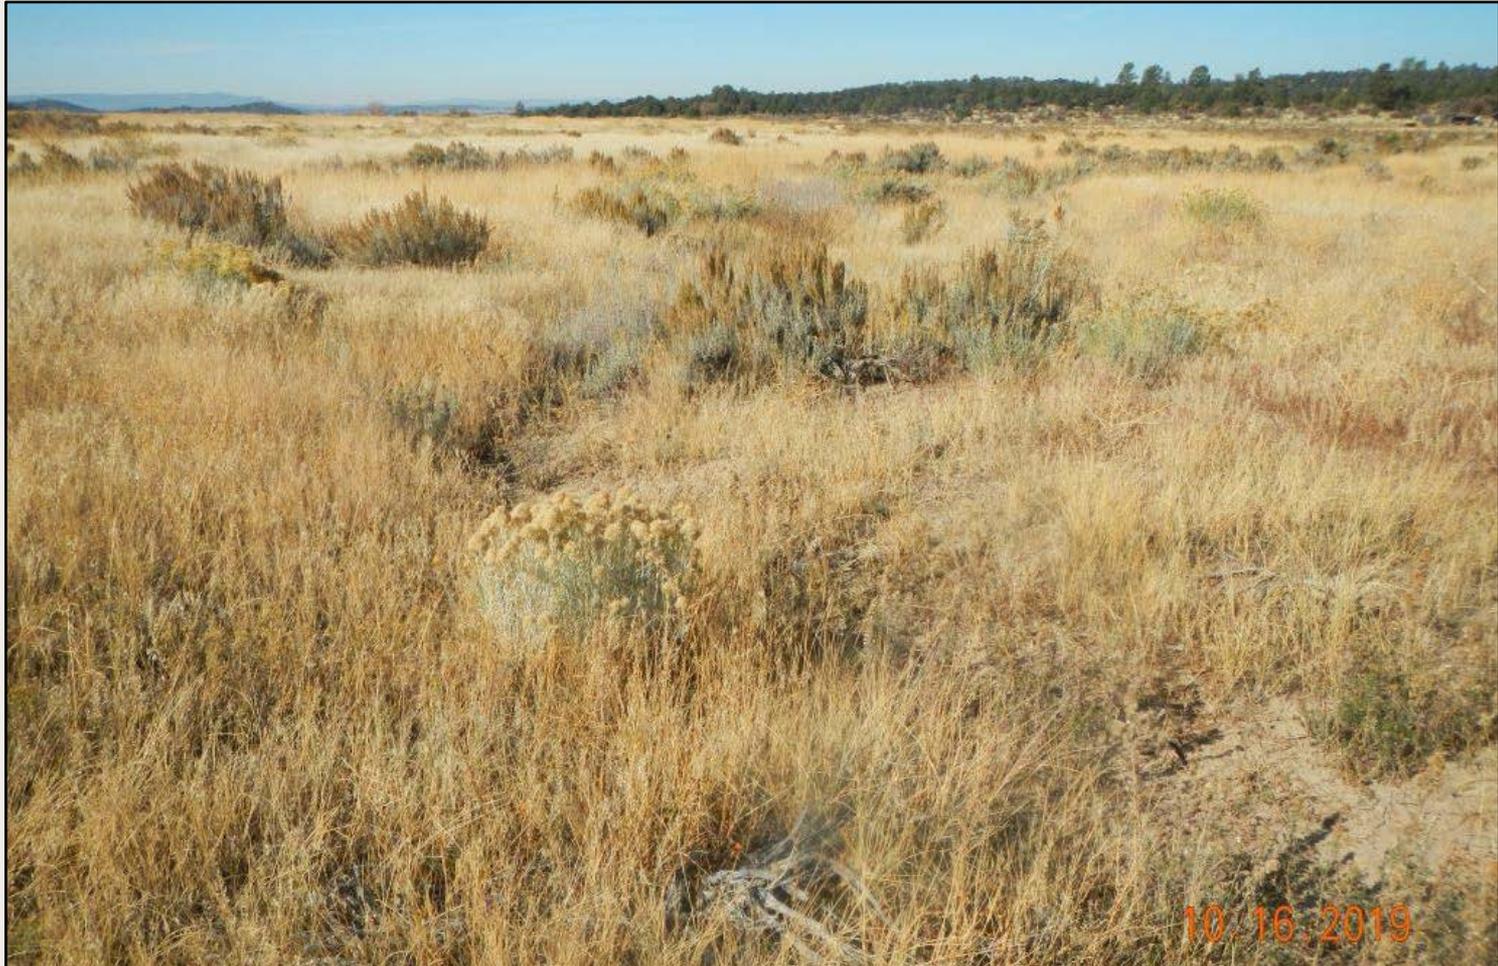
Photo 5. View of reference area vegetation north of the project area. Vegetation is comprised of sagebrush and mixed perennial grasses such as smooth brome, western wheatgrass, and sand dropseed.
