Inspection Photos
Operator: BP America
Location/API #: 067-10003
Date: 10-16-2019

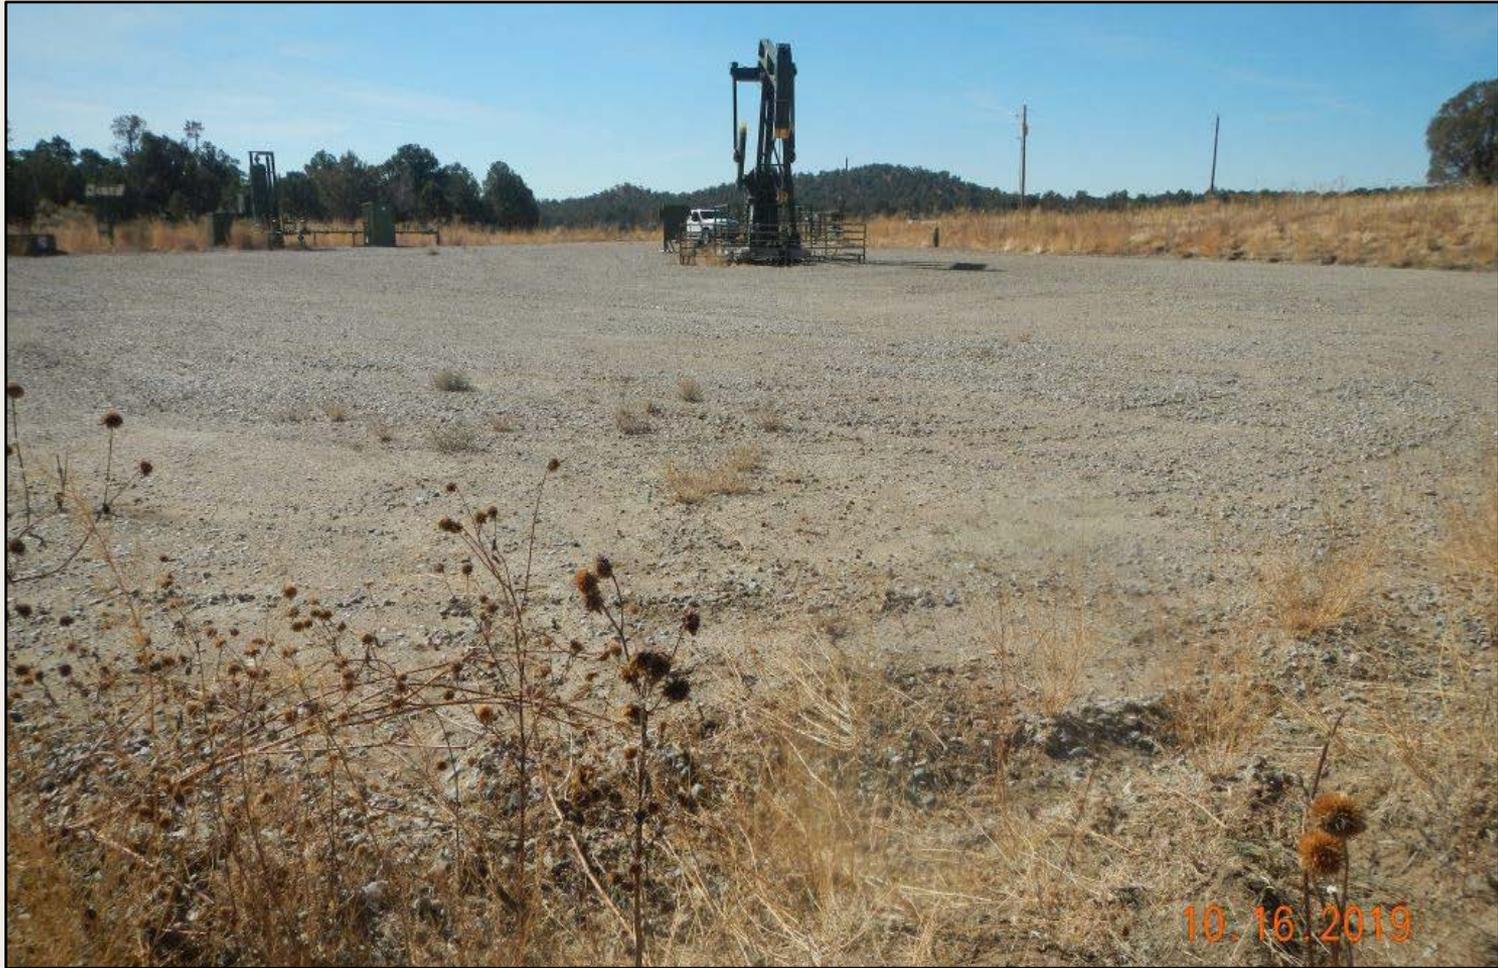
Photo 1. View of the project area from the northeastern project area facing center.

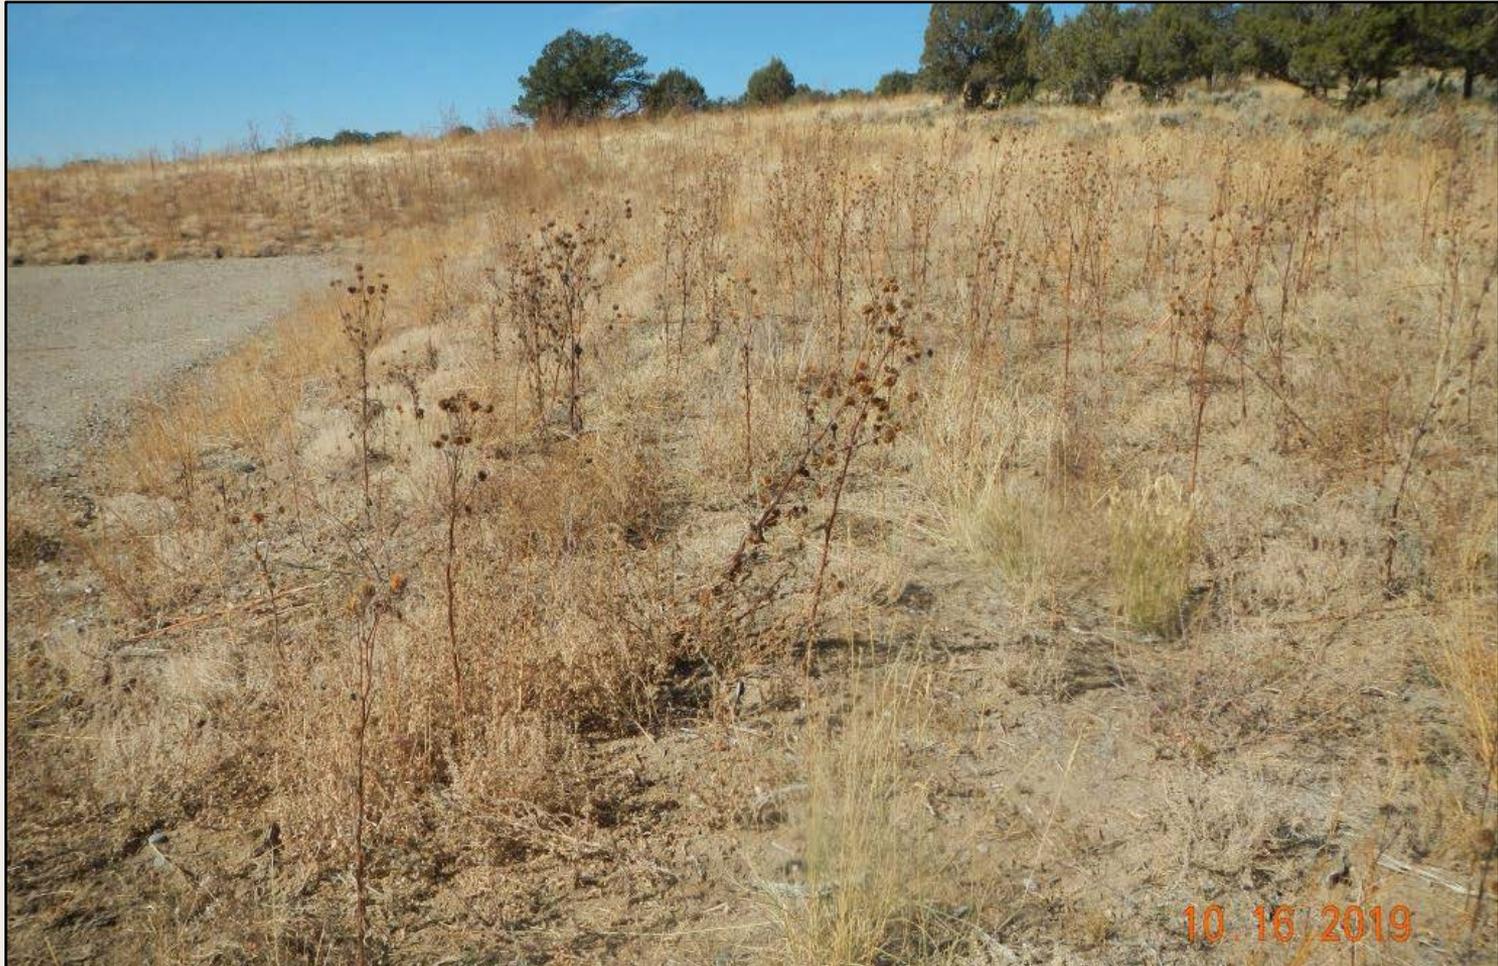
Photo 2. View of the northern project area from the northeastern corner facing westward.

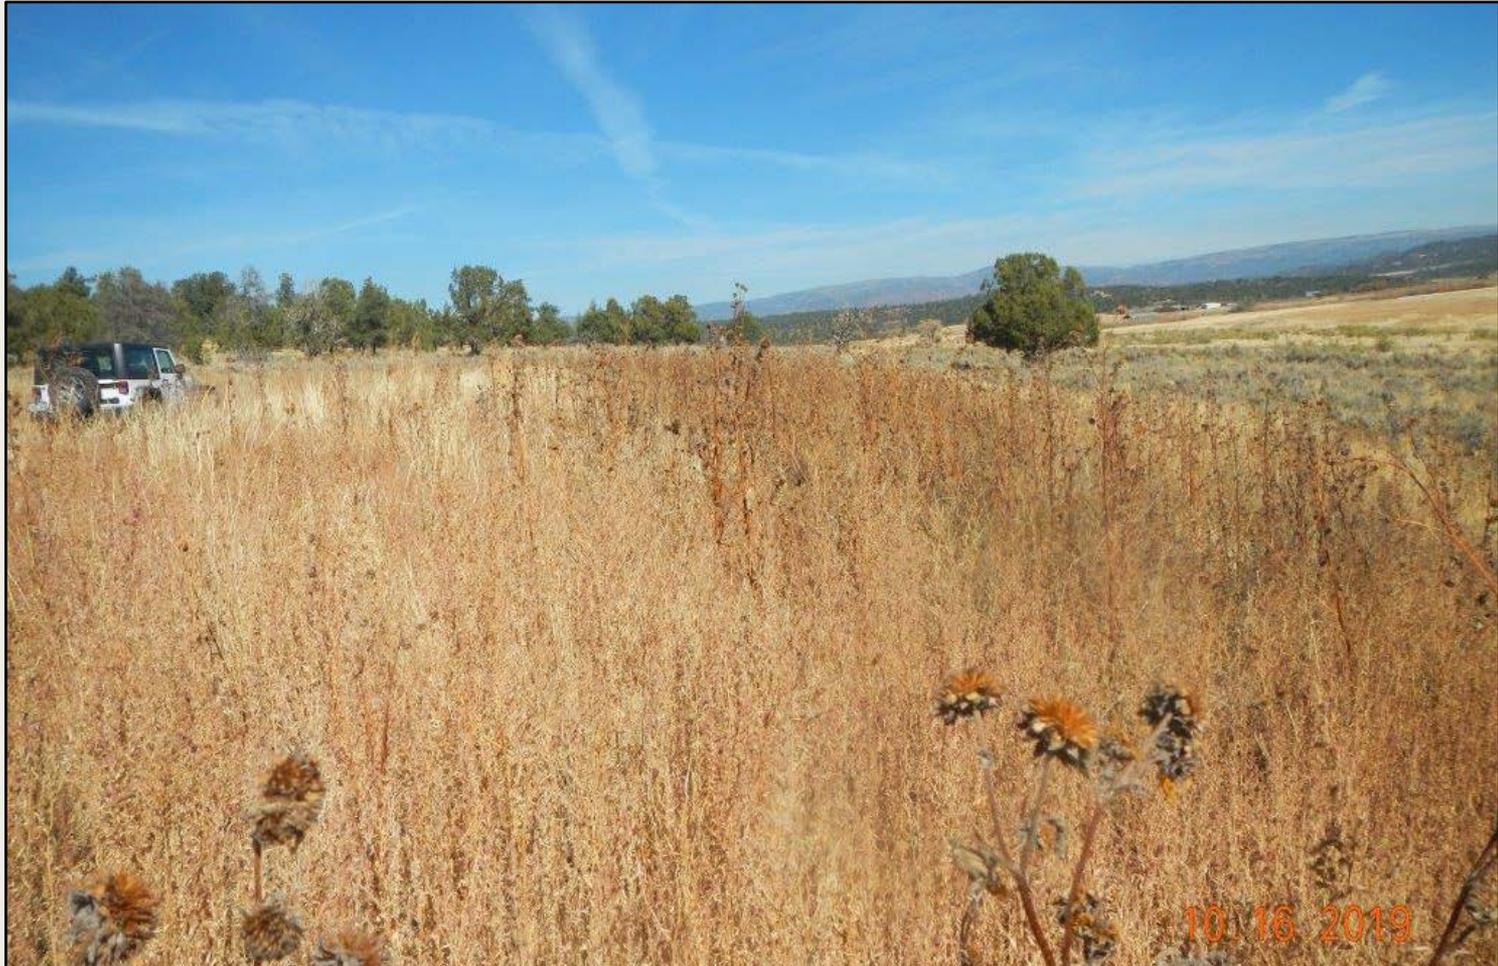
Photo 3. View of the eastern fill slope, from the southeastern edge facing northward. Tall annual weeds (kochia and mustard) are threatening desirable species establishment and need to be managed.

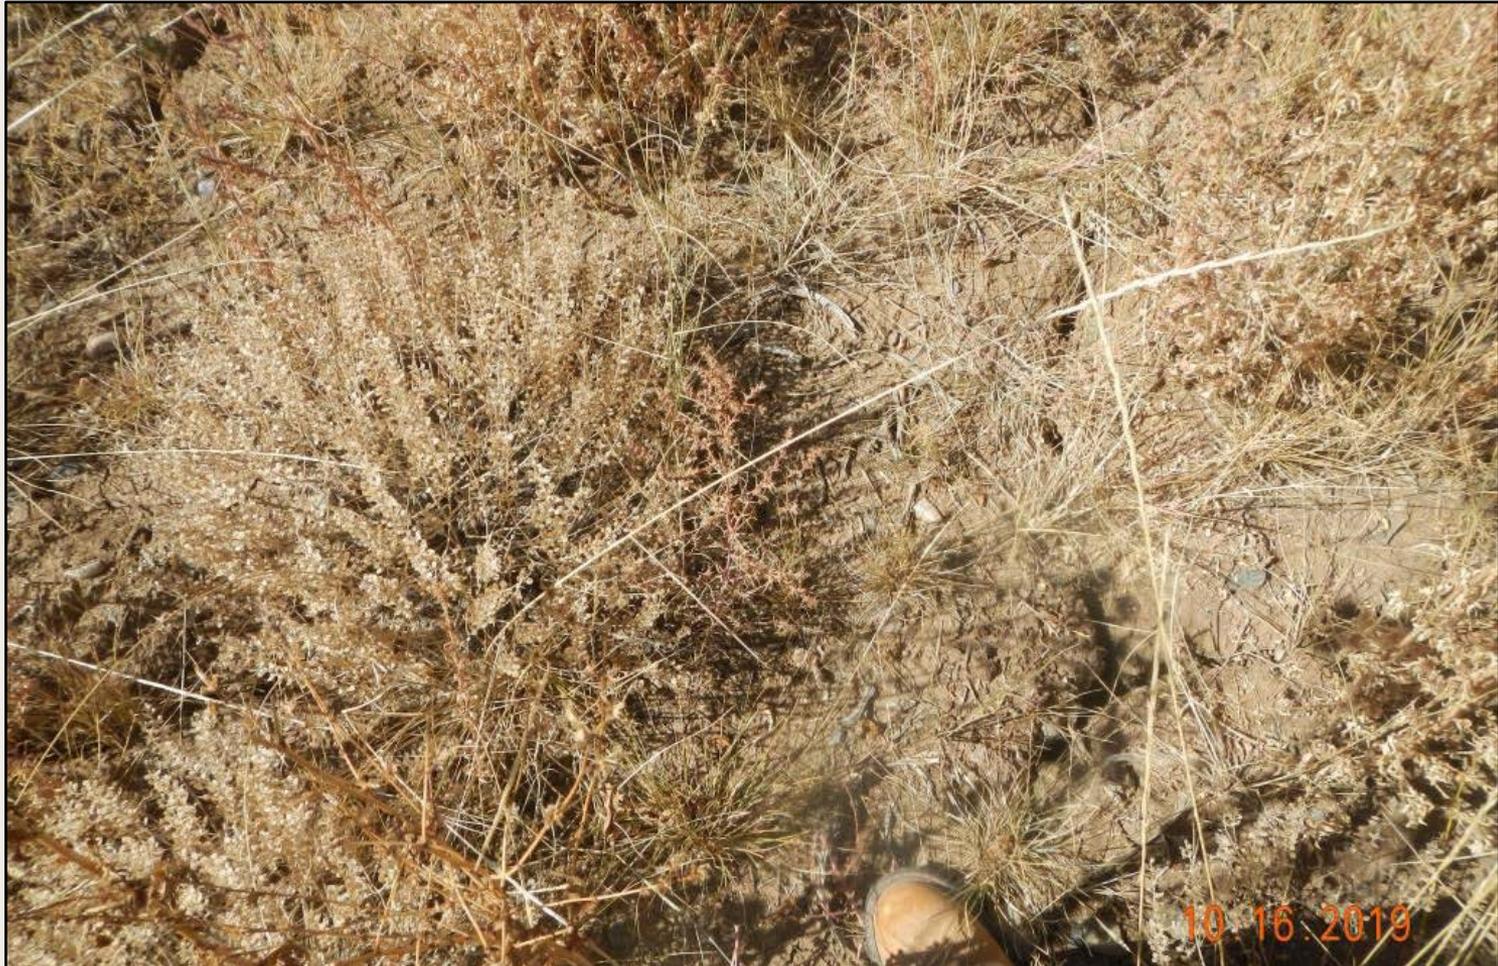
Photo 4. Birdseye view of desirable species becoming established beneath dense annual vegetation. Desirable cover is approximately 20 percent.

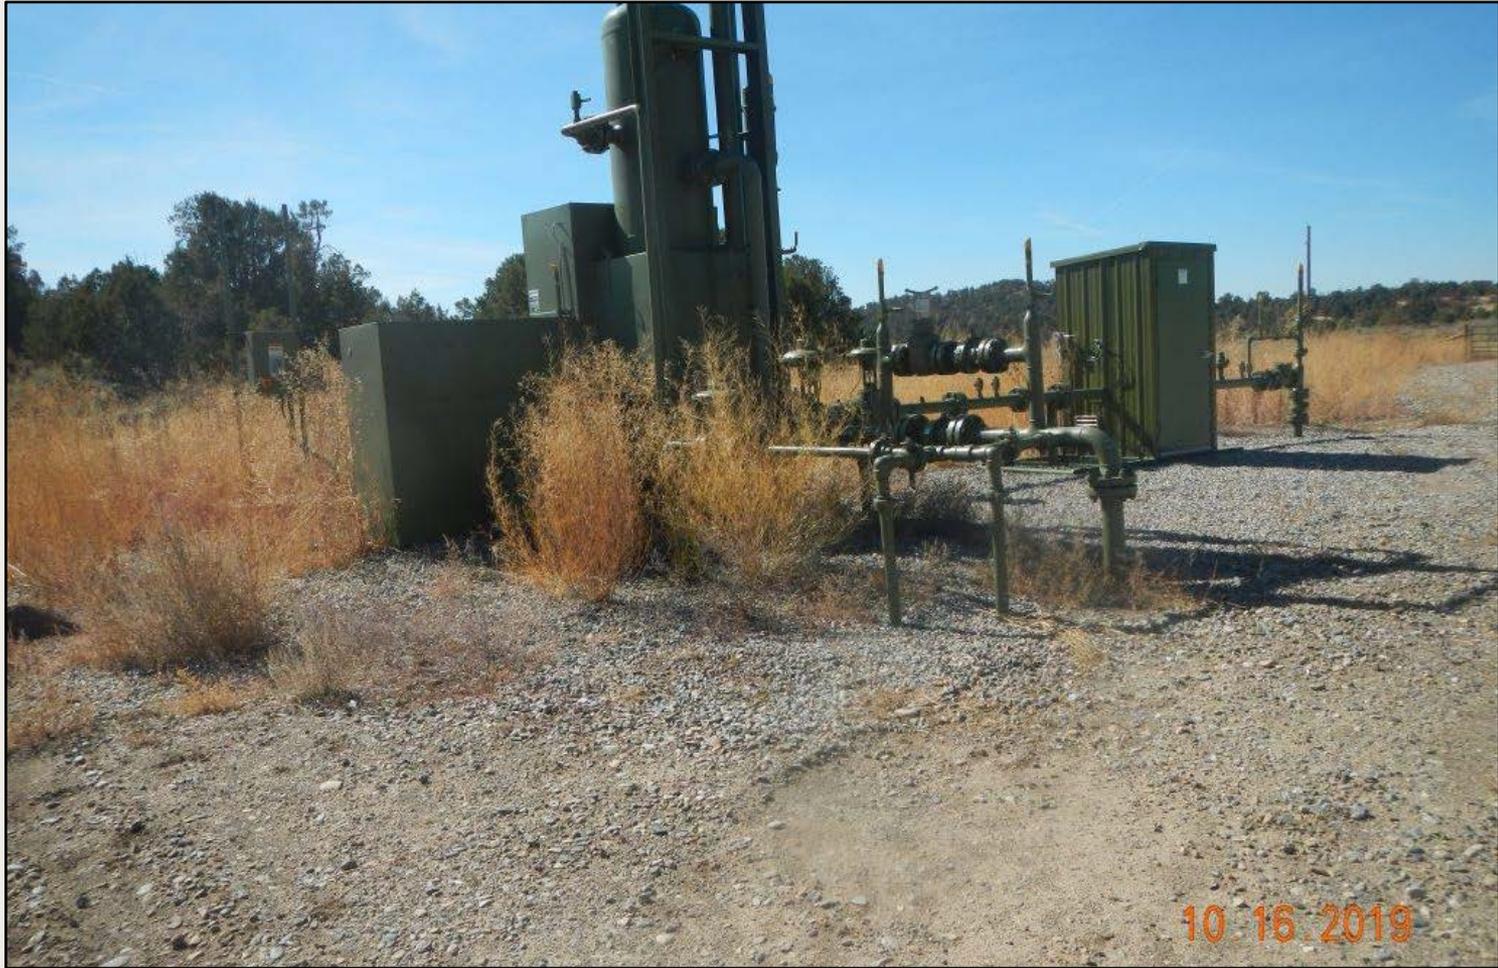
Photo 5. View of weeds growing around equipment, needing to be controlled.

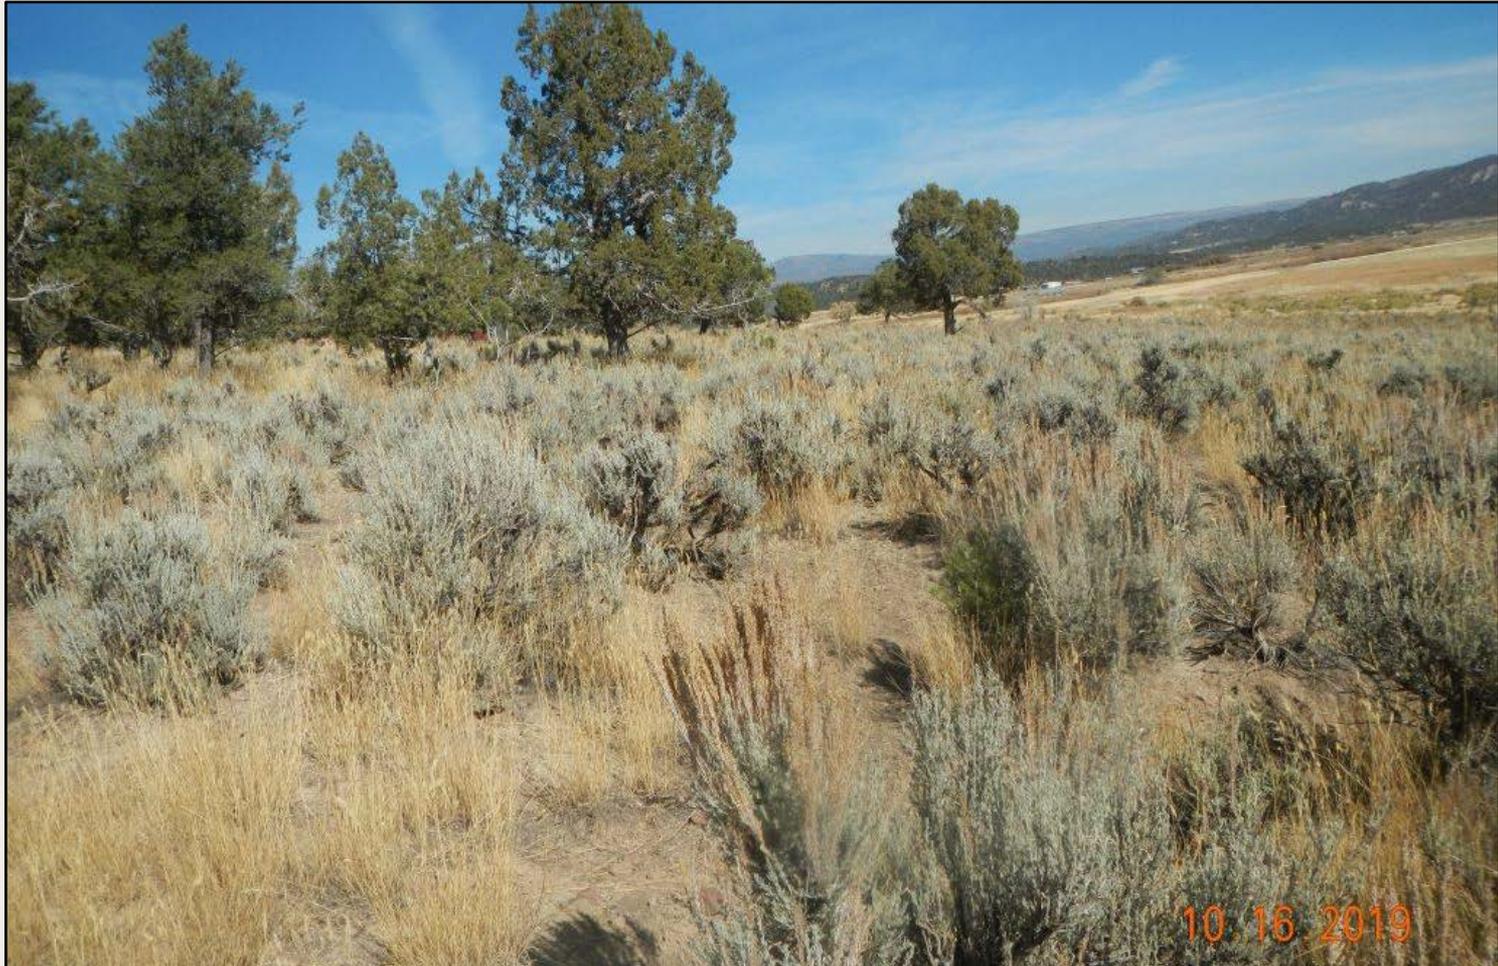
Photo 6. View of reference area vegetation north of the project area, comprised of sagebrush and pinyon-juniper woodland, interspersed with native and non-native grasses and forbs.
