Inspection Photos

Location Name: TOP GEAR 14-21 FOLLOWUP

API#: 05-071-07602

INSP. #: 695101654

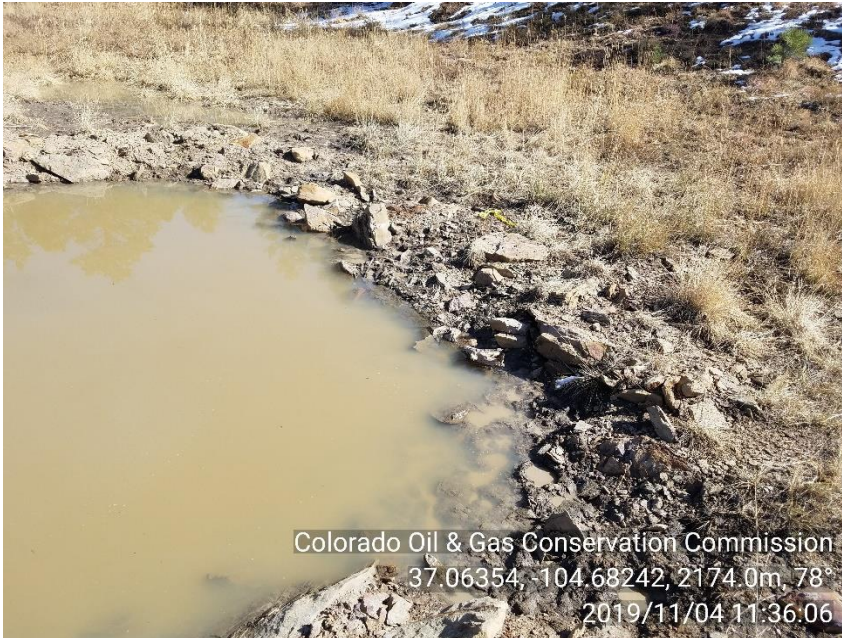
PHOTO 3: FLUID IN EARTH PIT IS ABOVE FREEBOARD MARKER. Lower fluid level so at least two feet of freeboard exists per Rule 902.b. CA DATE 11-5-19 (THIS IS THE SECOND WORKING OF FLUID LEVEL IN PIT ABOVE 2' FREEBOARD PIT SIZE AND DEPTH MAY BE A FACTOR IN THIS REOCCURRENCE, AT TIME OF NEXT REINSPECTION IF FLUID LEVEL IN PIT IS OUT OF COMPLIANCE ENFORCEMENT MAY BE CONSIDERED).

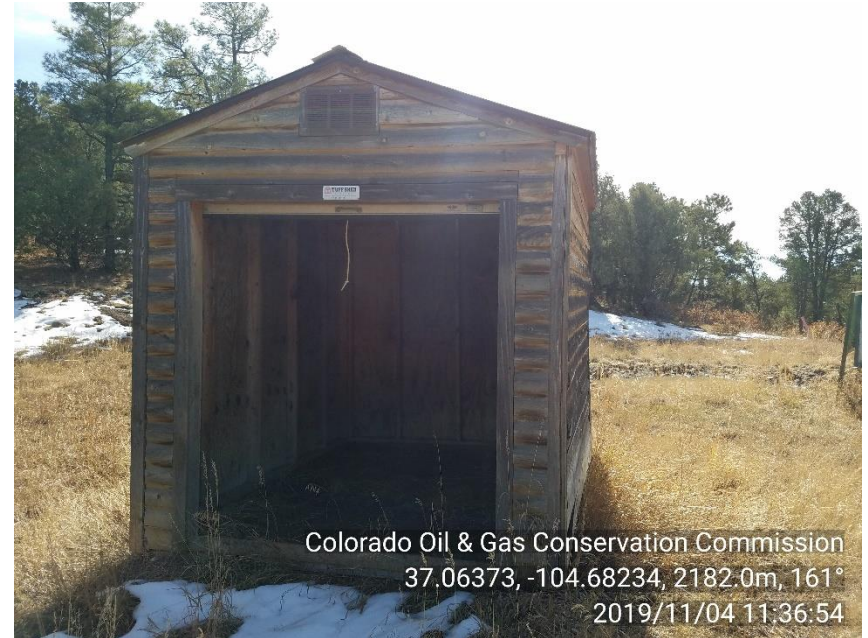
PHOTO 4: UNUSED EQUIPMENT (WELLHEAD HOUSE IS PLACED TO THE SIDE OF LOCATION AND IS NOT IN USE). REMOVE OR USE UNUSED EQUIPMENT IN ACCORDANCE WITH RULE 603.f. CA DATE 12-4-19

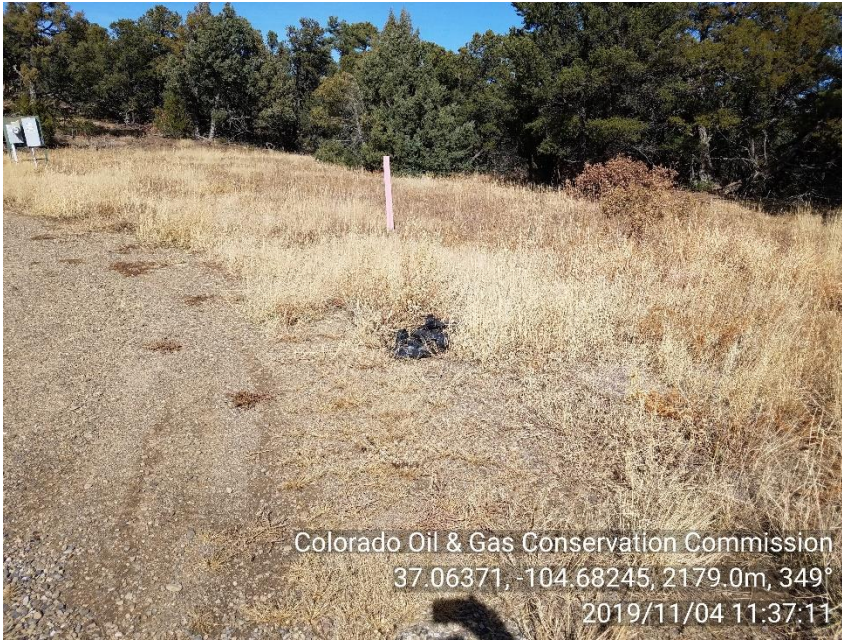
**PHOTO 5: TRASH IN SEVERAL SPOT AROUND
LOCATIO. POLICE LOCATION AND SURROUNDING
AREA FOR TASH AND INSPECT AT REGULAR
INTERVALS TO PREVENT TRASH ON AROUND
LOCATION IN ACCORDANCE WITH RULE 603.f. CA
DATE 12-4-19**

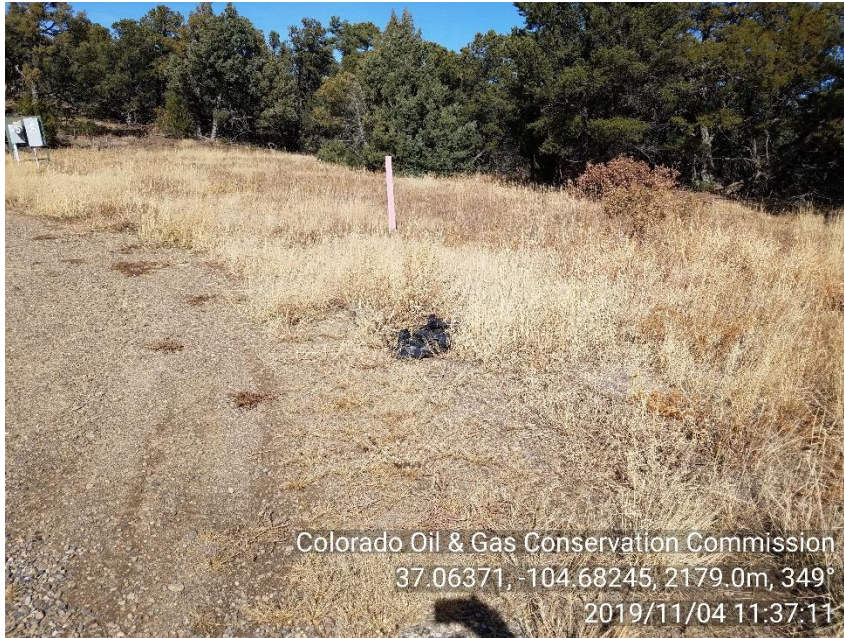
**PHOTO 5: TRASH IN SEVERAL SPOT AROUND
LOCATIO. POLICE LOCATION AND SURROUNDING
AREA FOR TASH AND INSPECT AT REGULAR
INTERVALS TO PREVENT TRASH ON AROUND
LOCATION IN ACCORDANCE WITH RULE 603.f. CA
DATE 12-4-19**
