Inspection Photos
Location Name: PATTI C 31-33
API#: 05-071-08950
INSP. #: 695101717

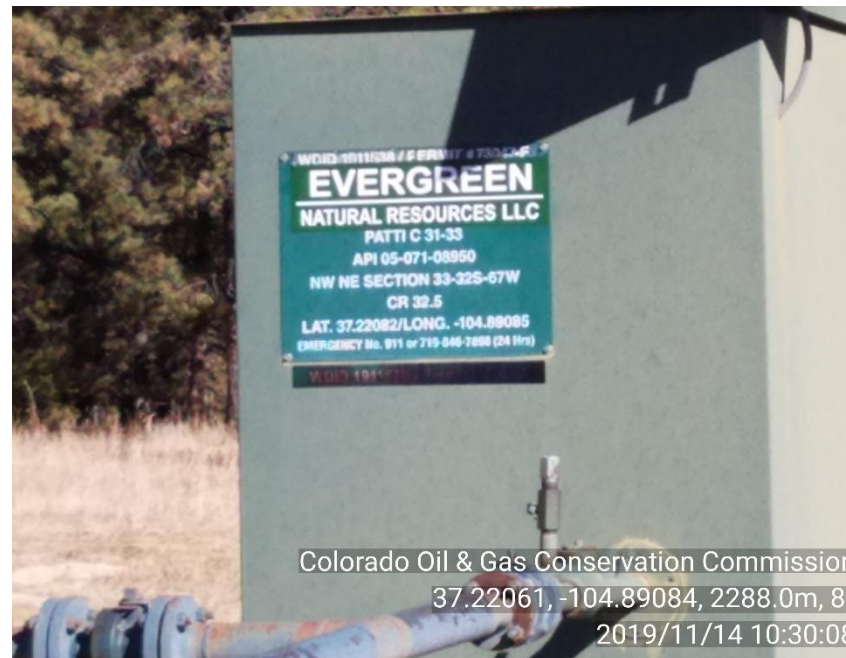
PHOTO 2: WELL SIGN

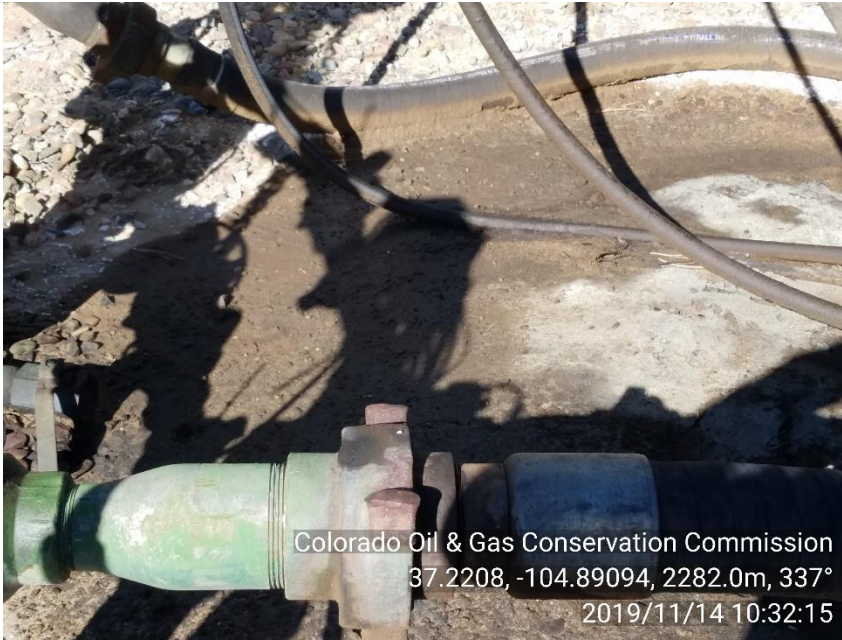
PHOTO 3: AREA OF IMPACTED SOIL NEAR WELLHEAD APPEARS TO BE OIL STAINED. Remove and dispose impacted material in approved manner, service and maintain equipment and self inspect to prevent recurrence of conditions per 1002.f(2) and 907. CA DATE 12-14-19

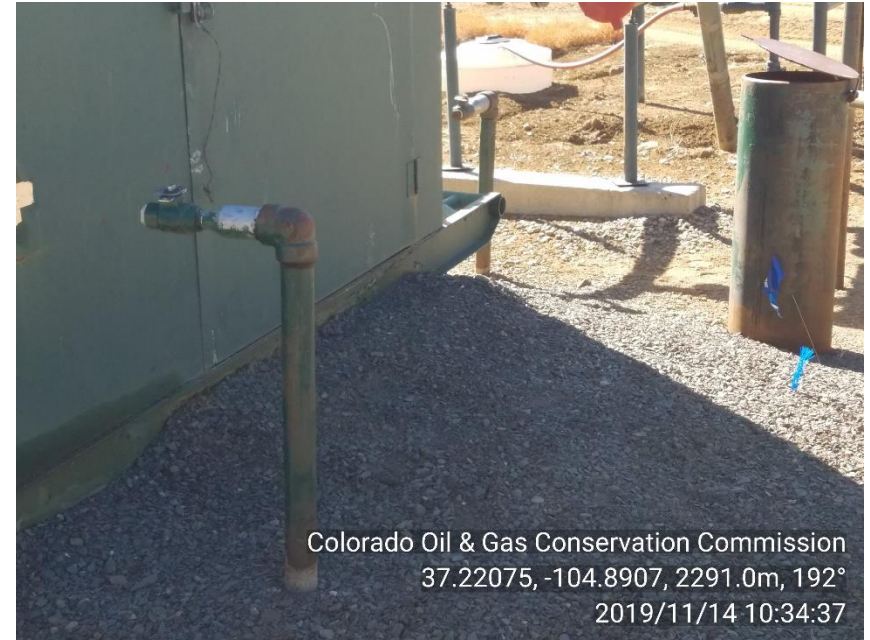
PHOTO 4: TWO UNUSED RISERS NEAR METER HOUSE. REMOVE UNUSED RISERS IN ACCORDANCE WITH RULE 603.f. AND NTO. CA DATE 2-14-20.
