Inspection Photos
Location Name: LADYHAWKE 41-31 TR
API#: 05-071-09118
INSP. #: 695101731

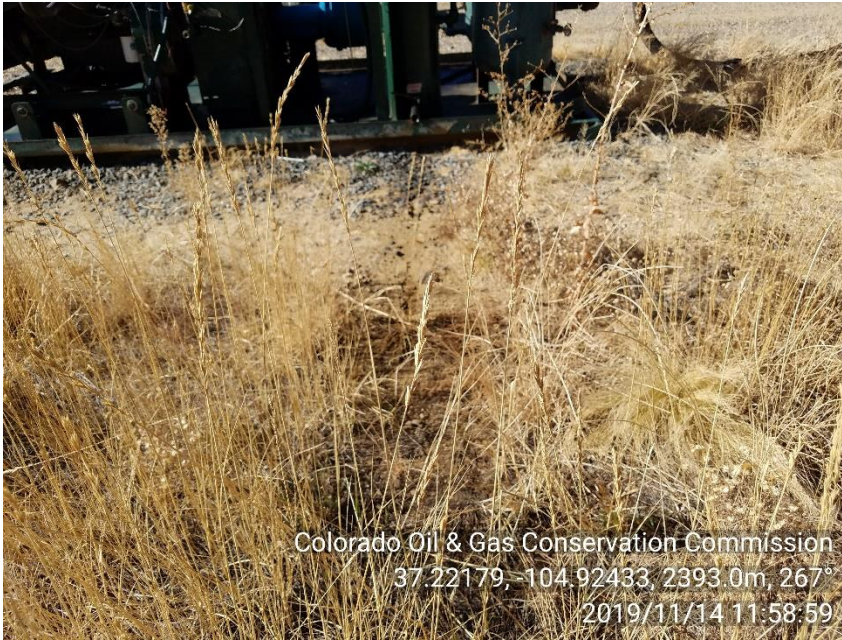
PHOTO 4: AREA OF IMPACTED SOIL NEAR COMPRESSOR. Remove and dispose impacted material in approved manner, service and maintain equipment and self inspect to prevent recurrence of conditions per 1002.f(2) and 907. CA DATE 12-14-19.
