Inspection Photos

11/06/2019

Operator: MARALEX RESOURCES INC - 53255

Location ID: 312612

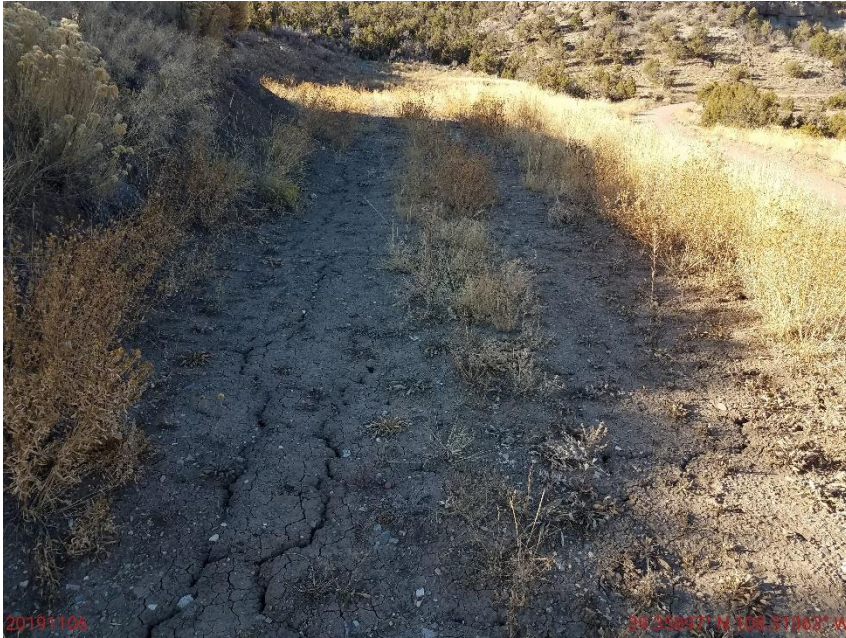
Photo 1: Photo taken from the northeast end of the location, facing southwest. Photo shows vegetation on the access road. Access road has not achieved a uniform desirable vegetative establishment. Only two (2) growing seasons have passed and additional time may be required, however, additional seeding activities is advised to facilitate reclamation.

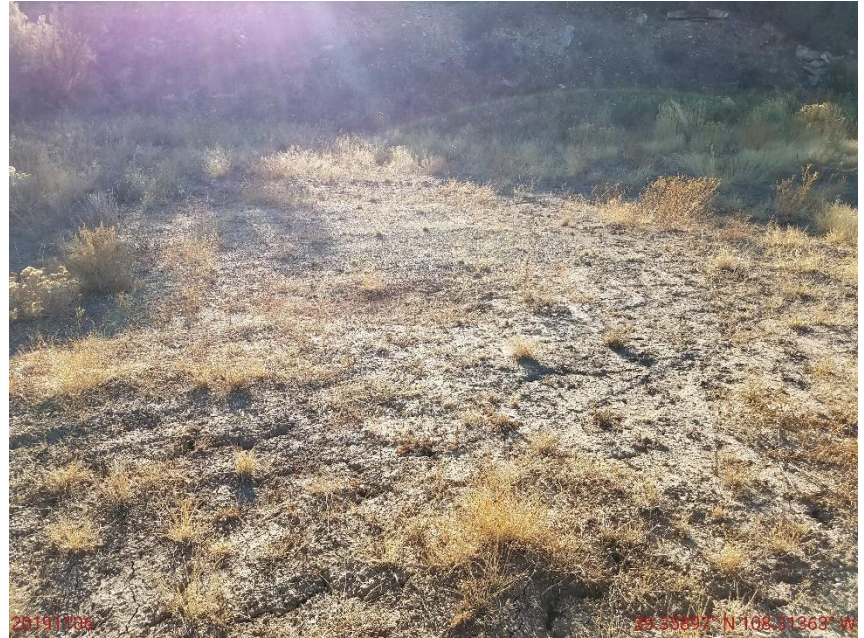
Photo 2: Photo taken from the east end of the location, facing south. Photos 2-4 provide an overview of the location from south, to west, to northwest. Photos show vegetation on the location. Location has not achieved a uniform desirable vegetative establishment. Only two (2) growing seasons have passed and additional time may be required, however, additional seeding activities is advised to facilitate reclamation. Based on historic aerial imagery, this appears to be where facilities were located.

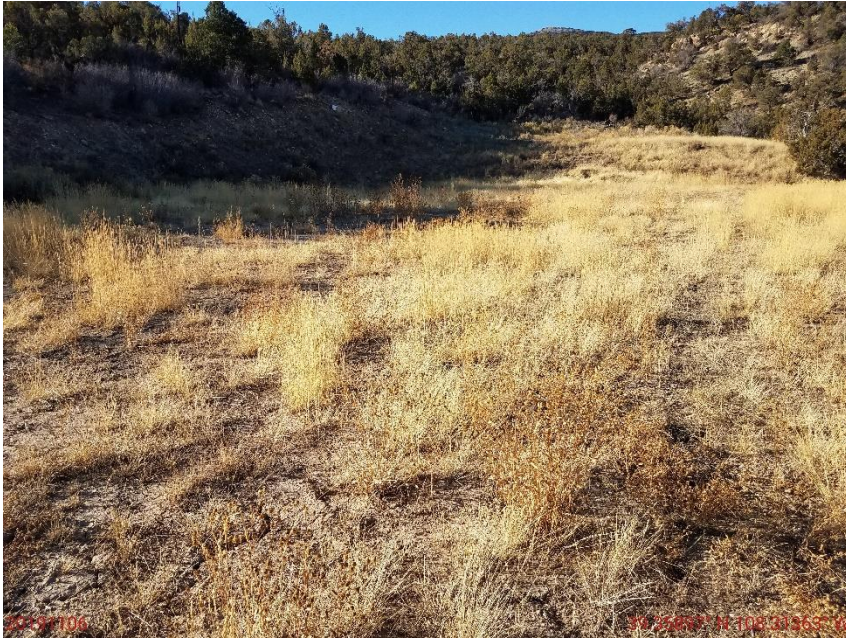
Photo 3: See comment under photo 2.

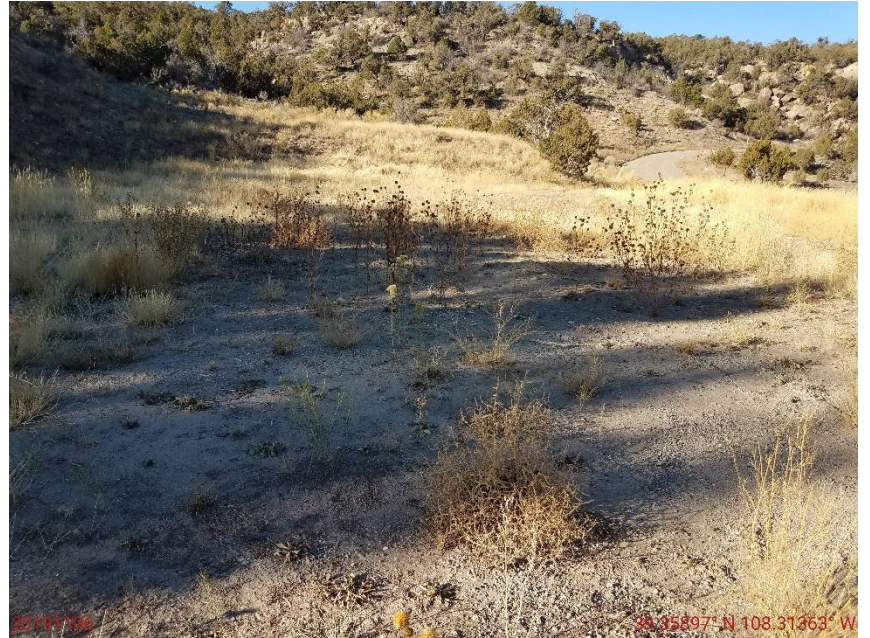
Photo 4: See comment under photo 2. Based on historic aerial imagery, this appears to be where the well was located.

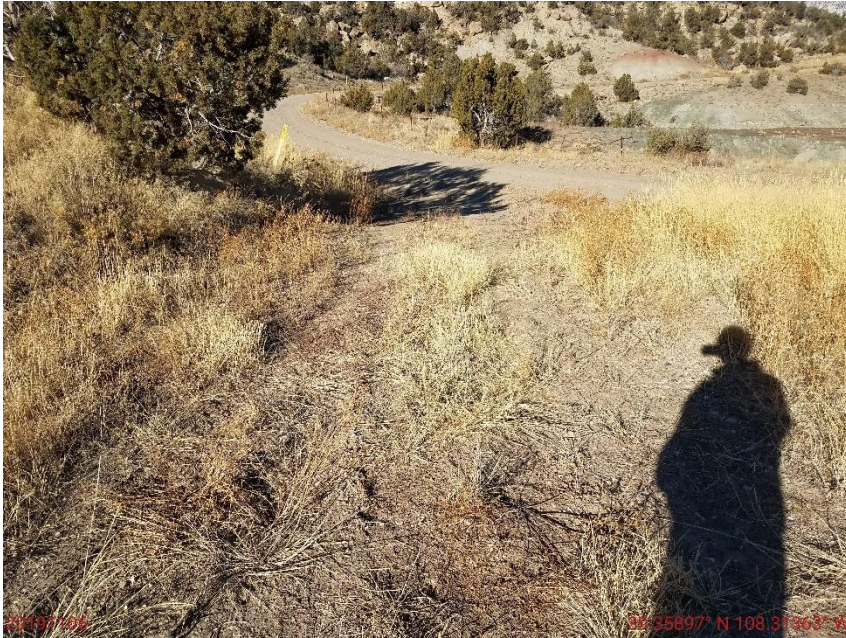
Photo 5: Photo taken from the southwest end of the location, facing southwest. Photo shows access road. Vehicle traffic on access road and pad evident and is likely hindering reclamation.

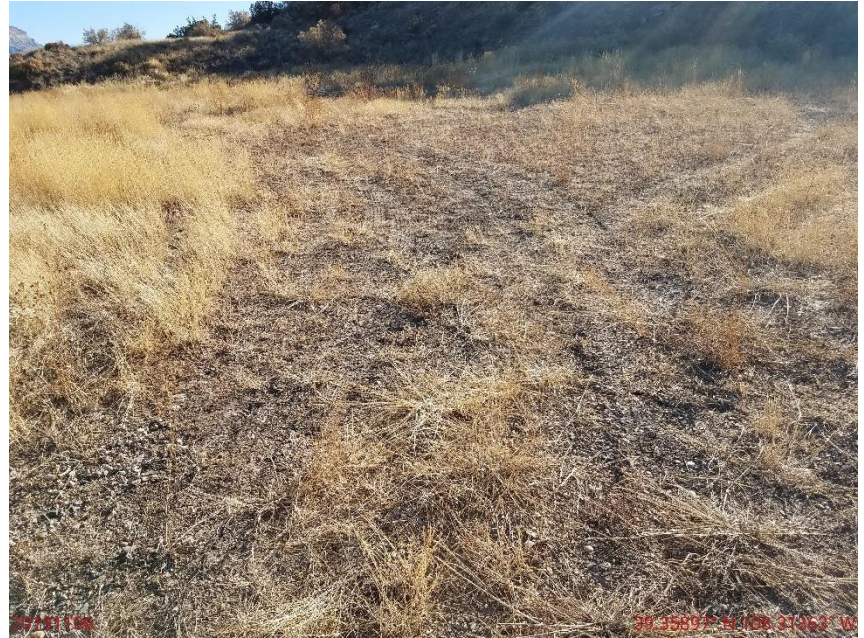
Photo 6: Photo taken from the northwest corner of the location, facing southeast. See comments under photo 5.
