# Construction and Stormwater Inspection

Operator: VERDAD RESOURCES LLC- #10651

Location ID: 467102

Inspection Photos  
Location Name: Bringelson Fed /2021 & 2029  
Location ID: 467102

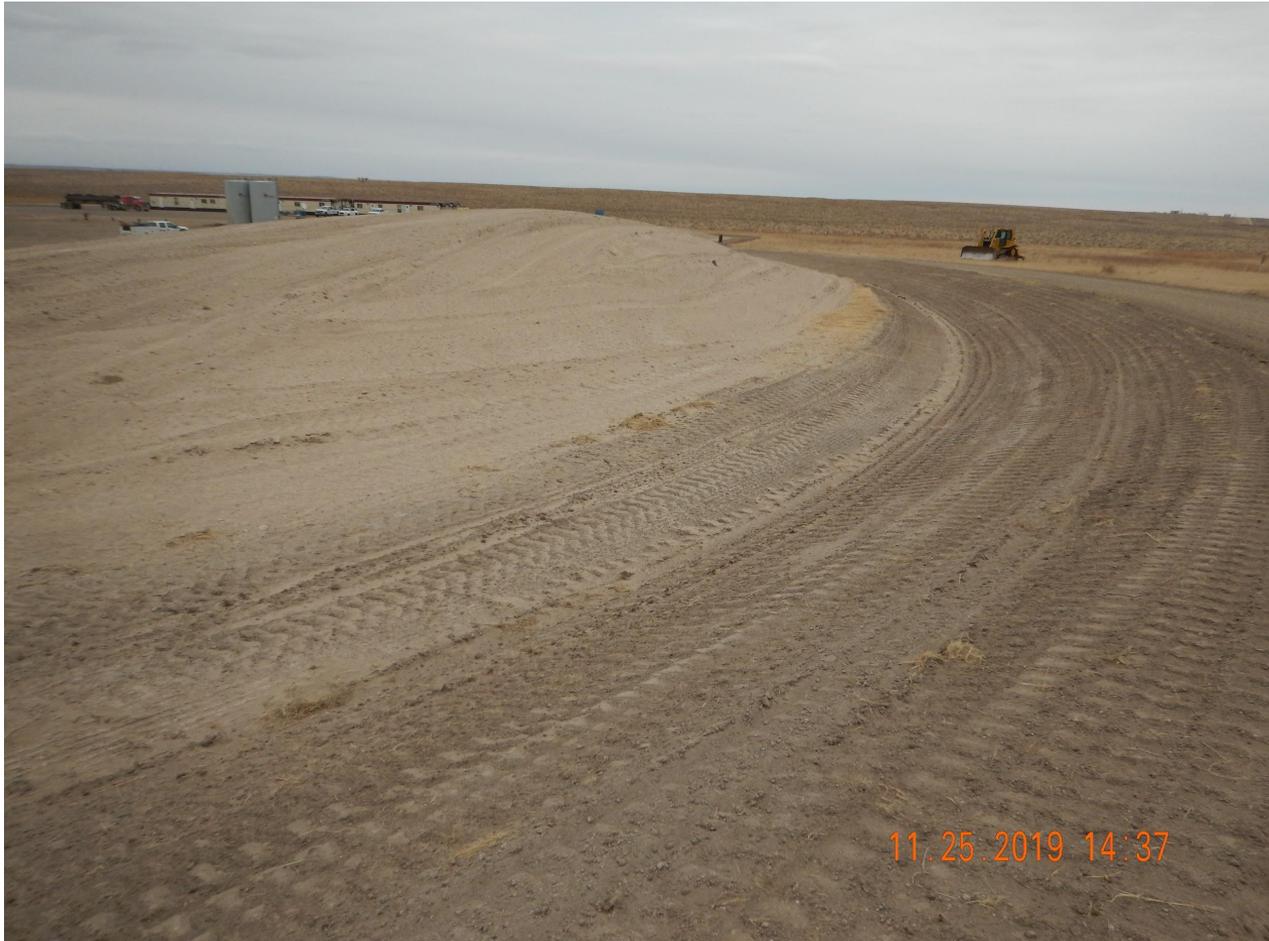
**Photo 1.** Photo taken from the southwestern perimeter of location, facing East. Photo illustrates a ditch and berm BMP installed around the entire perimeter of location. Operator also has another ditch BMP along portions of the western, northern and eastern well pad. Also, photo illustrates one of two soil stockpiles that have been temporarily stabilized with equipment tracking.

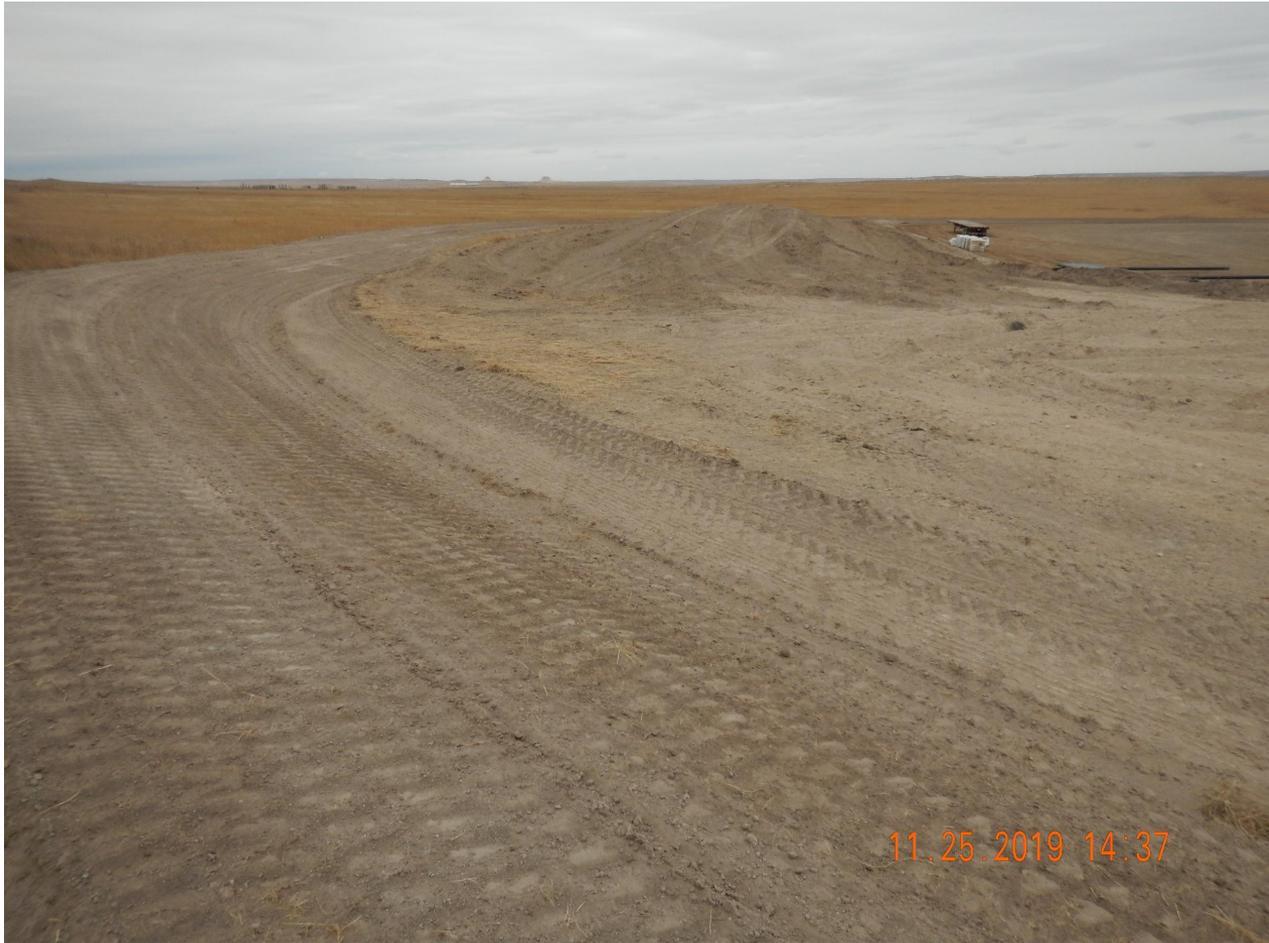
**Photo 2.** Photo taken from the southwestern perimeter of location, facing North. Photo illustrates a ditch and berm BMP installed around the entire perimeter of location. Also, photo illustrates the second soil stockpile that has been temporarily stabilized with equipment tracking.

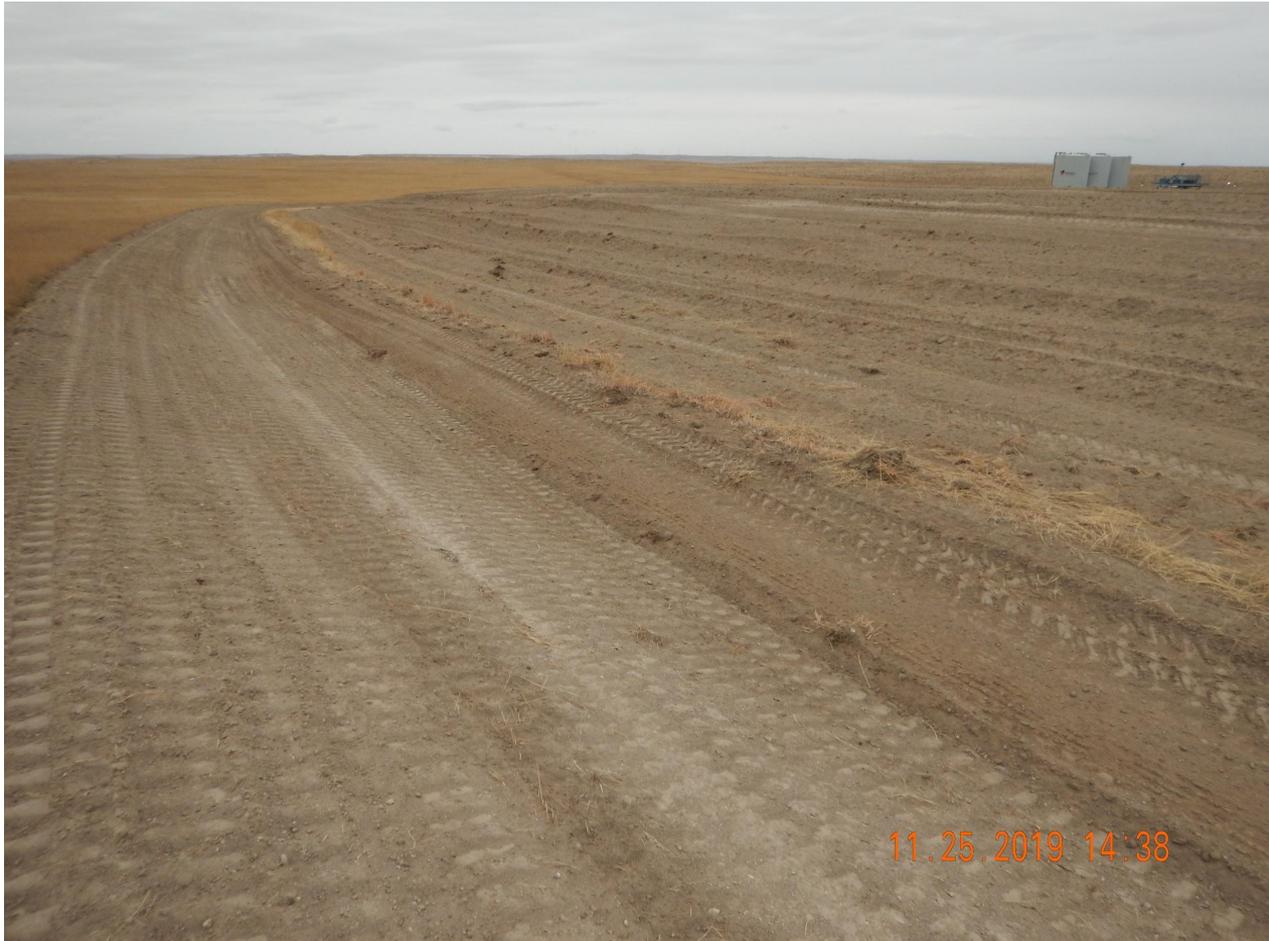
**Photo 3.** Photo taken from the western perimeter of location, facing North. See comments under Photo 2.

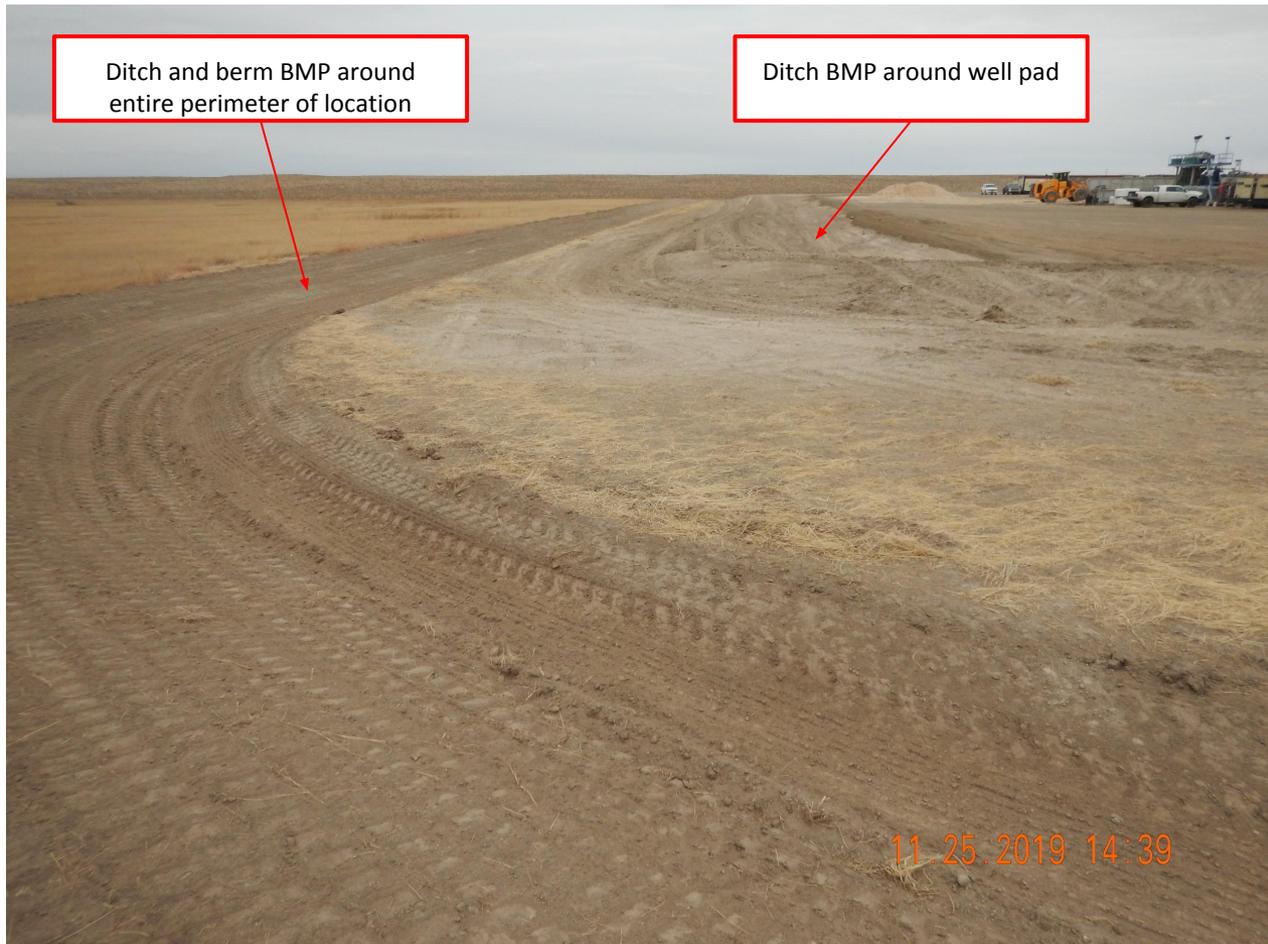
**Photo 4.** Photo taken from the northwestern perimeter of location, facing East. Photo illustrates a ditch and berm BMP installed around the entire perimeter of location.

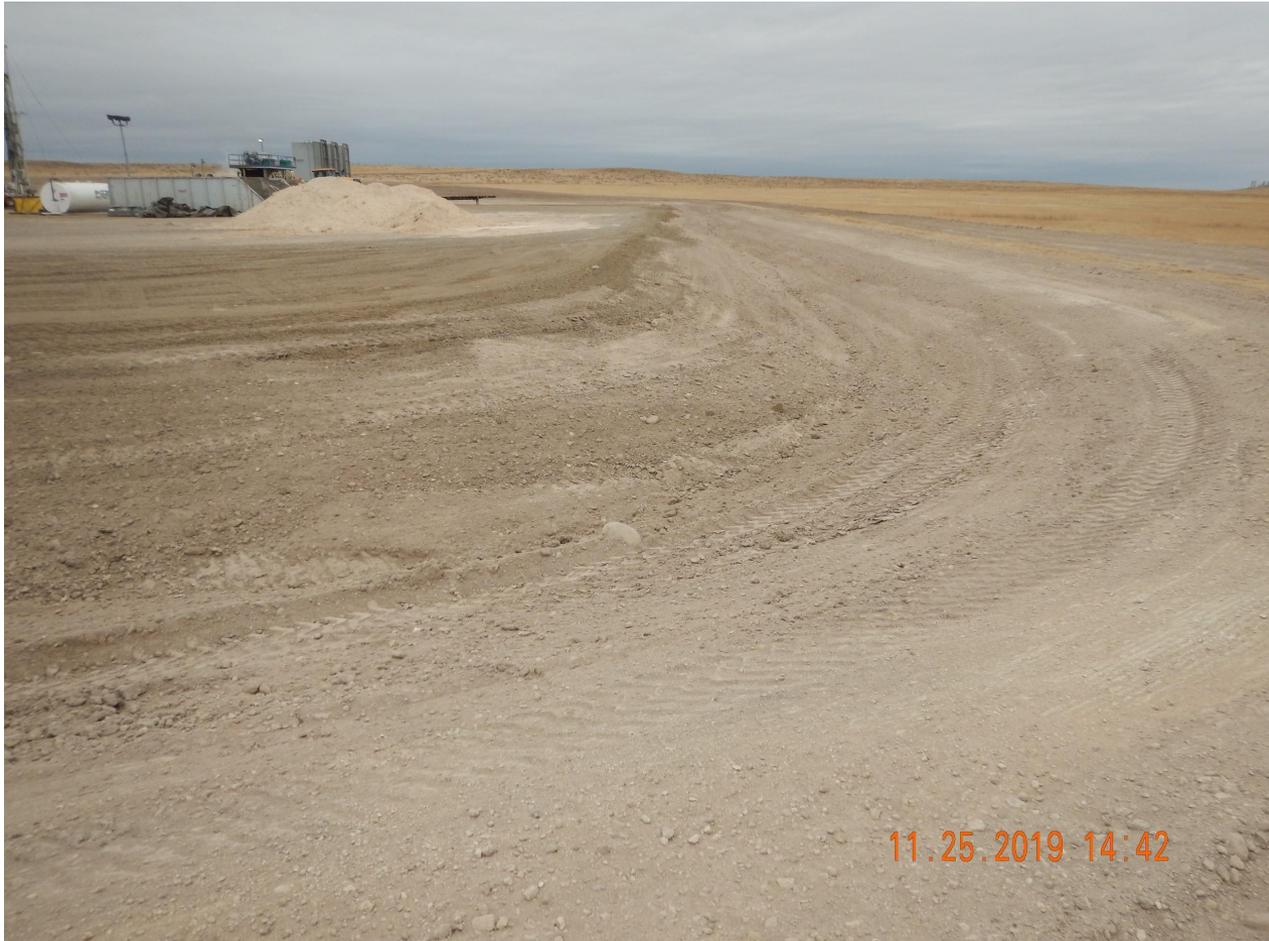
**Photo 5.** Photo taken from the northeastern perimeter of location, facing West. Photo illustrates the ditch BMP around the entire well pad perimeter.

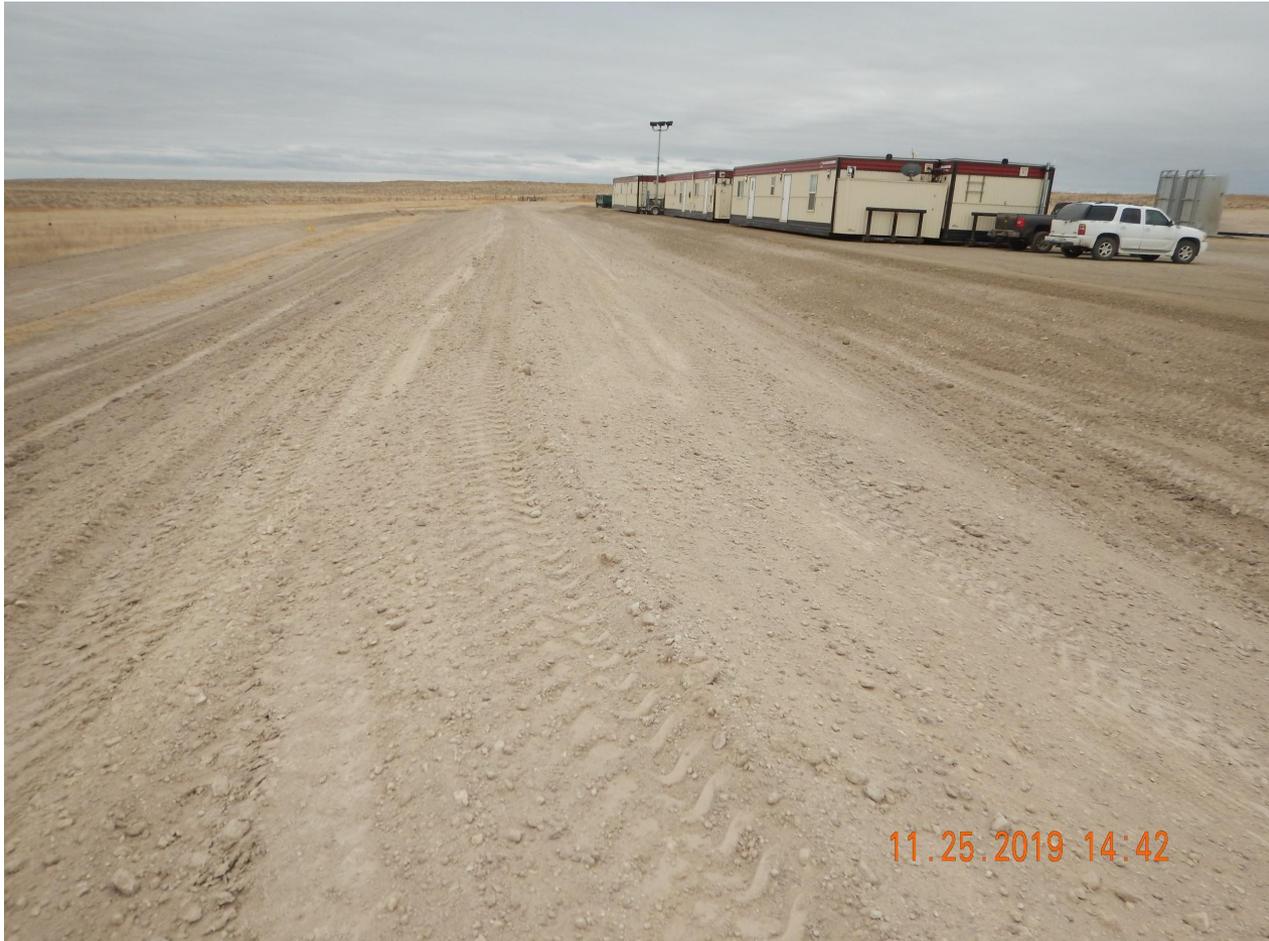
**Photo 6.** Photo taken from the northeastern perimeter of location, facing South. See comments under Photo 5.

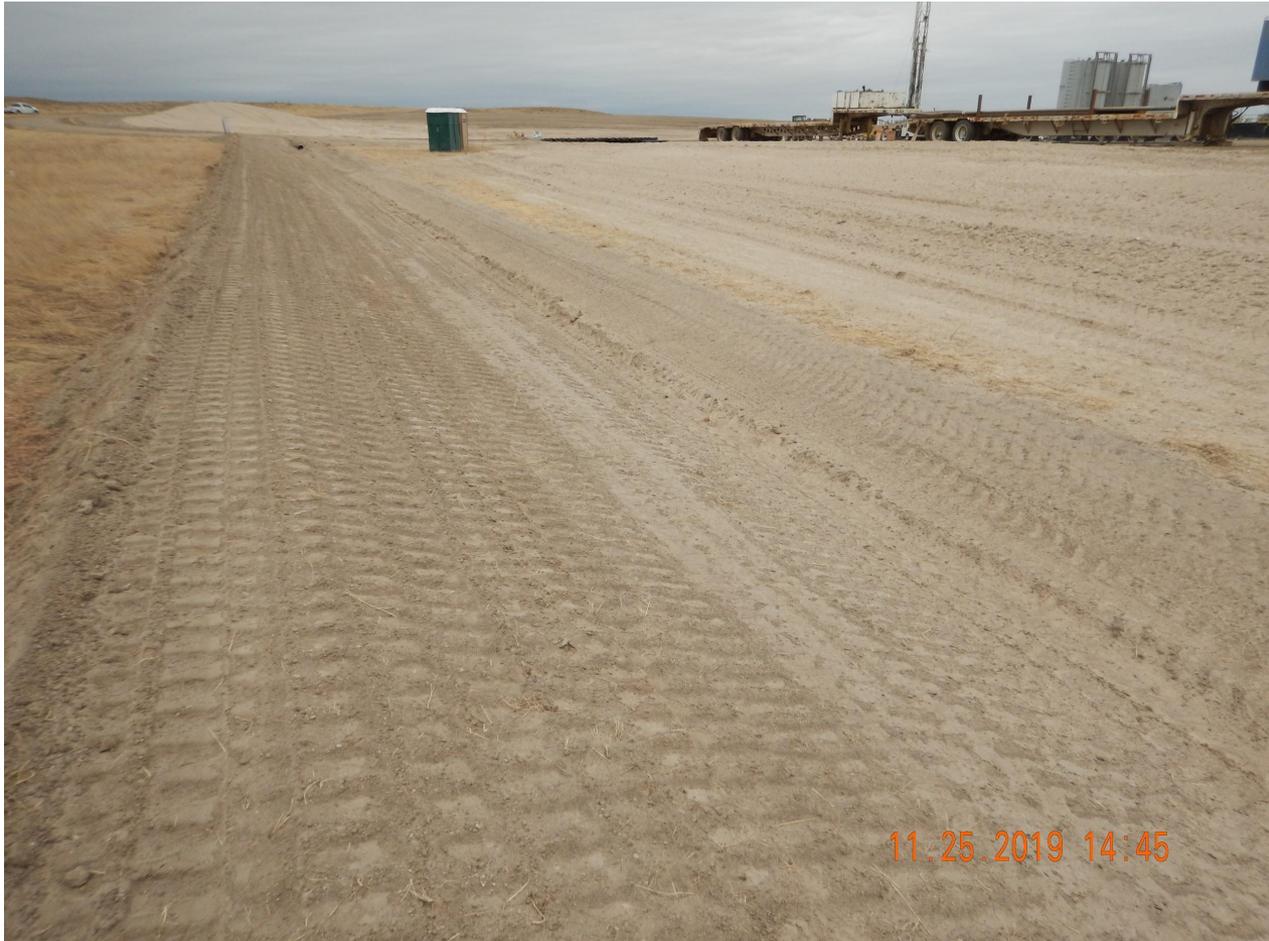
**Photo 7.** Photo taken from the southeastern perimeter of location, facing West. See comments under Photo 1.
