Inspection Photos

Location Name: TRUE BLUE 42-3 FOLLOW UP

API#: 05-071-09432

INSP. #: 695101864

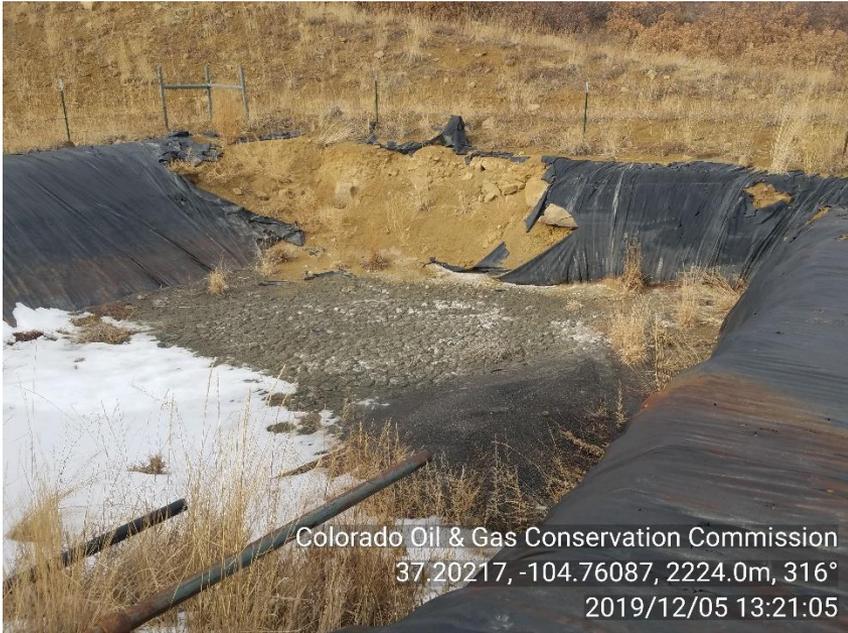
PHOTO 3: LINER HAS DETERIORATED AND HAS SEVERAL HOLES IN IT. REMOVE (IF NOT REQUIRED) OR MAINTAIN LINER IN ACCORDANCE WITH RULE 904. CA DATE 02-05-20

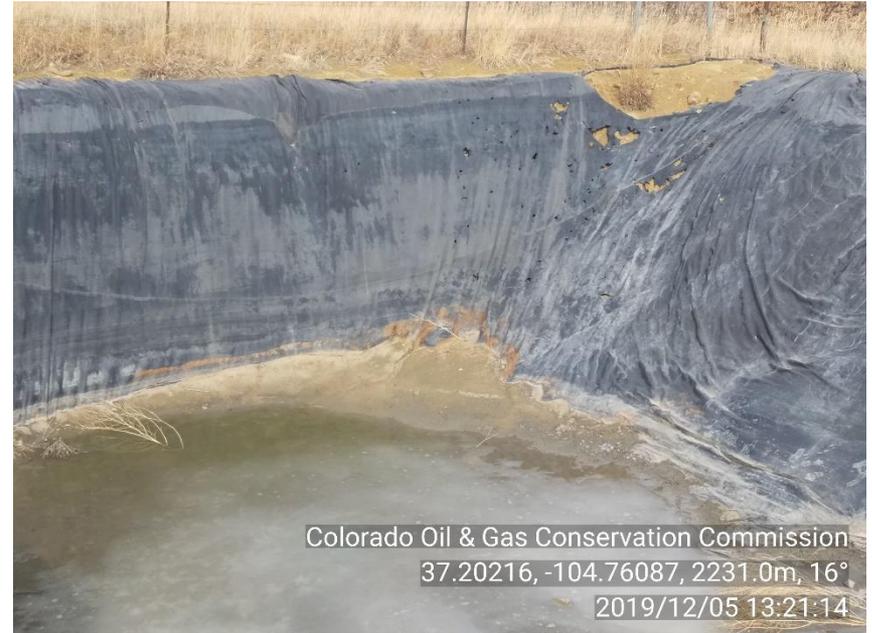
PHOTO 4: ANOTHER IMAGE OF CONDITION OF PIT LINER

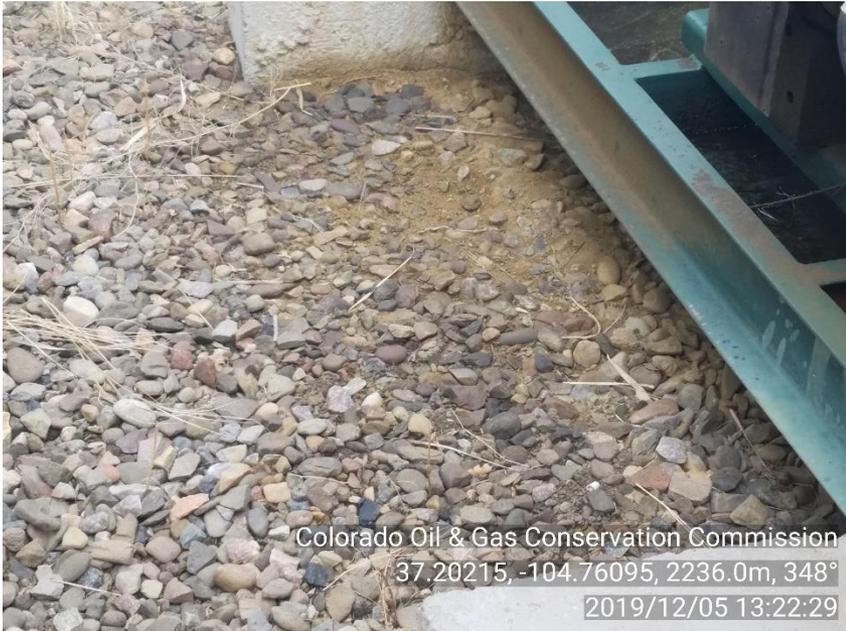
PHOTO 5: OILY IMPACTED SOIL NEAR ENGINE SKID. Remove and dispose impacted material in approved manner, service and maintain equipment and self inspect to prevent recurrence of conditions per 1002.f(2) and 907. CA DATE 01-05-20

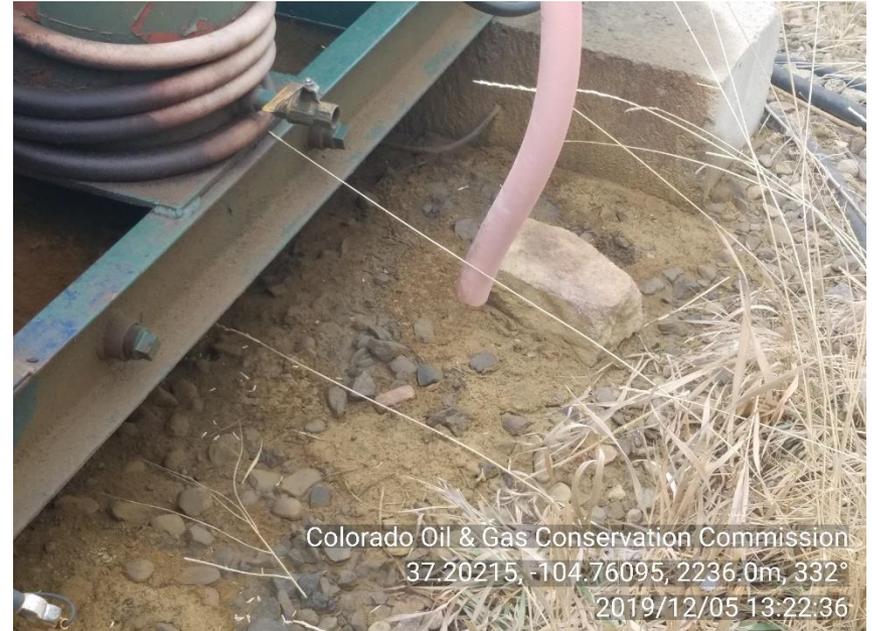
PHOTO 6: ANOTHER IMAGE OF OILY IMPACTED SOIL NEAR ENGINE SKID. Remove and dispose impacted material in approved manner, service and maintain equipment and self inspect to prevent recurrence of conditions per 1002.f(2) and 907. CA DATE 01-05-20

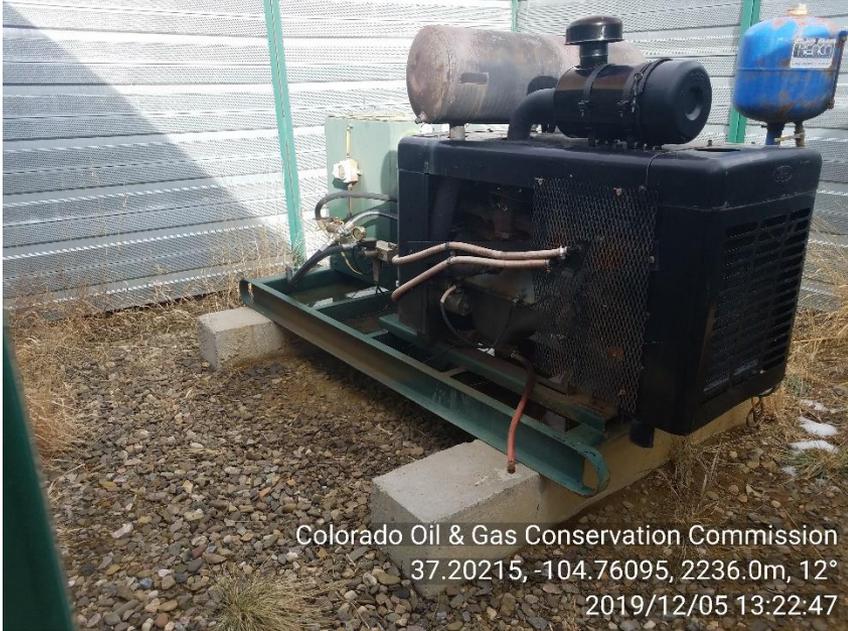
PHOTO 7: UNUSED EQUIPMENT STORED ON LOCATION (ENGINE SKID AND SOUND WALLS). REMOVE UNUSED EQUIPMENT IN ACCORDANCE WITH RULE 603.f. CA DATE 01-05-20

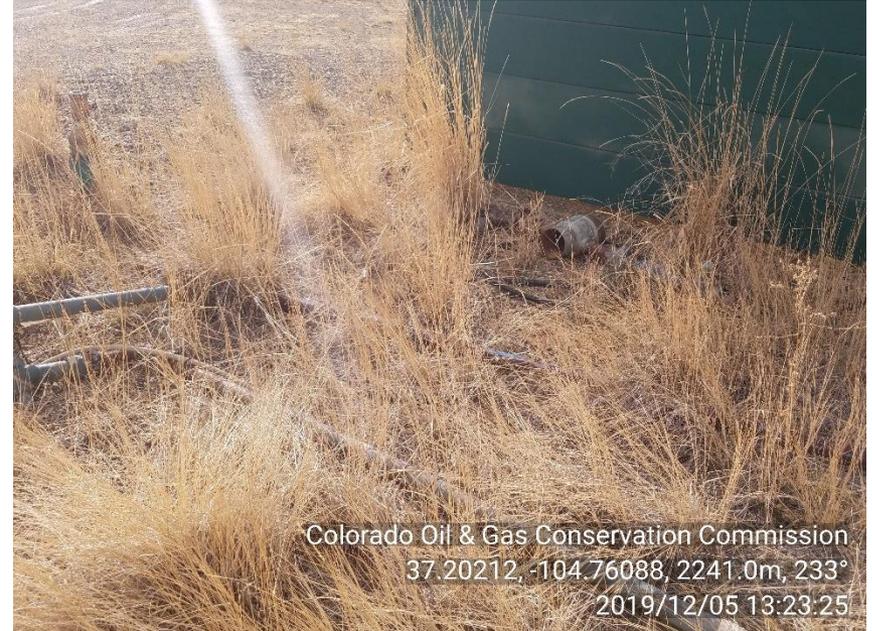
PHOTO 8: UNUSED EQUIPMENT STORED ON LOCATION (WELLHEAD EQUIPMENT, 2" PIPE AND PC PUMP W/SUB). REMOVE UNUSED EQUIPMENT IN ACCORDANCE WITH RULE 603.f. CA DATE 01-05-20

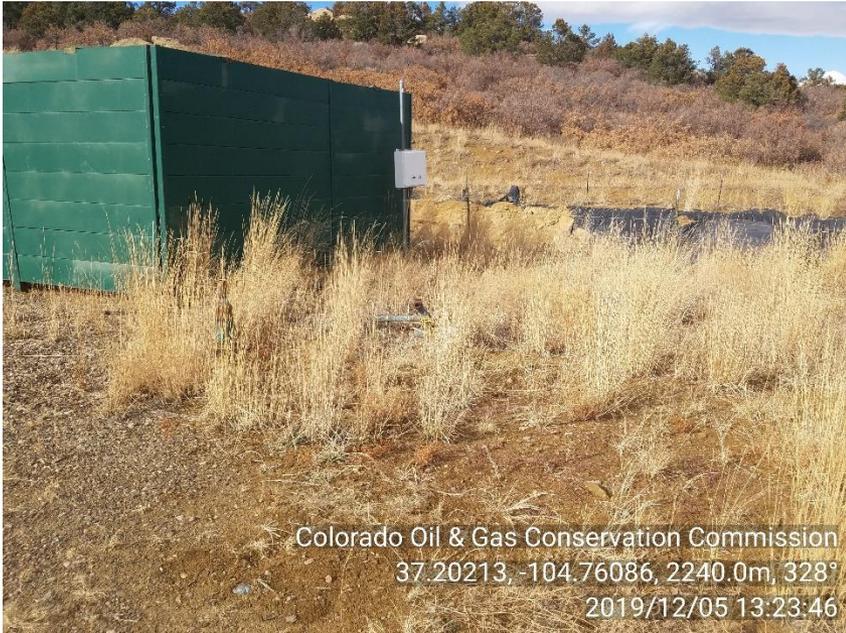
PHOTO 9: GRASS/WEEDS AROUND WELLHEAD.
CUT/MAINTAIN GRASS/WEEDS IN ACCORDANCE WITH RULE
603.f. CA DATE 01-05-20

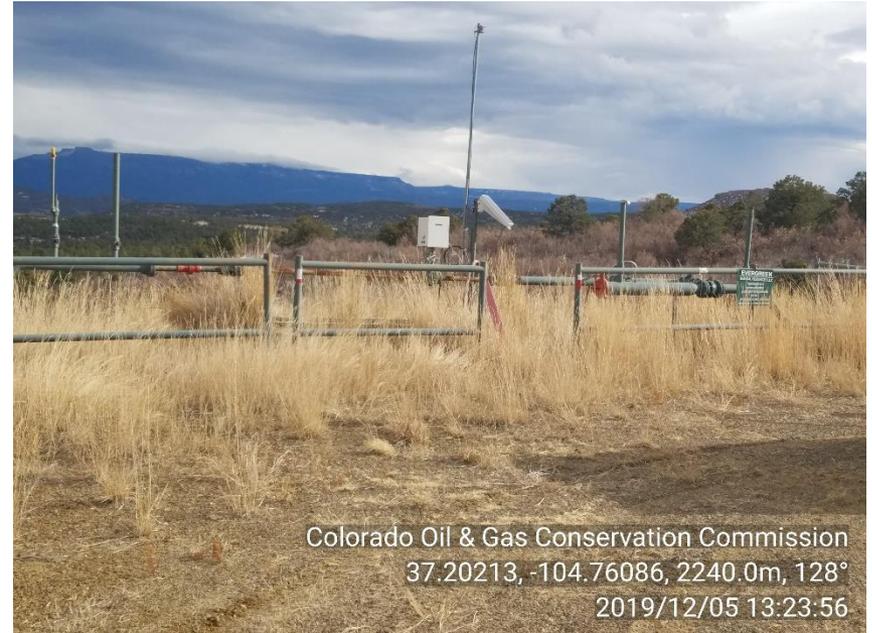
PHOTO 10: : GRASS/WEEDS AROUND METERRUN.
CUT/MAINTAIN GRASS/WEEDS IN ACCORDANCE WITH RULE
603.f. CA DATE 01-05-20
