Inspection Photos

Location Name: GROLSCH 44-7 CA DATE 2-16-20

API#: 05-071-07652

INSP. #: 695102034

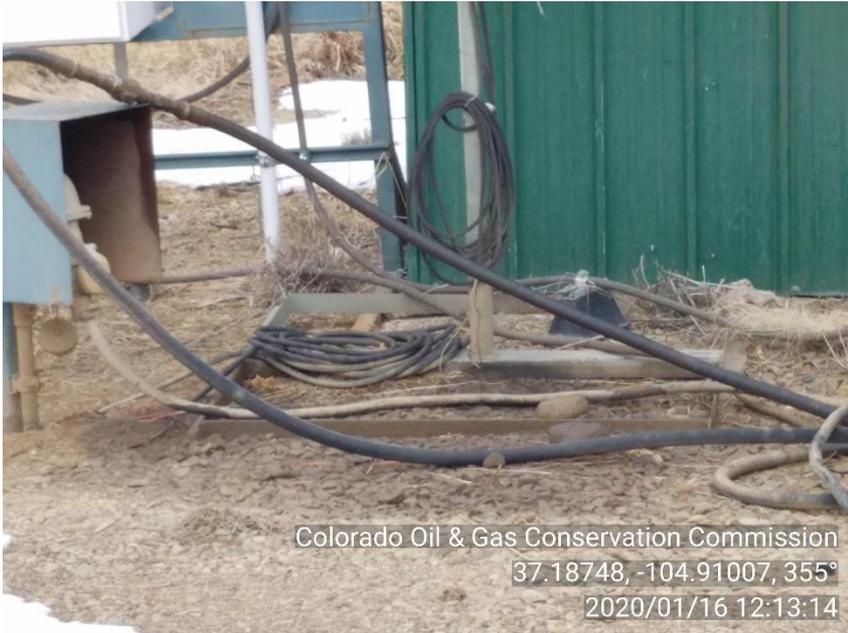
PHOTO 3: ARE OF IMPACTED SOIL APPEARS TO BE FROM LEAK HYDRAULIC CONNECTION OF DRIVEHEAD HOSE. Non E&P Waste not properly stored, handled, transported, treated, or disposed per Rule 907A.
