Construction and Stormwater Inspection

Operator: HIGHPOINT OPERATING CORPORATION- #10071

Location ID: 428174

Inspection Photos
Location Name: Siebring /5-63-32
Location ID: 428174

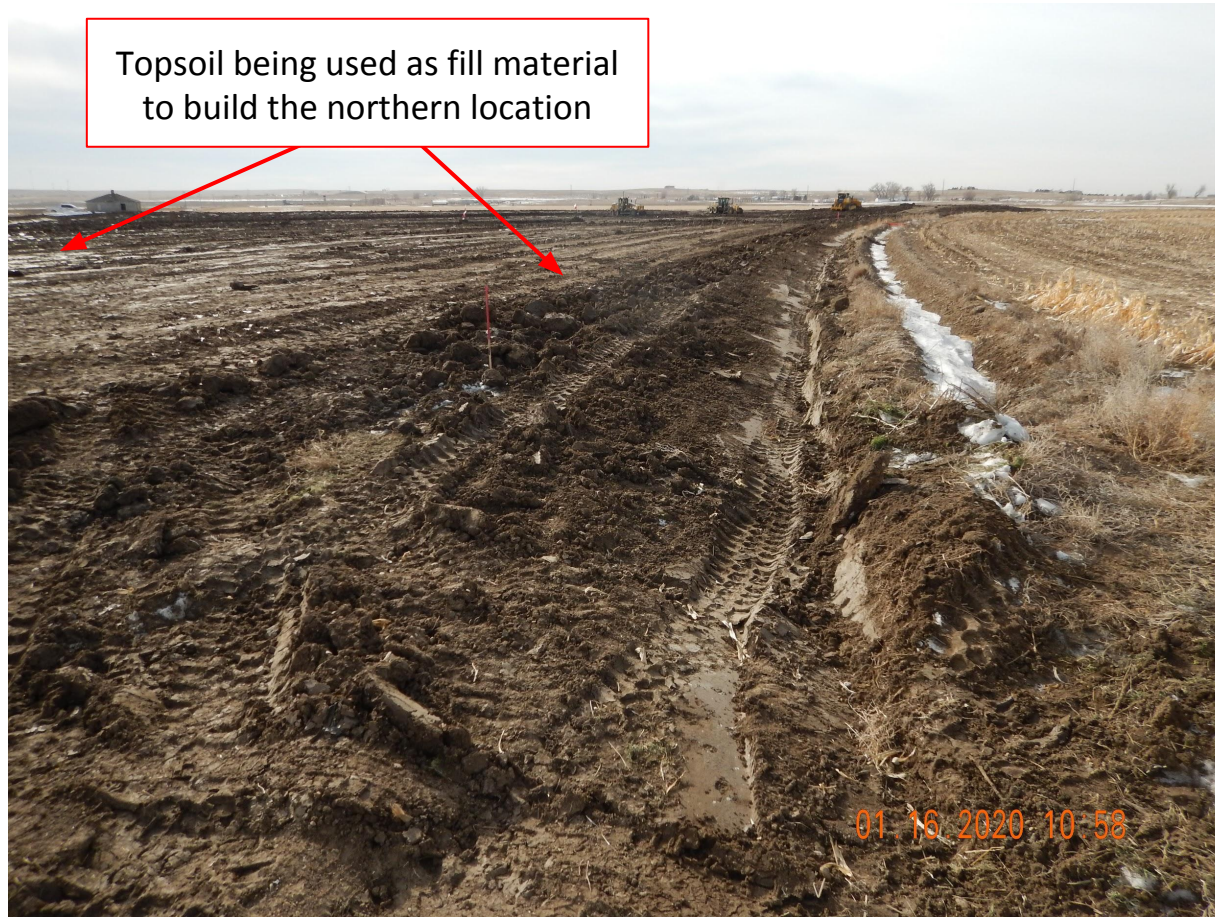
Photo 1. Photo taken from the northwestern perimeter of location, facing South. Photo illustrates a ditch BMP which is directed to a sediment trap (still in-process).

Also, the photo illustrates topsoil being used as fill material to build up the northern part of the location.

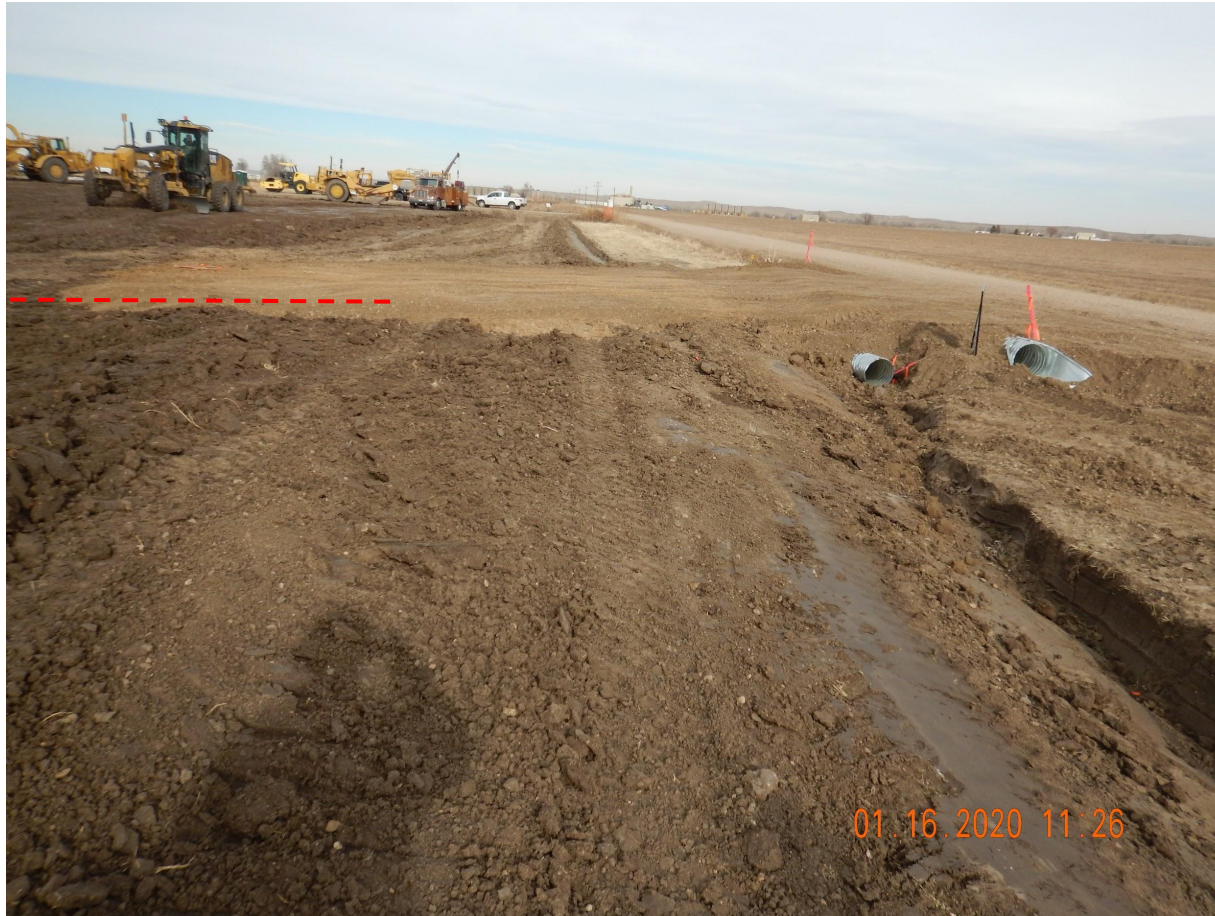
Photo 2. Photo taken from the eastern perimeter of location, facing North. Photo illustrates a ditch BMP which is directed to a sediment trap (still in-process) along with culverts.

Note: Everything approximately north of the red-dashed line was built using topsoil.

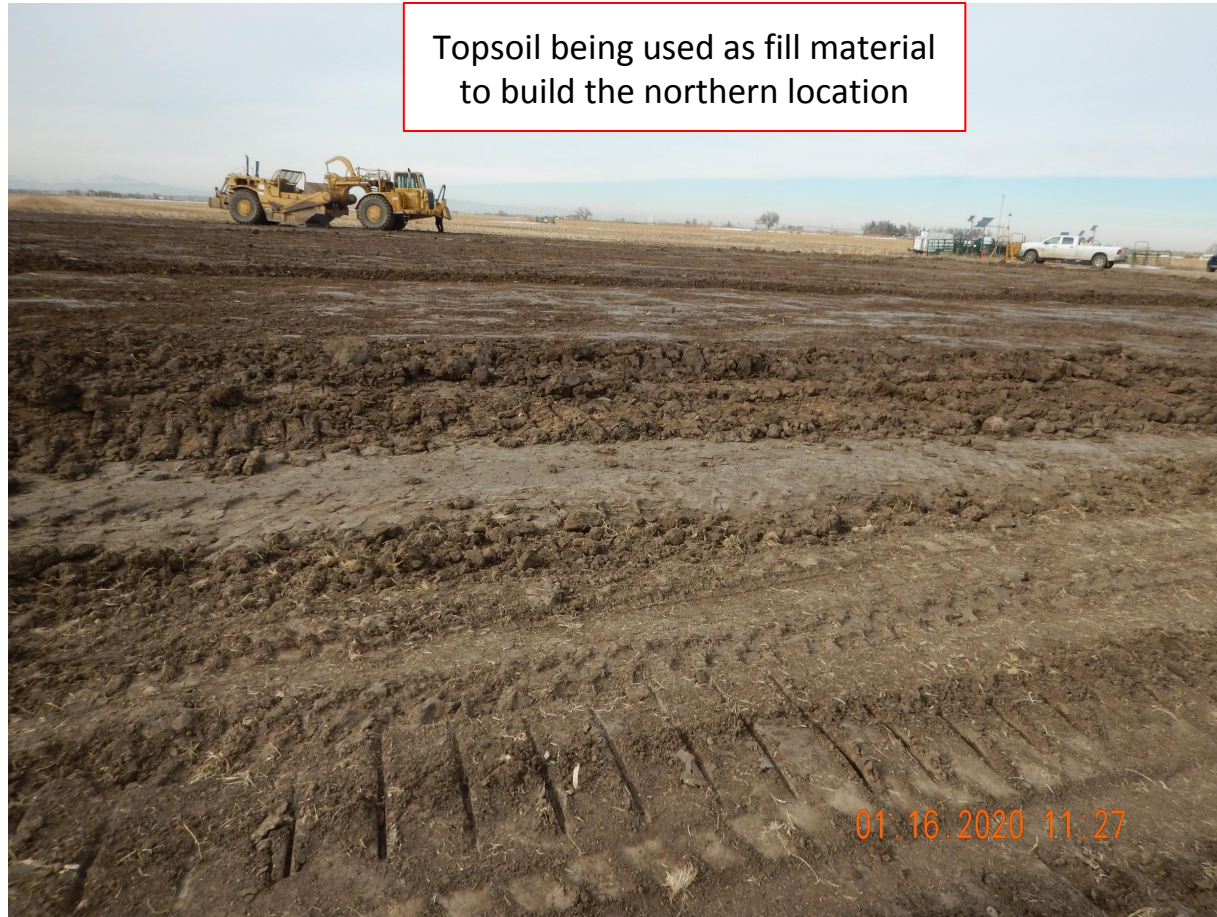
Photo 3. Photo taken from the eastern perimeter of location, facing West. Photo illustrates topsoil being used as fill material to build up the northern part of the location.

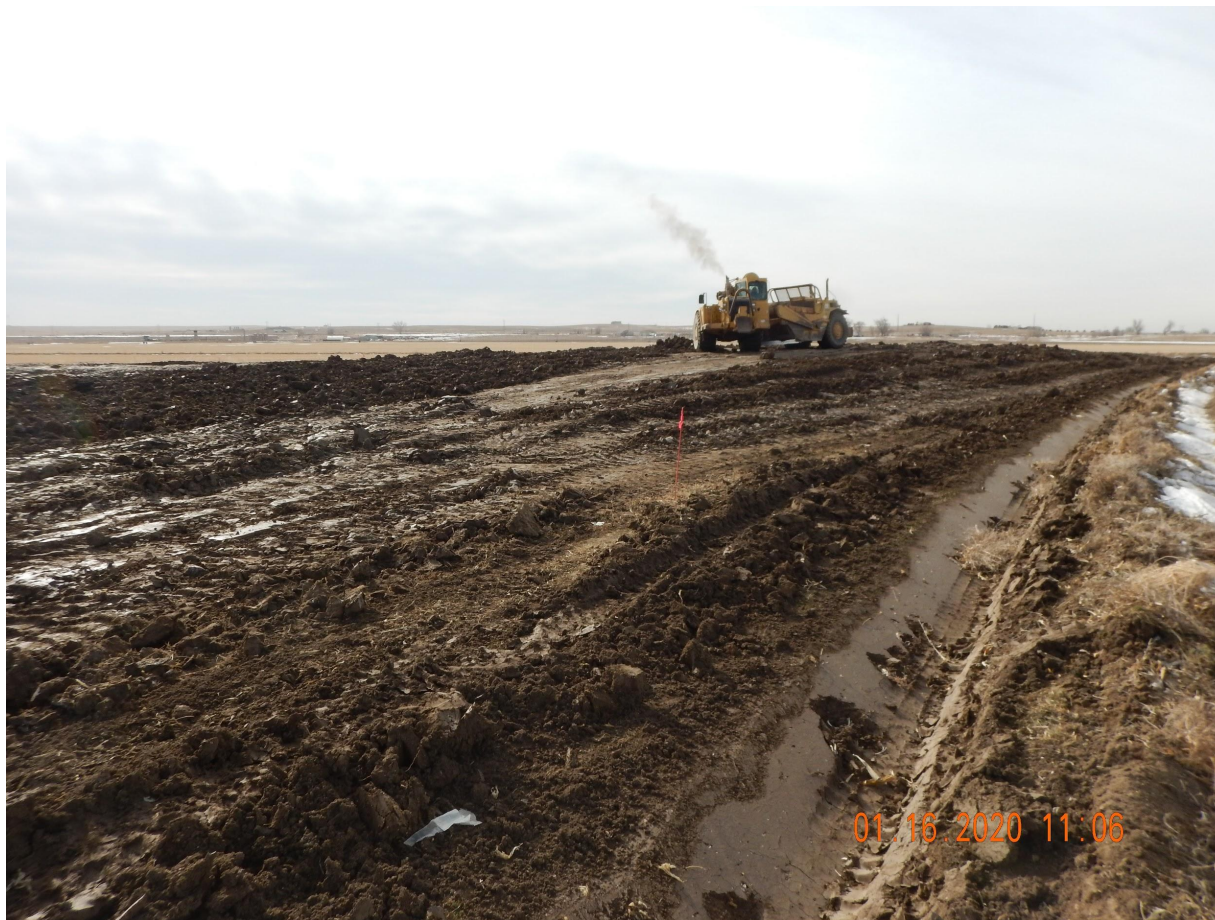
Photo 4. Photo taken from the western perimeter of location, facing South. Photo illustrates the southwestern topsoil stockpile.

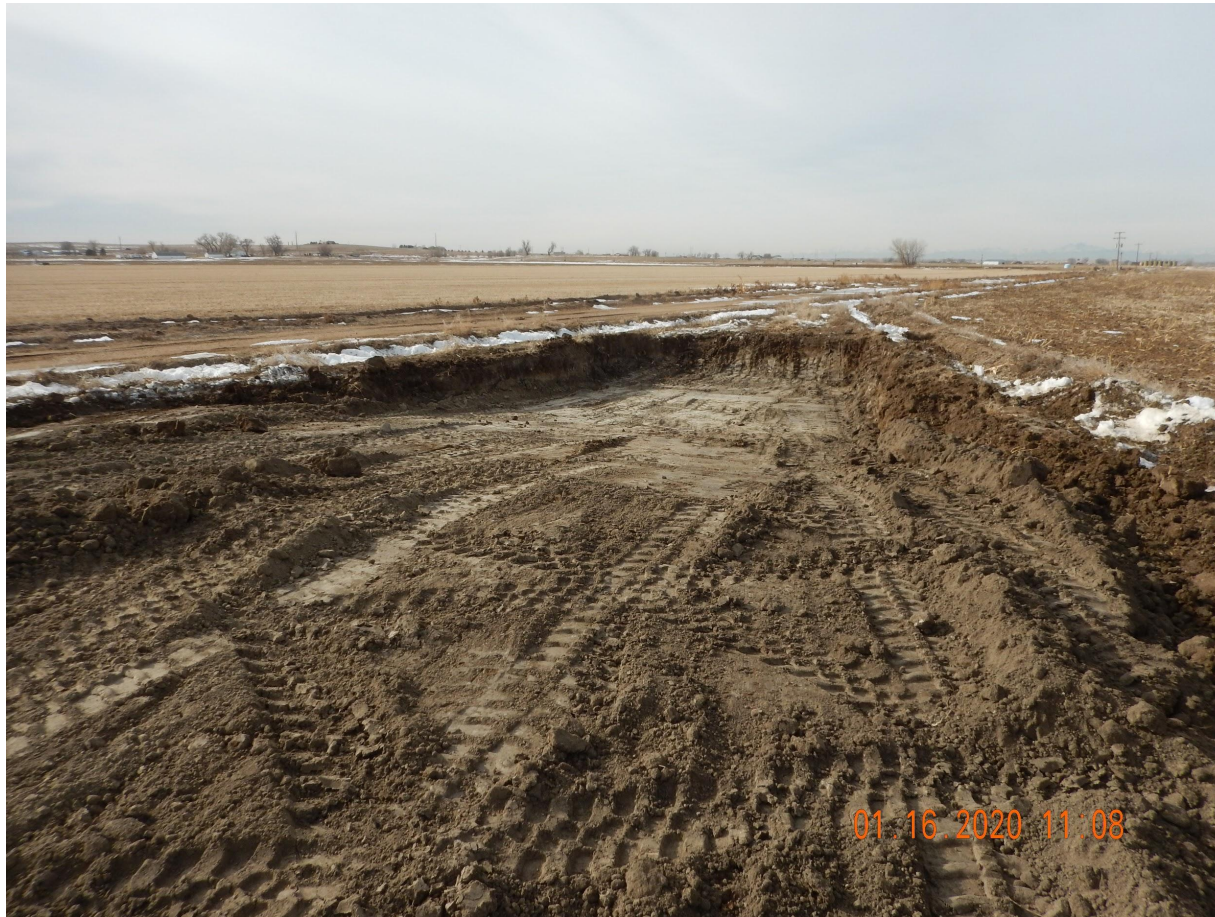
Photo 5. Photo taken from the southwestern perimeter of location, facing Southwest. Photo illustrates the sediment trap which is still in-process of being constructed.

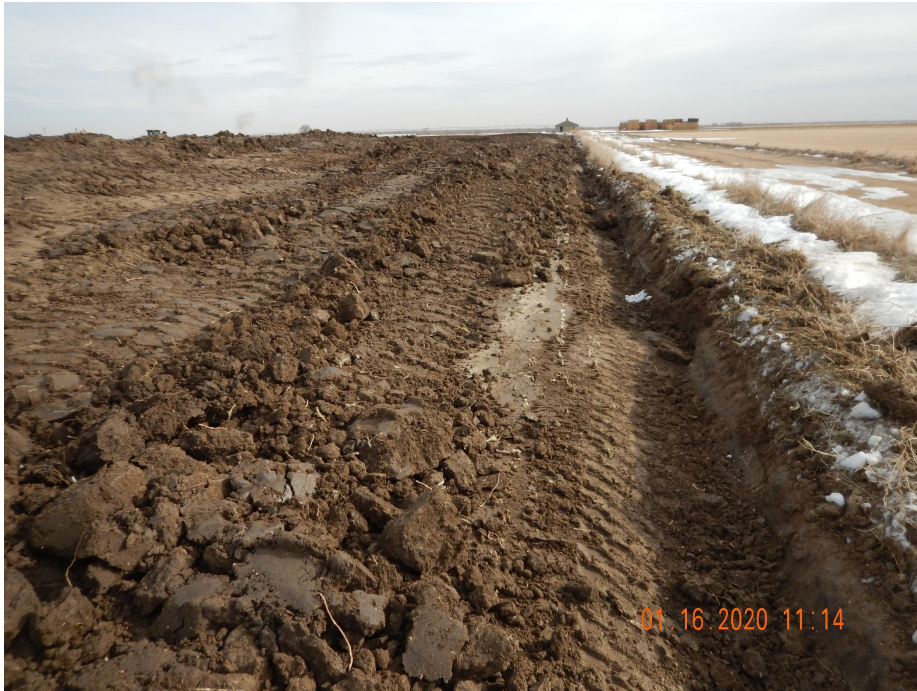
Photo 6. Photo taken from the southwestern perimeter of location, facing East. See comments under Photo 1 regarding the ditch BMP.

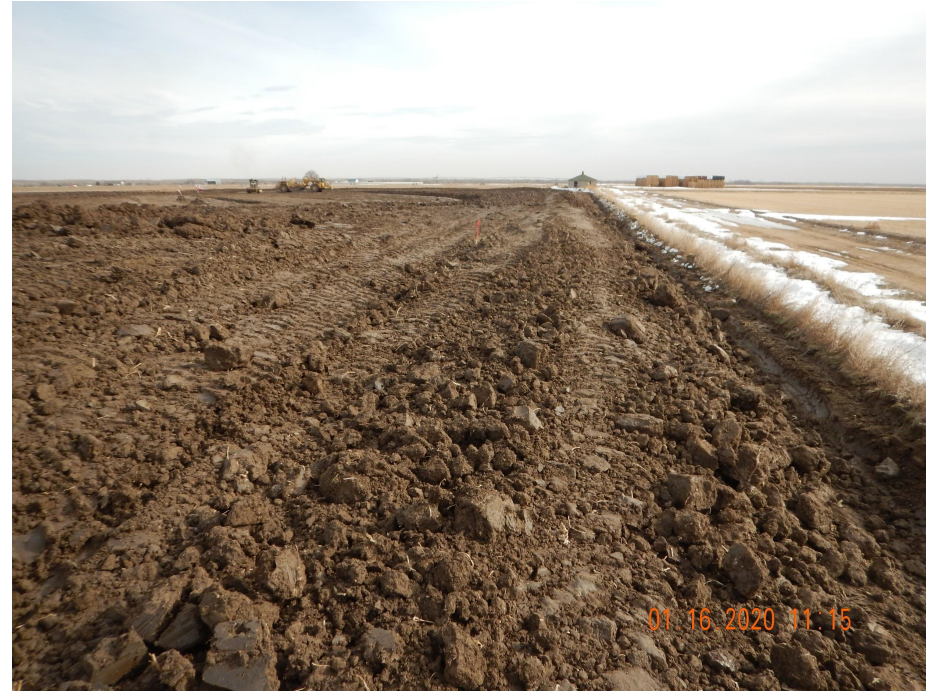
Photo 7. Photo taken from the southern perimeter of location, facing East. Photo illustrates topsoil being stored along the southern perimeter of location.

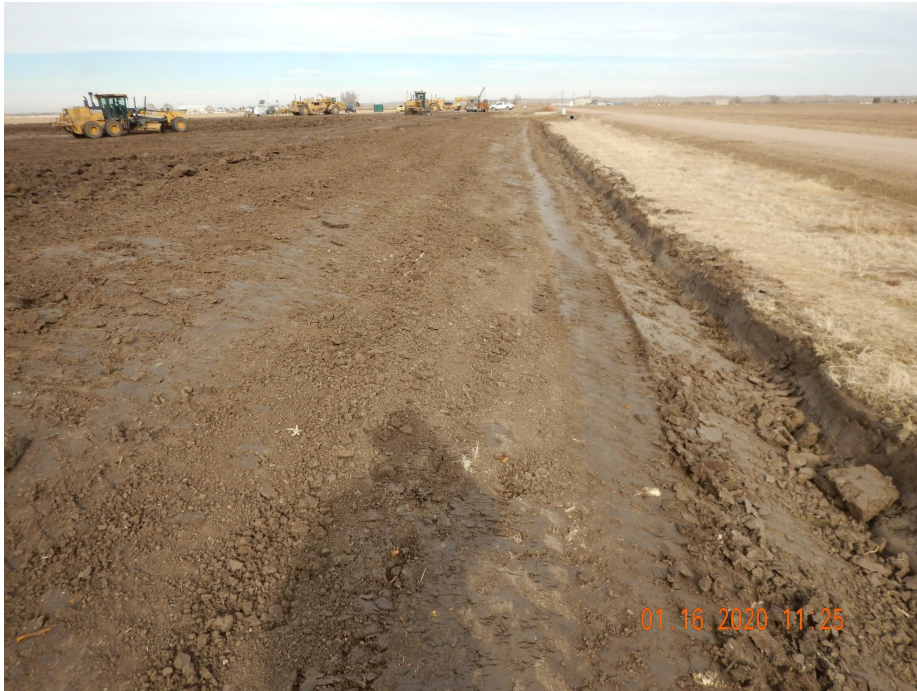
Photo 8. Photo taken from the southeastern perimeter of location, facing North. Photo illustrates topsoil being stored along a portion of the eastern perimeter of location. See comments under Photo 1 regarding the ditch BMP.

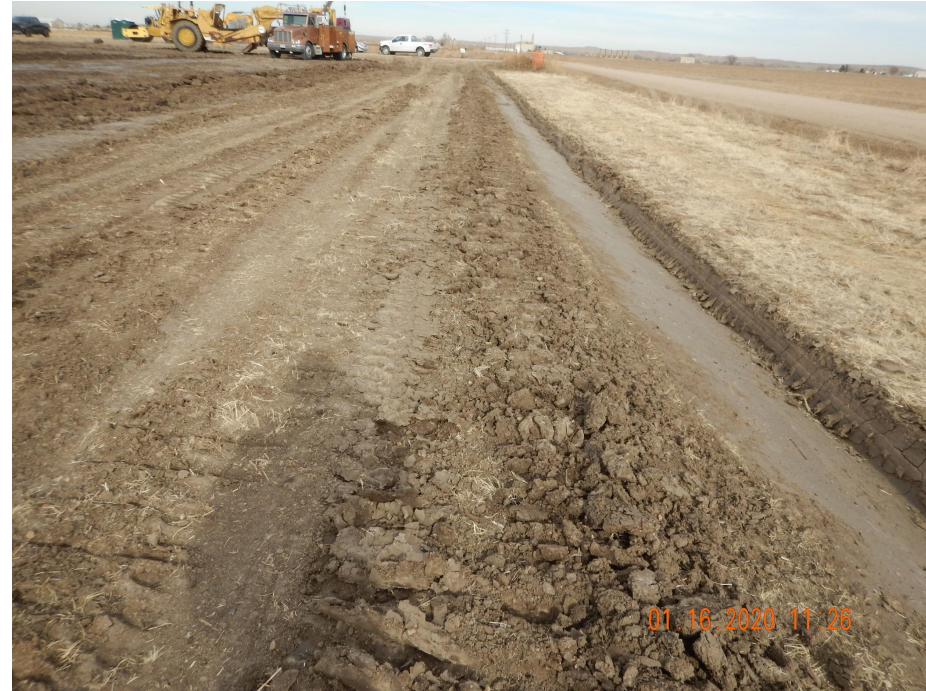
Photo 9. Photo taken from the eastern perimeter of location, facing East. See comments under Photo 1 regarding the ditch BMP.

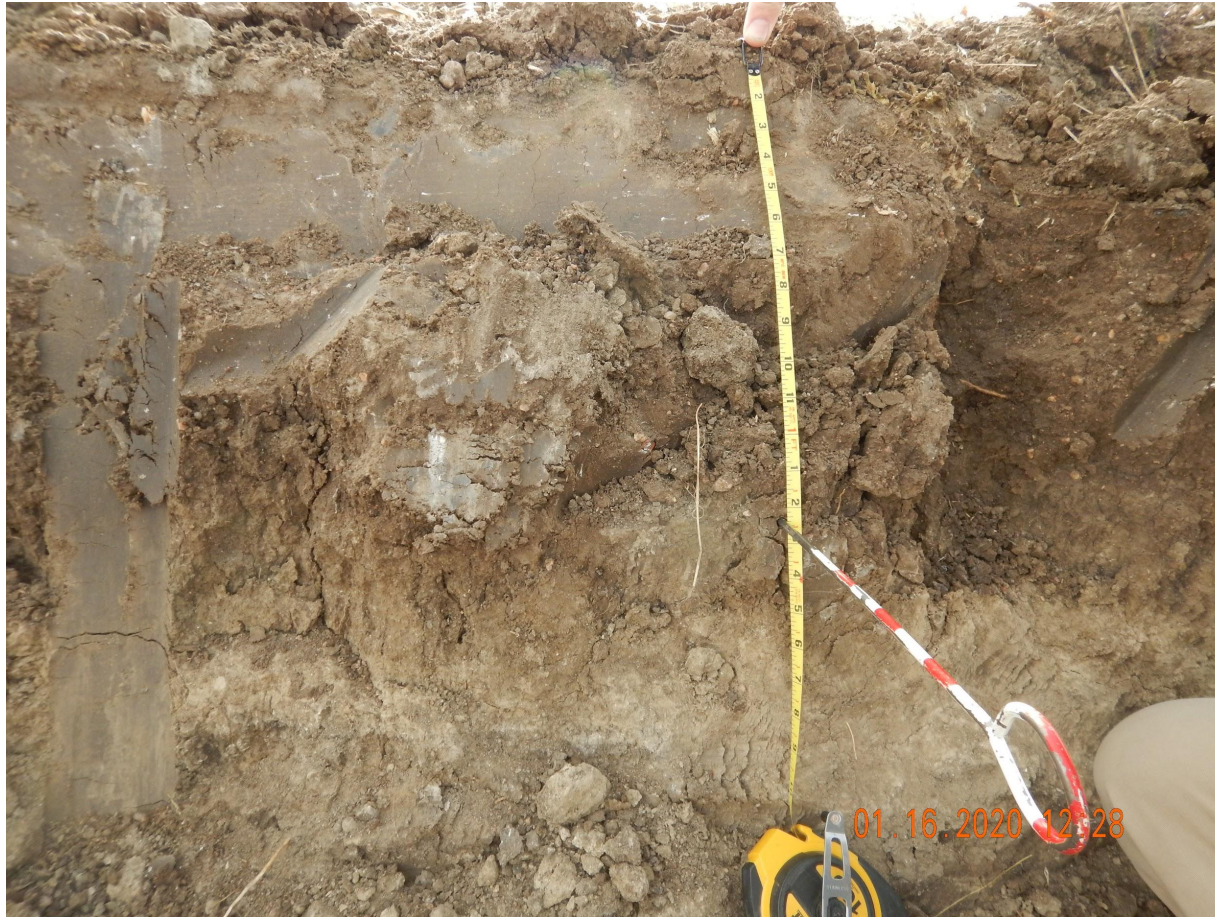
Photo 10. Photo taken from within the sediment trap located along southwestern perimeter of location. Based on field observations and physical characteristics (color, texture, structure, and primary root depth), topsoil is approximately 14 inches. Note: COGCC staff gave a conservative estimate on topsoil depth as it was observed up to 17-18
