Interim Reclamation and Stormwater Inspection

Operator: UPLAND EXPLORATION LLC- #10701

Location ID: 462919

Inspection Photos
Location Name: Little Lady 21 /South Well Pad
Location ID: 462919

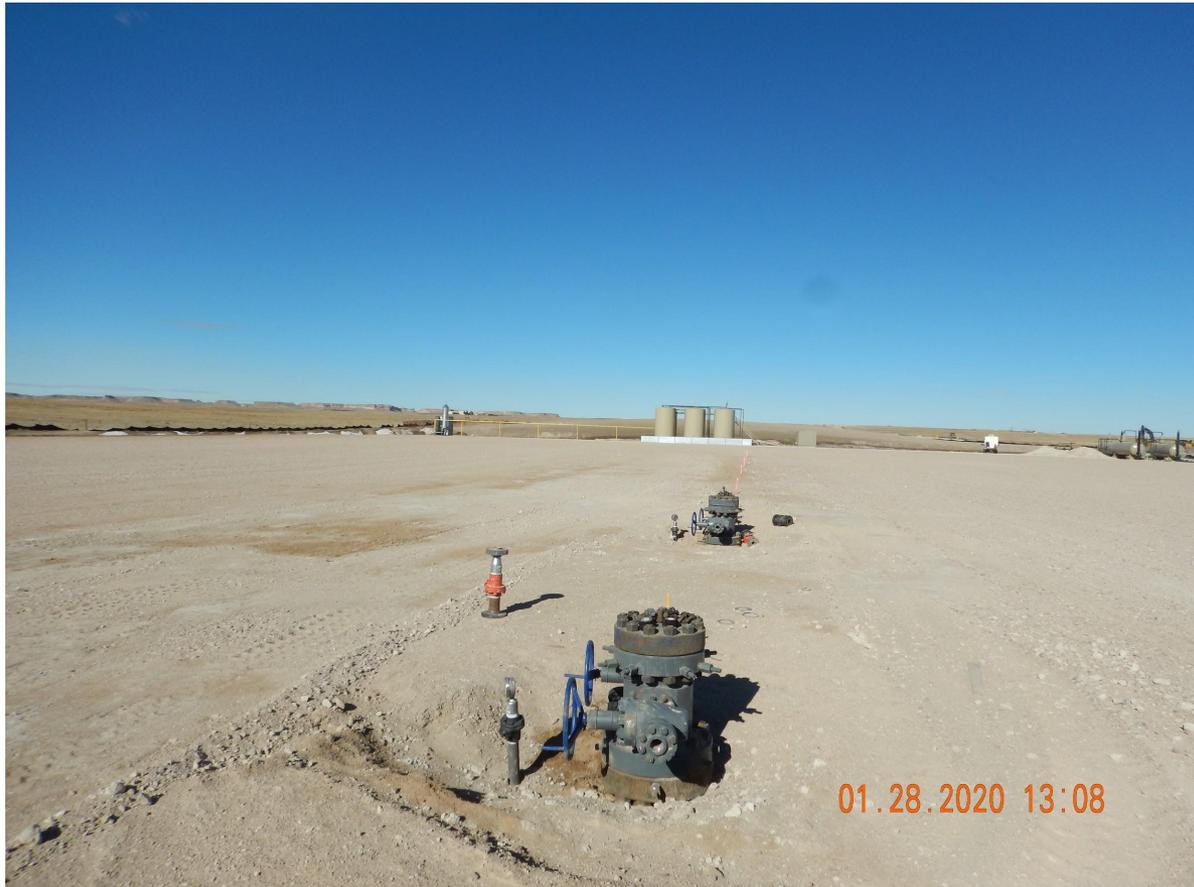
Photo 1. Photo taken from the wells, facing North. Photo illustrates Operator has backfilled around the wells to mitigate the previous safety hazard of open cellars.

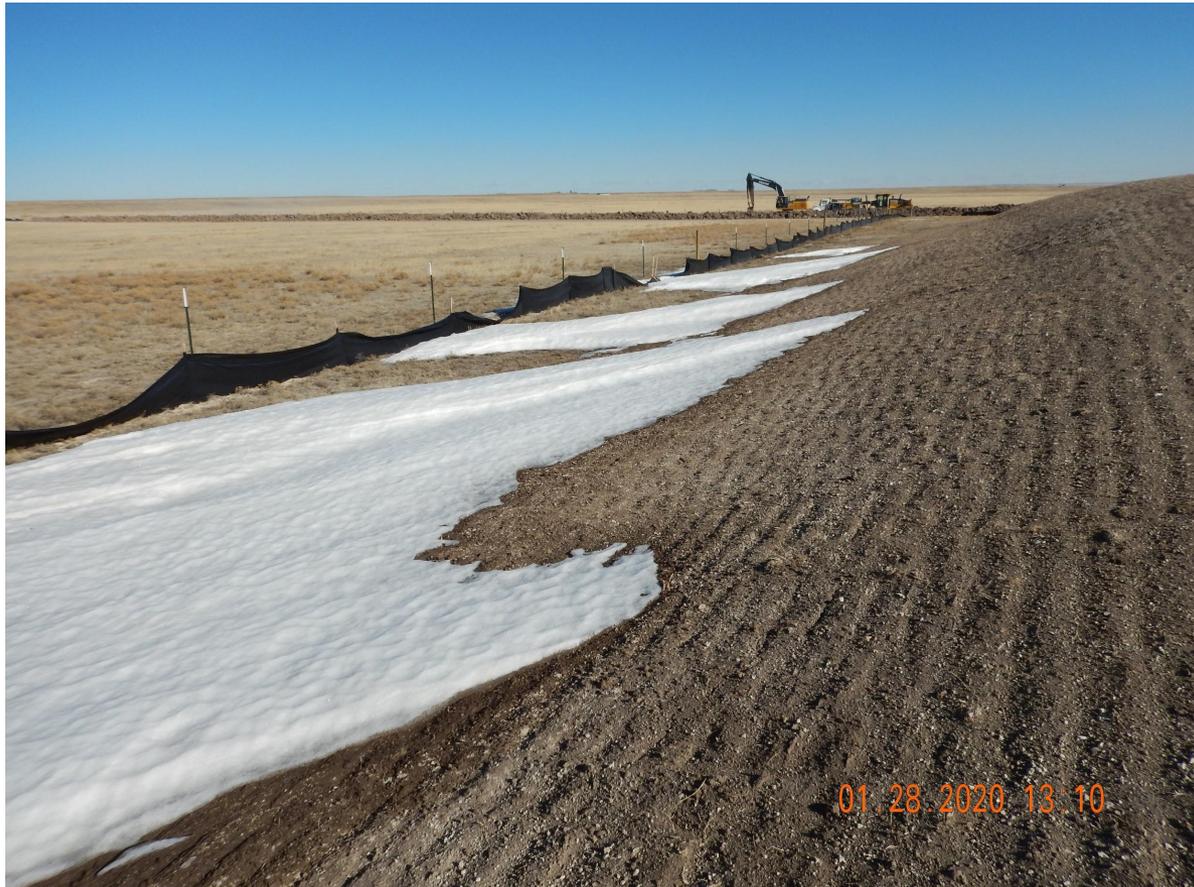
Photo 2. Photo taken from the topsoil stockpile, facing East. Photo illustrates stormwater BMP (silt fence) around the topsoil is not in proper functioning condition.

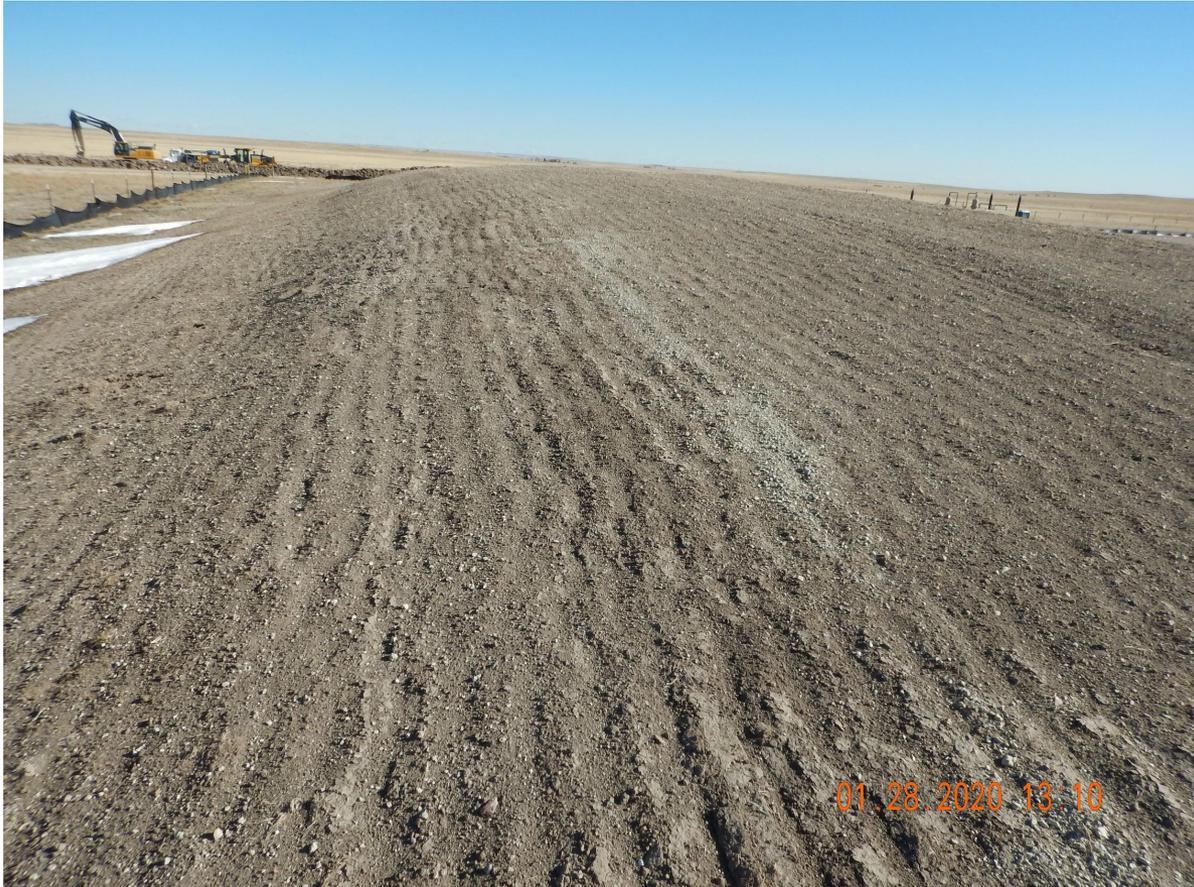
Photo 3. Photo taken from the topsoil stockpile, facing East. Photo illustrates topsoil has not been properly stabilized. Equipment tracking is only a temporary stabilization BMP.

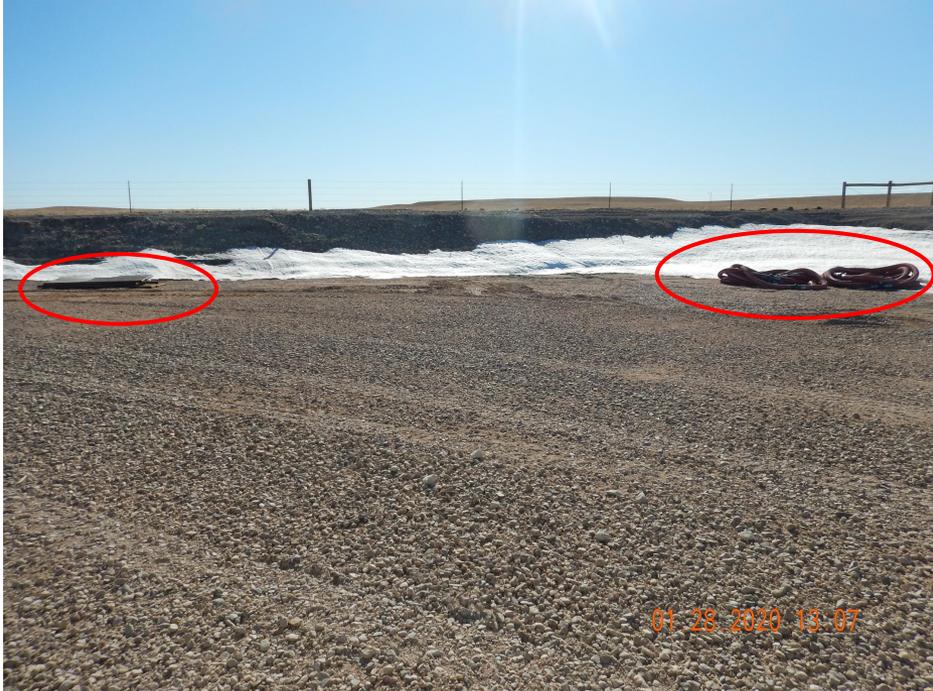
Photo 4. Photo taken from the southwestern location, facing South. Photo illustrates unused equipment being stored at location.

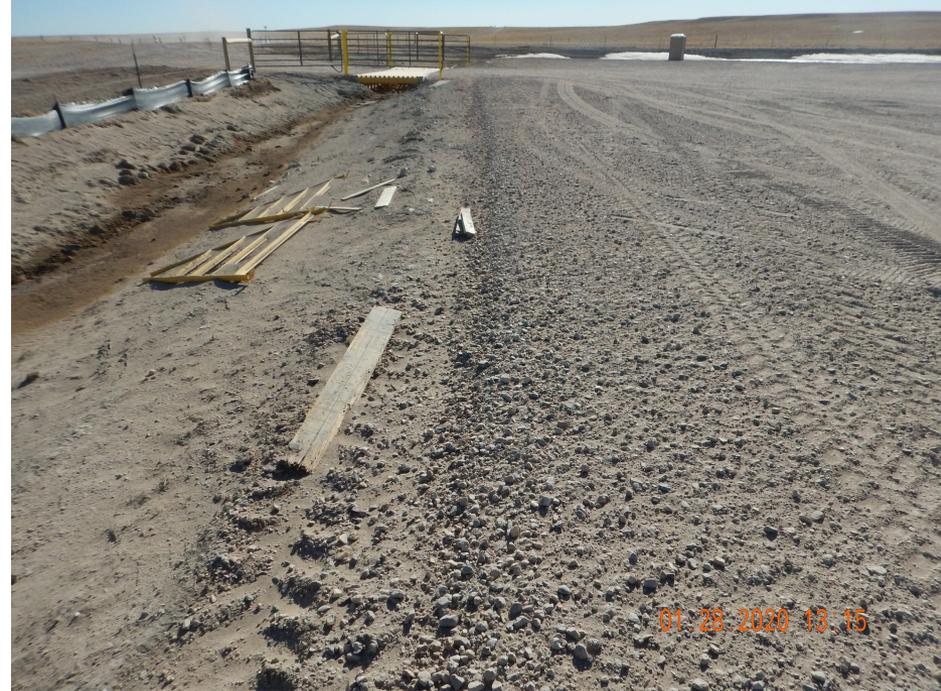
Photo 5. Photo taken from the southeastern location, facing South. Photo illustrates unused equipment and debris being stored at location.

Photo also illustrates the retention area along the eastern location for stormwater management.
