Construction and Stormwater Inspection

Operator: UPLAND EXPLORATION LLC- #10701

Location ID: 462908

Inspection Photos
Location Name: Little Lady 21 /North Well Pad
Location ID: 462908

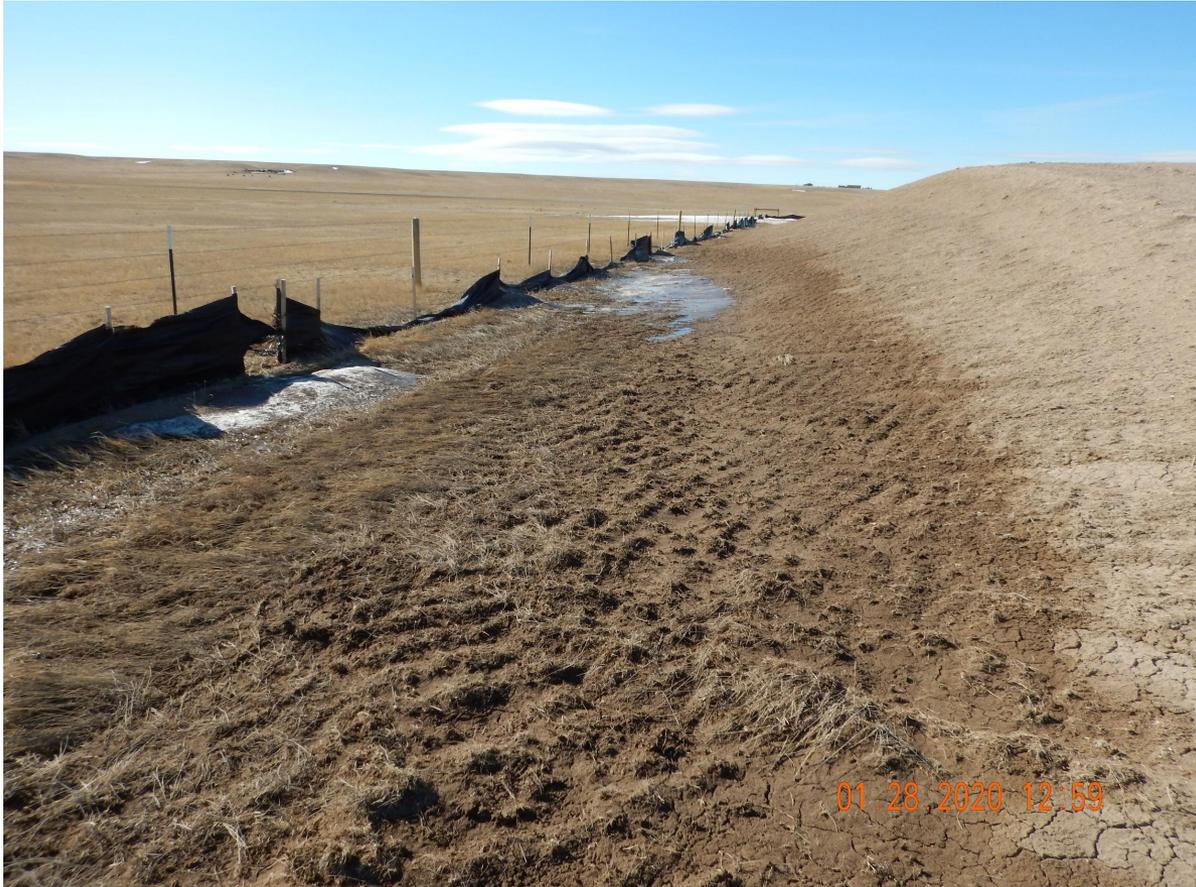
Photo 1. Photo taken from the topsoil stockpile, facing West. Photo illustrates stormwater BMP (silt fence) around the topsoil is not in proper functioning condition.

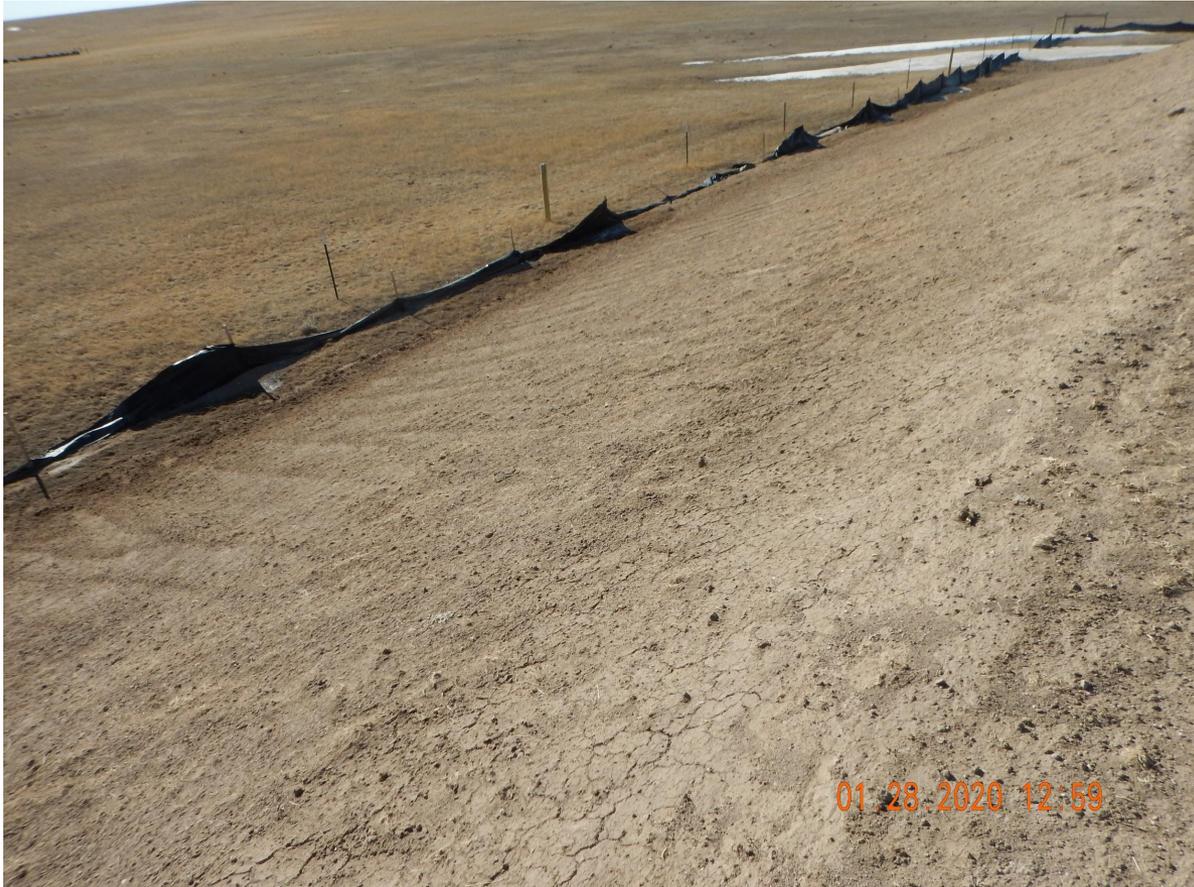
Photo 2. Photo taken from the topsoil stockpile, facing West. Photo illustrates topsoil has not been properly stabilized. Equipment tracking is only a temporary stabilization BMP.

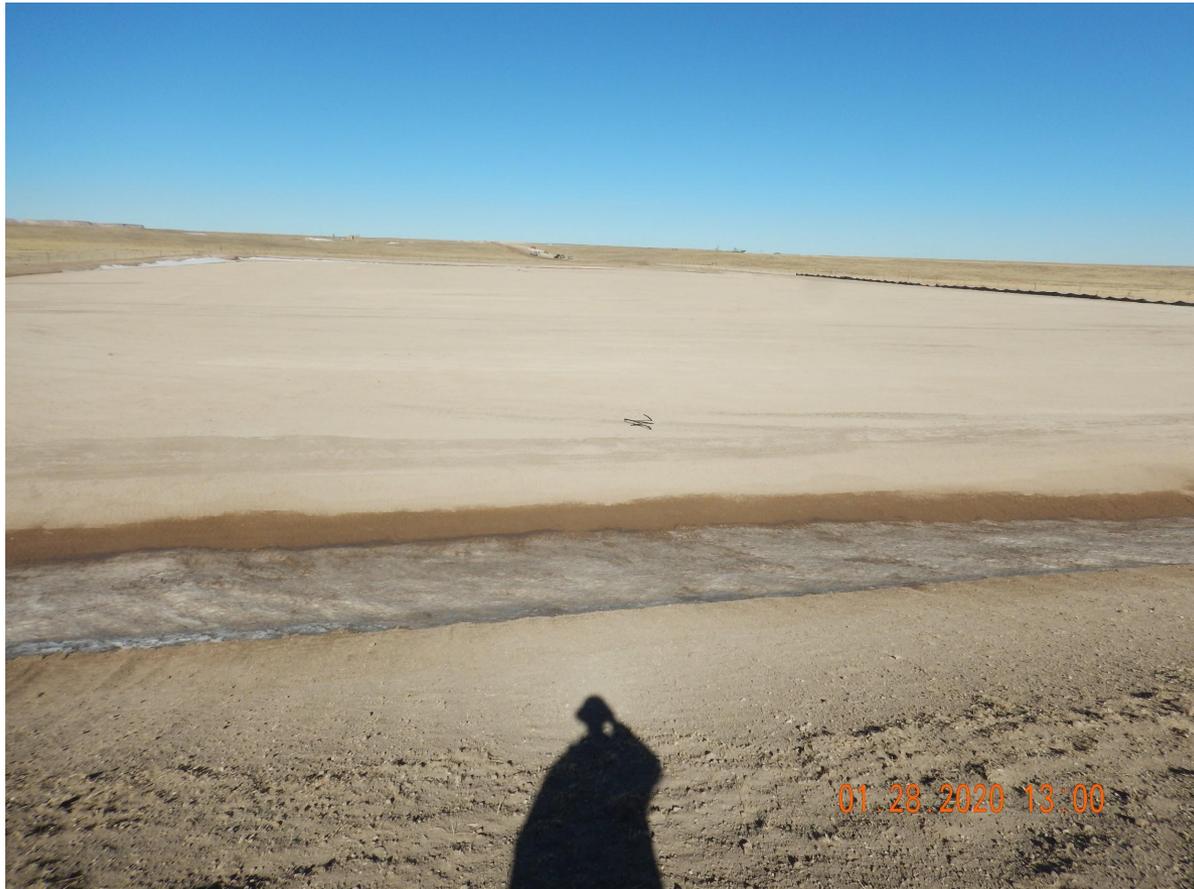
Photo 3. Photo taken from the topsoil stockpile, facing North. Photo illustrates Operator has not spud the location yet. Also, there is a retention around the entire well pad for stormwater management.
