Inspection Photos

Location Name: PARADISE FEDERAL 13-8 TR CA DATE 2-1-20

API#: 05-071-07946

INSP. #: 695102104

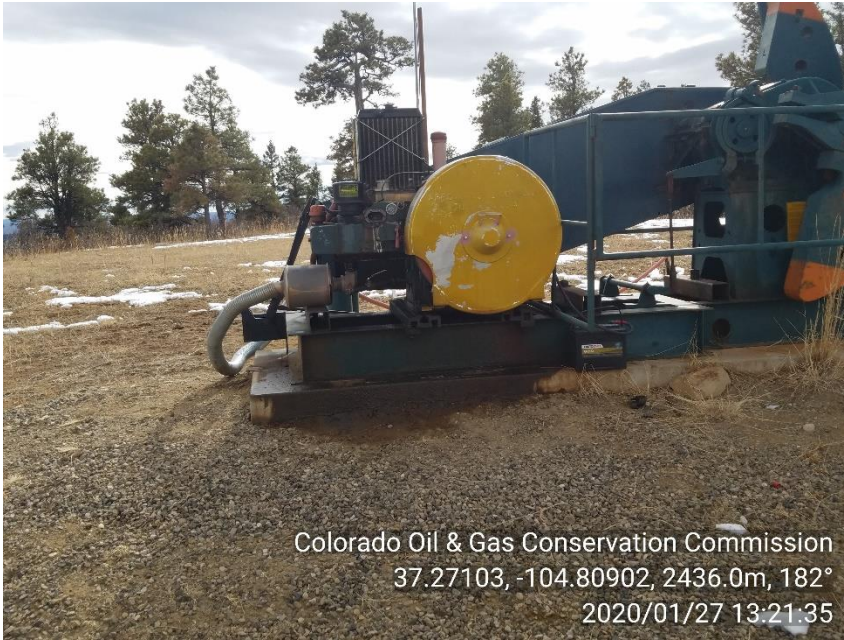
PHOTO 3: PRIME MOVER ON PUMPJACK IS LEAKING, OIL IS RUNNING OFF PUMPJACK BASE ON ONTO SOIL. Conduct maintenance on equipment (REPAIR LEAKS), cleanup stained material and review self inspection processes. CA DATE FOR CLEANUP OF IMPACTED SOIL 2-1-20. 30 DAYS TO REPAIR LEAKS ON PUMPJACK MOTOR.
