**Inspection Photos**  
**Operator: BP America**  
**Location #: 311980**  
**Date: 1-31-2020**

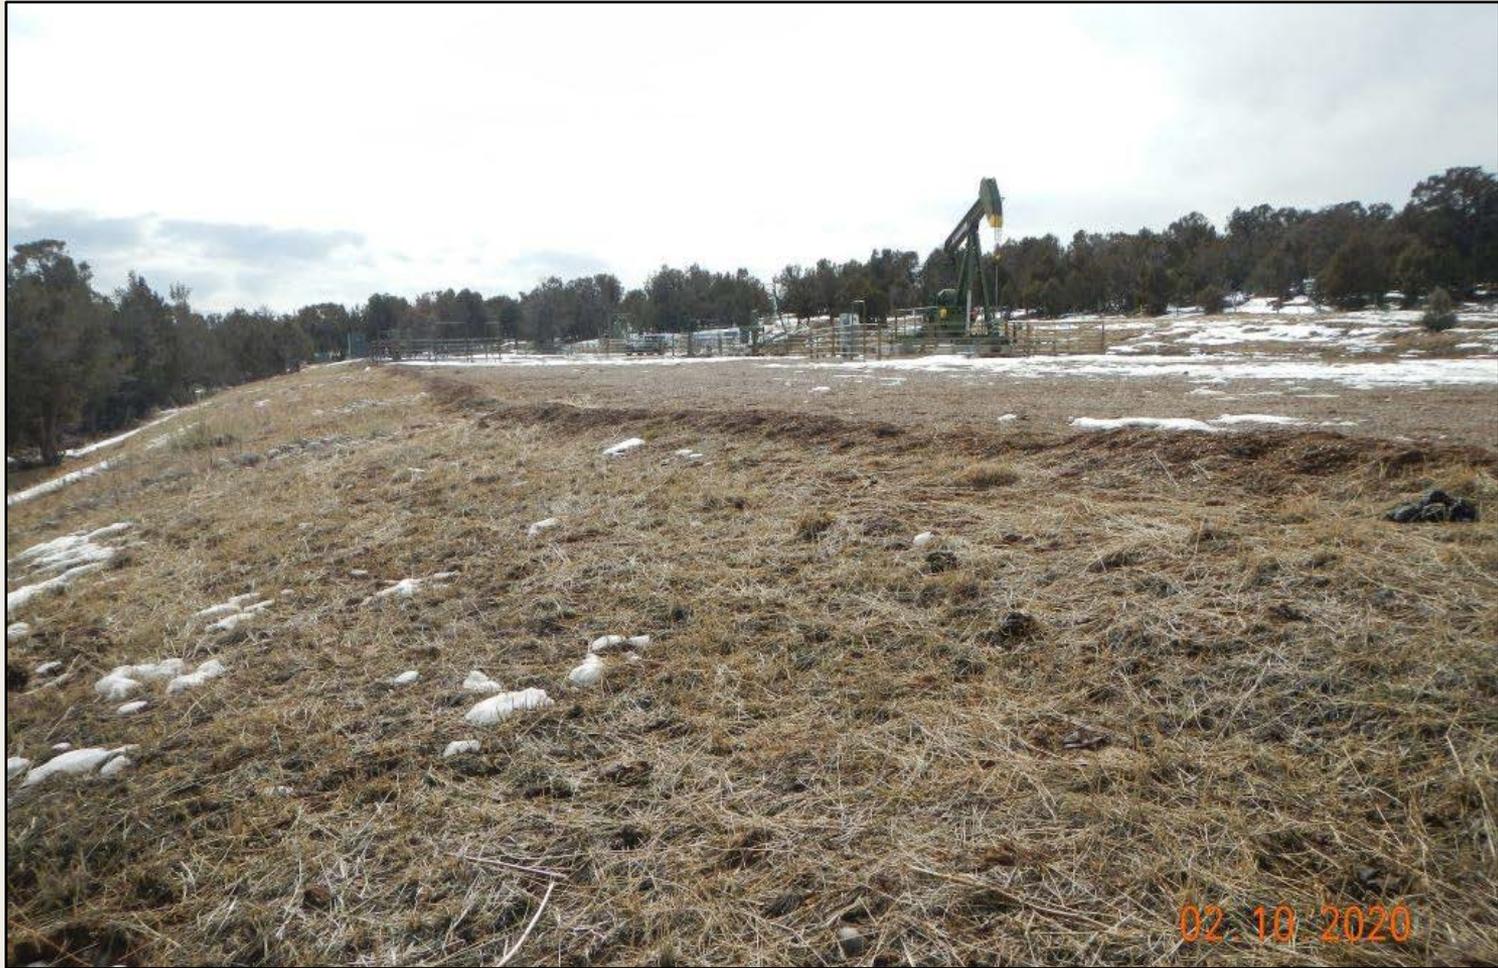
Photo 1. View of the project area from the northeastern corner facing center.

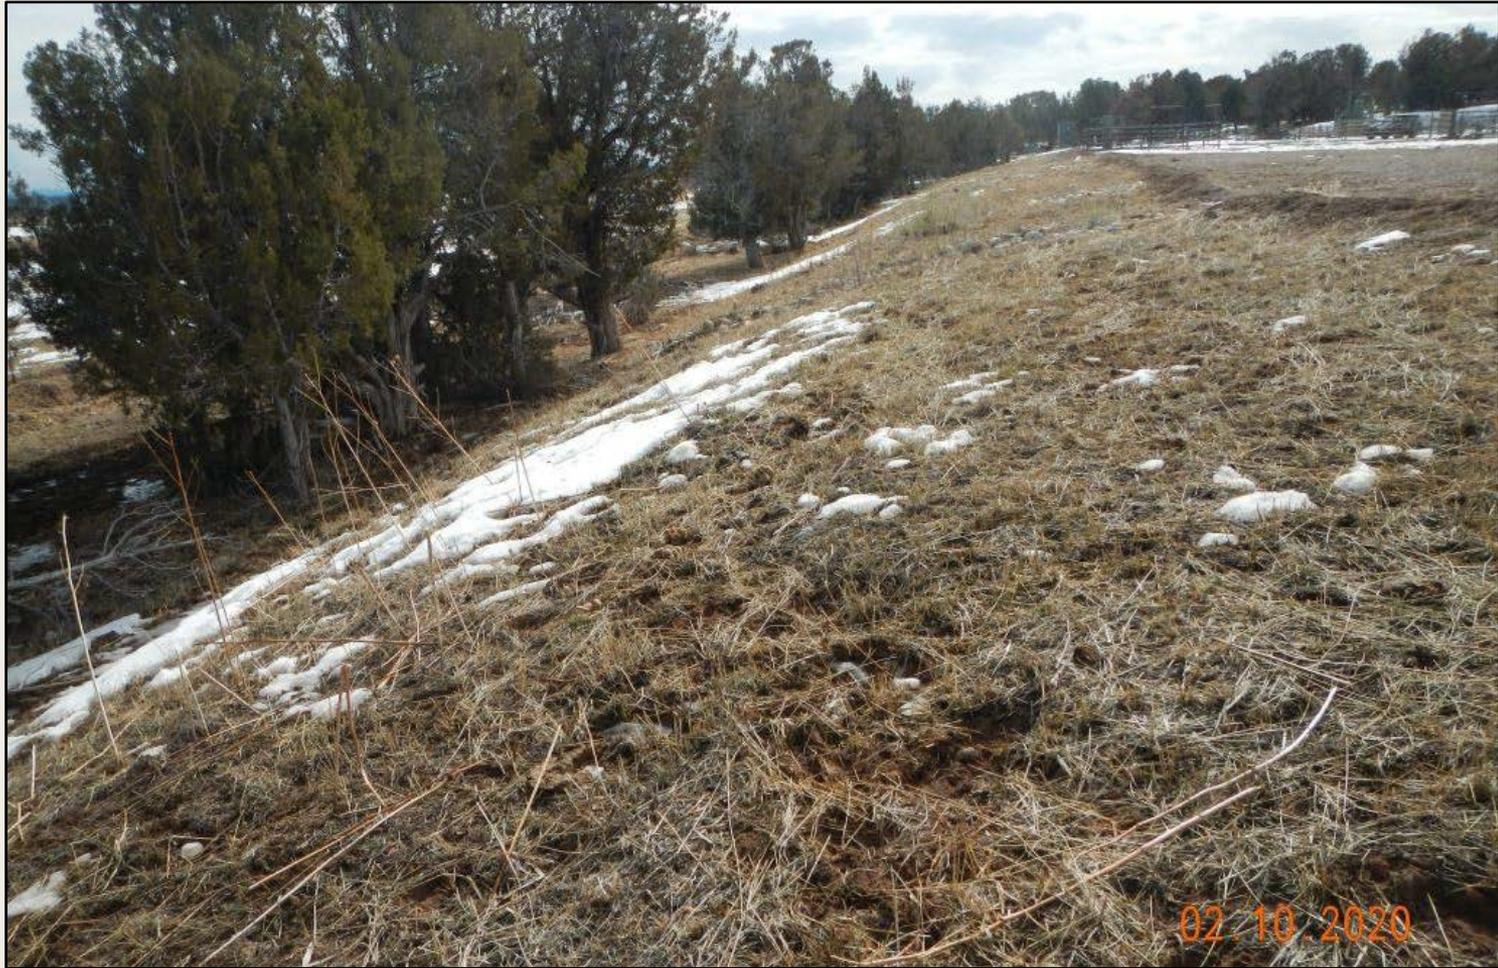
Photo 2. View of the eastern project area from the northeastern corner facing southward. Vegetation is largely in a grazed/dormant condition at this time, although perennial grasses are established similar to reference area vegetation.

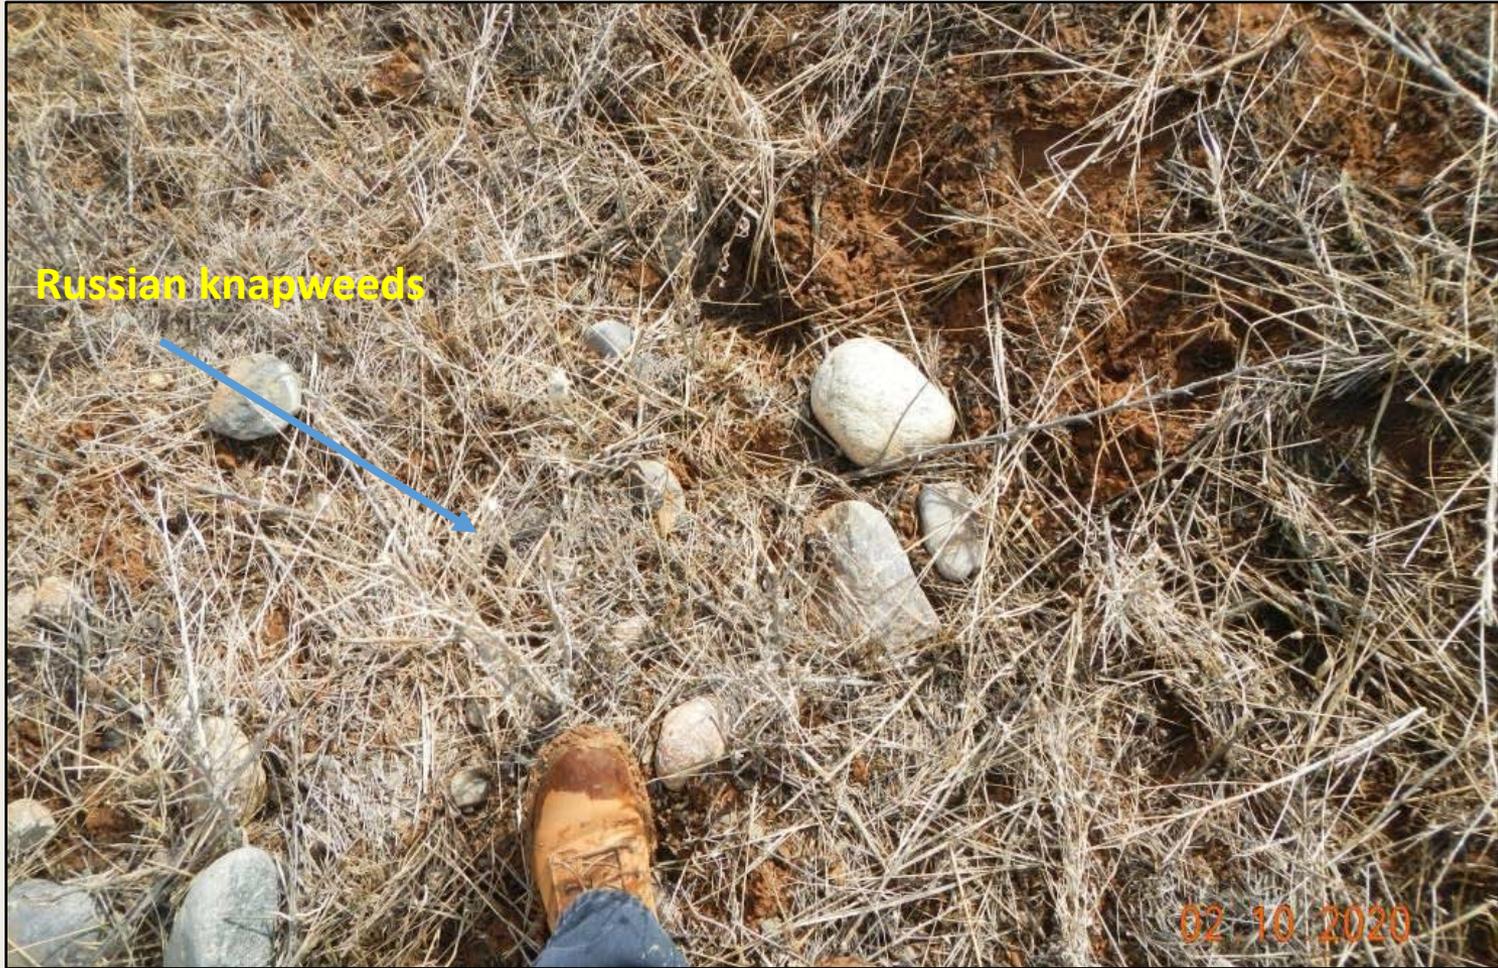
Photo 3. View of Russian knapweeds within the eastern project area. Approximately 200 individuals observed.

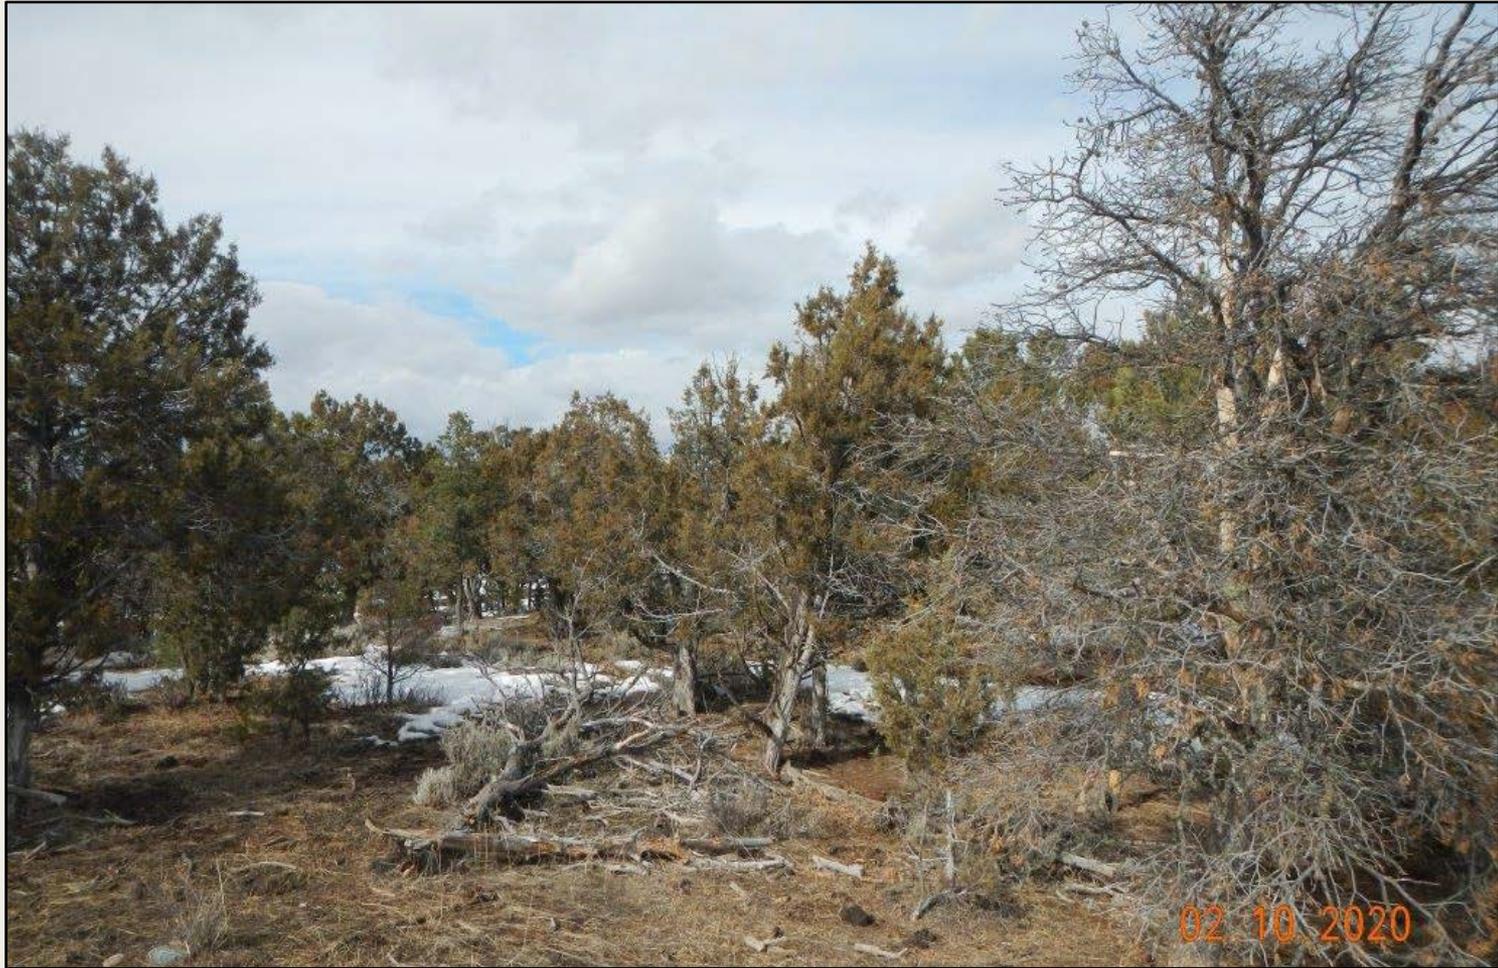
Photo 4. View of the reference area, comprised of pinyon juniper woodland with herbaceous understory, largely in a grazed/dormant vegetative condition.
