Inspection Photos
Operator: BP America
API#: 067-06816
Date: 3/2/2020

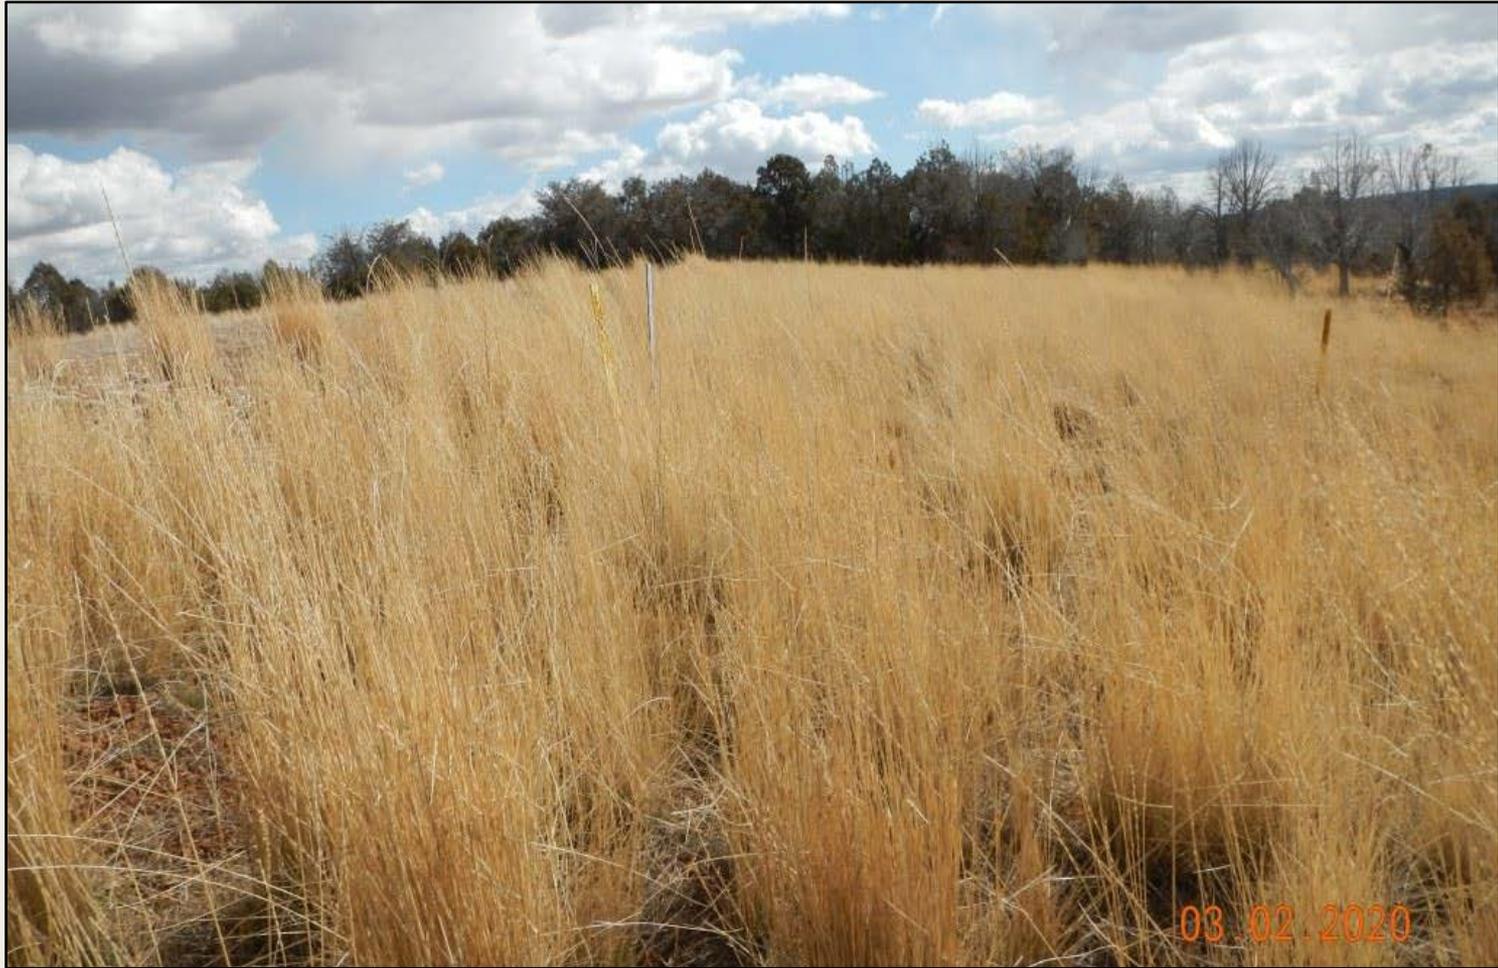
Photo 2. View of the southern fill slope facing eastward, revegetation is largely comprised of intermediate wheatgrass. Intermediate wheatgrass is a non-native grass species that is not representative of reference area vegetation.

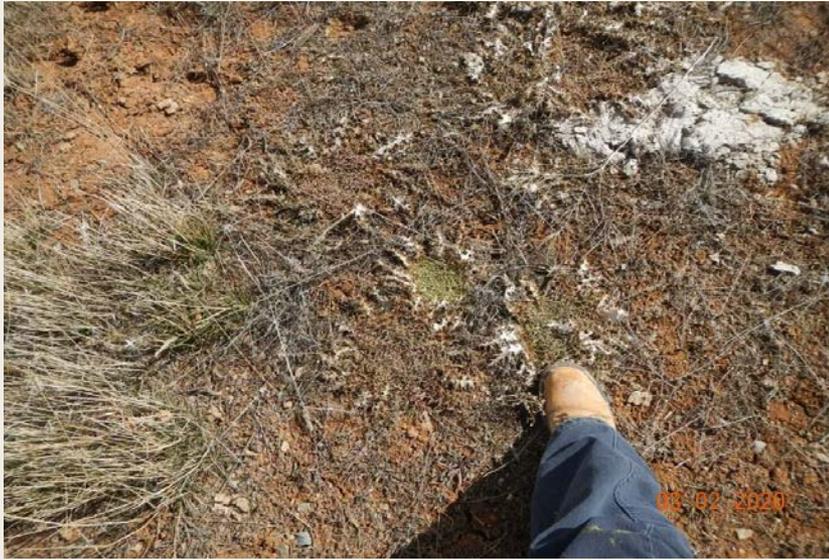
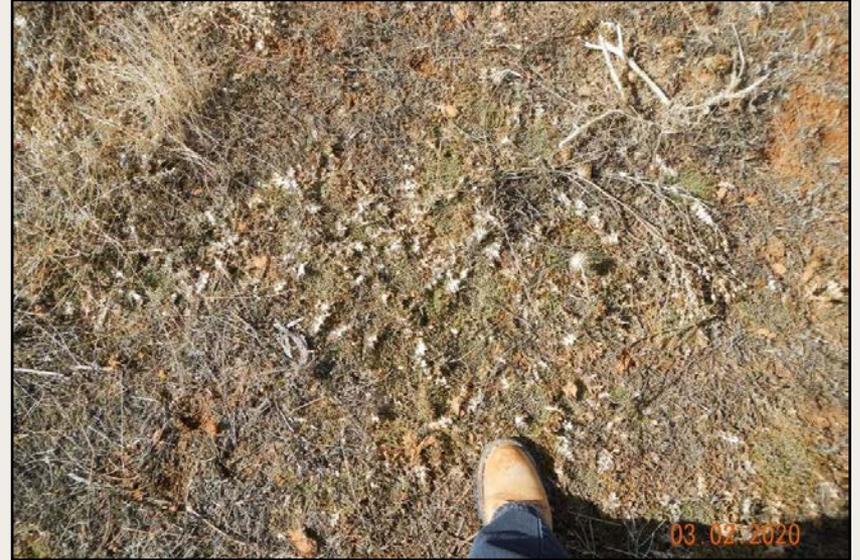
Photos 3/4. View of dense musk thistle rosettes within the western project area.

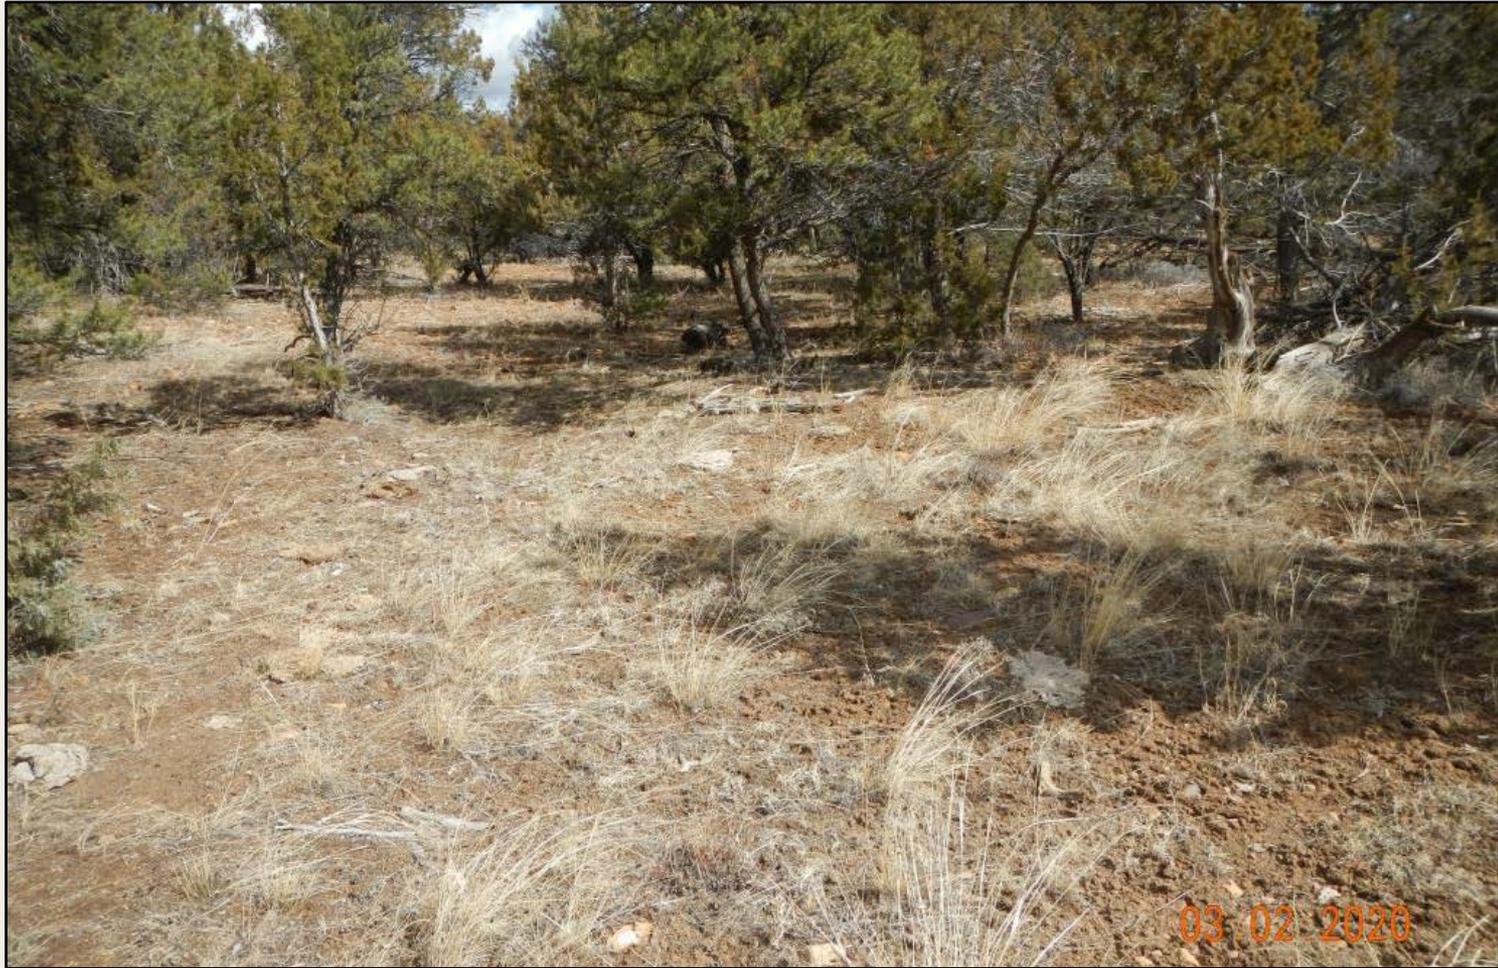
Photo 5. View of reference area vegetation comprised pinyon juniper woodland with herbaceous understory comprised of grasses such as Indian ricegrass and muttongrass and forbs in a dormant vegetative condition.
