Final Reclamation Inspection

Operator: PETROSHARE CORPORATION- 10454

Location ID: 319769

Inspection Photos
Location Name: TSUZUKI #1
Location ID: 319769

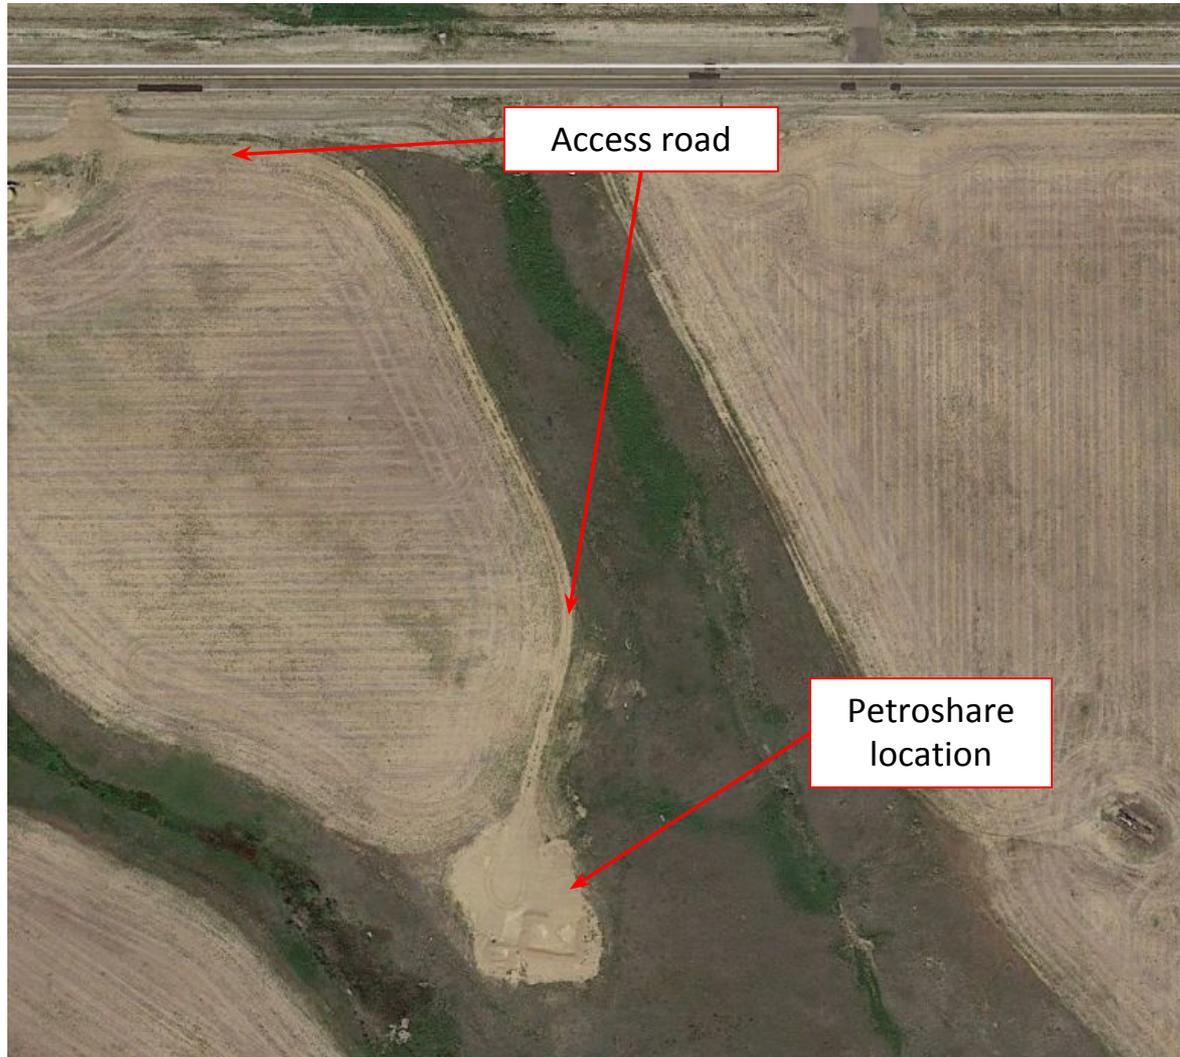
Photo 1. Google Earth aerial imagery taken 6/7/2017 illustrating the well and battery location, and access road post plugging and abandonment. Operator has failed to reclaim the access road and location per Rule 1004 and failed to respond to the previous corrective action inspection.

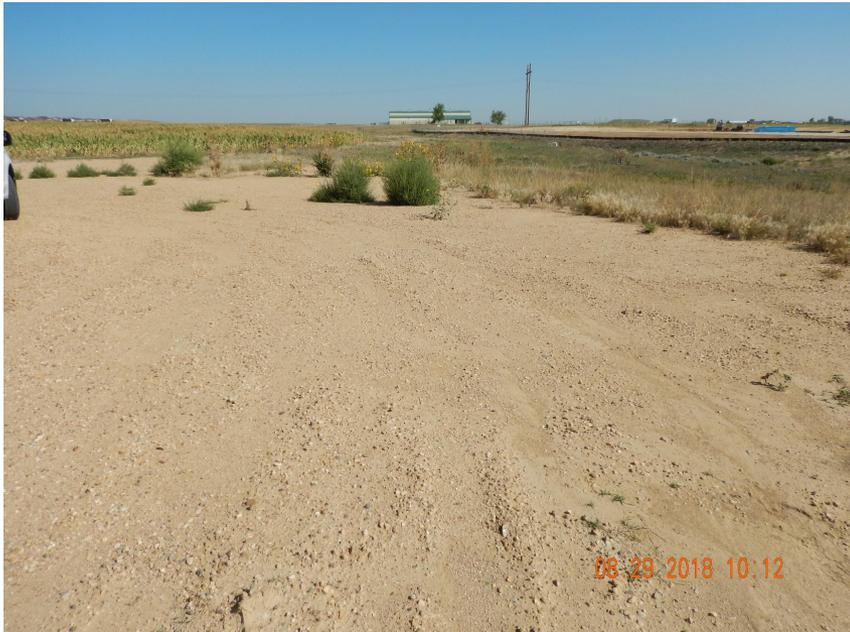
Photo 2. Photo taken from the southern well/battery location on 8/29/2018, facing North. Operator has not reclaimed the well/battery location and access road per Rule 1004 standards and failed to respond to the previous corrective action inspection. Also, weeds were observed along portions of the location.

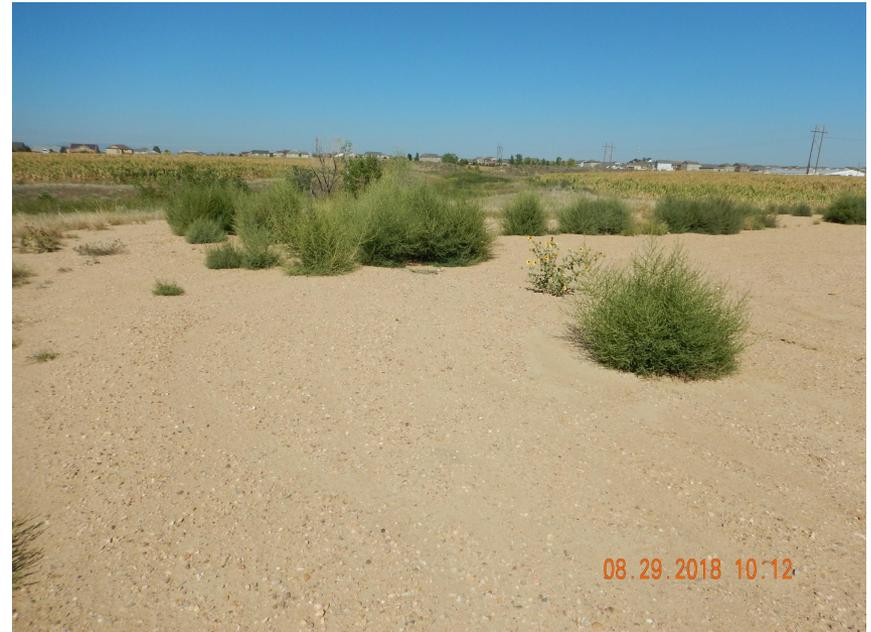
Photo 3. Photo taken from the southern well/battery location on 8/29/2018, facing Northwest. See comments under Photo 2.

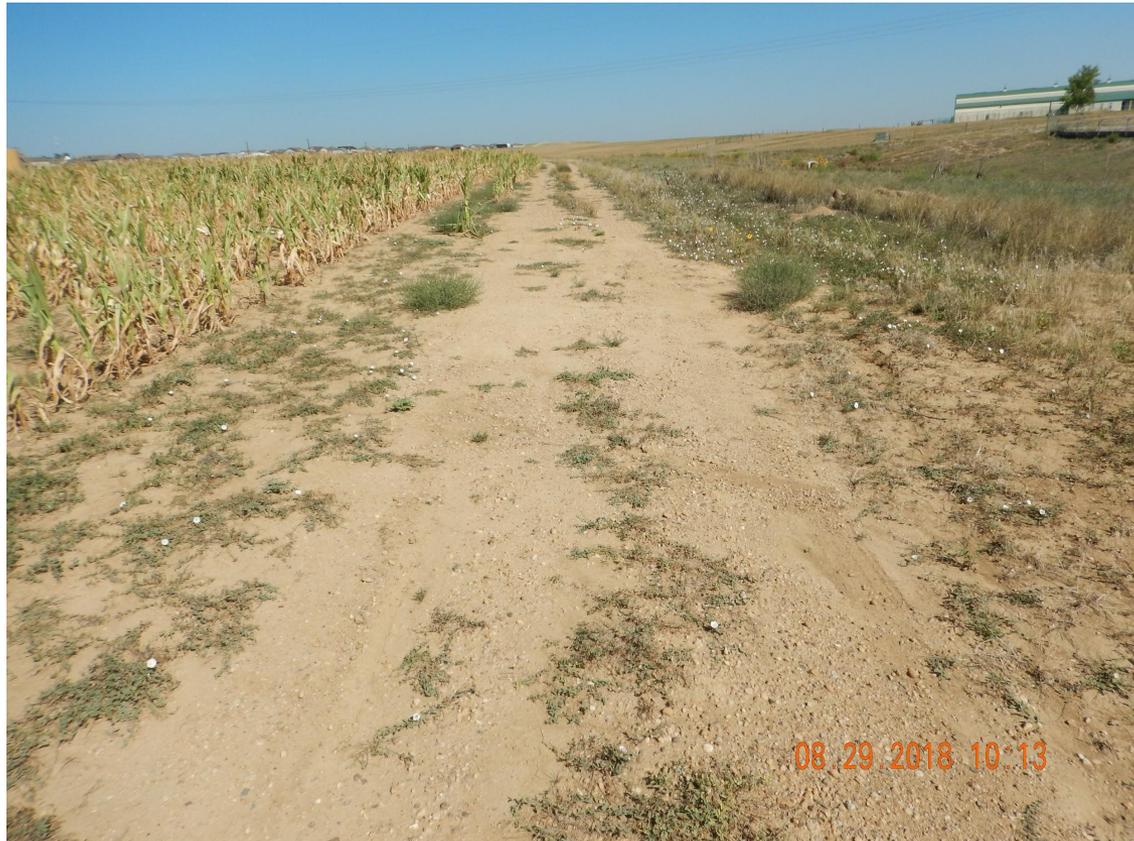
Photo 4. Photo taken along a portion of the access road on 8/29/2018, facing North. See comments under Photo 2.

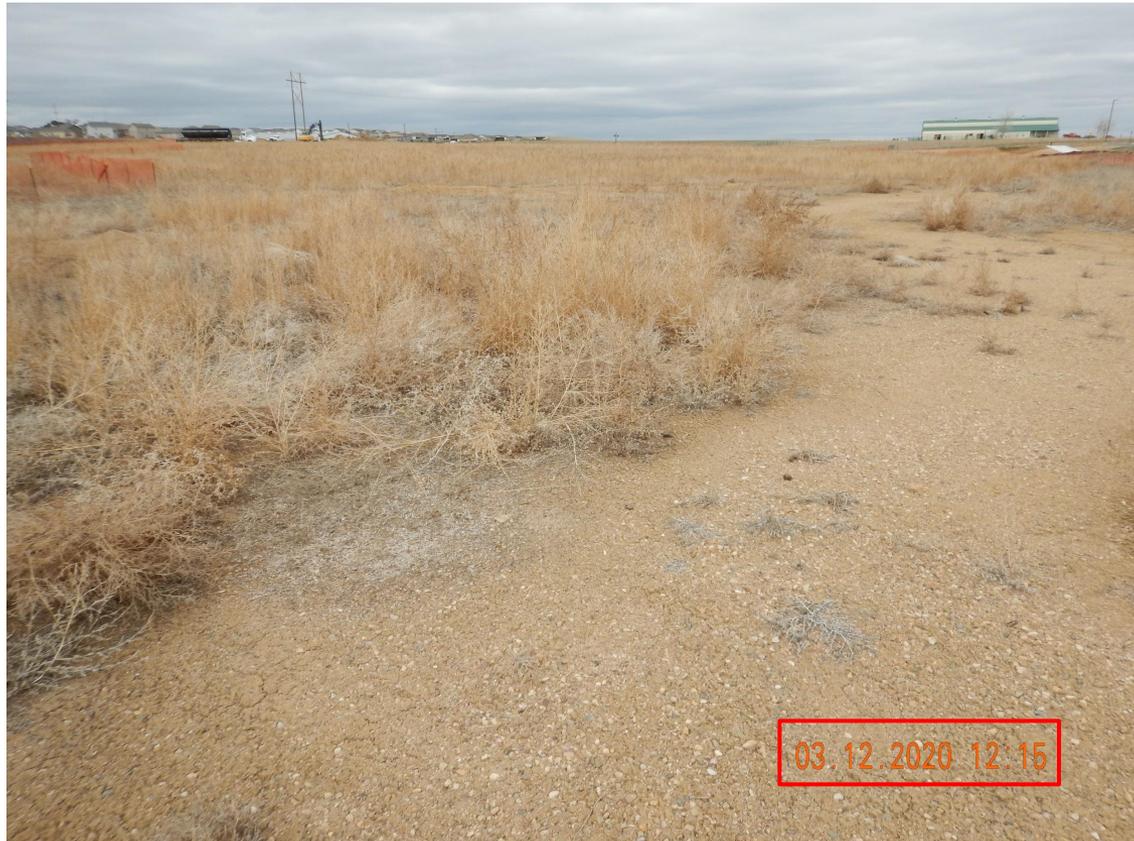
Photo 5. Photo taken from the well/battery location on 3/12/2020, facing North. Photo illustrates Operator has failed to perform final reclamation activities and control weeds.

Note: It appears the well/battery location is part of a land use change for a planned development for the Timberleaf subdivision.

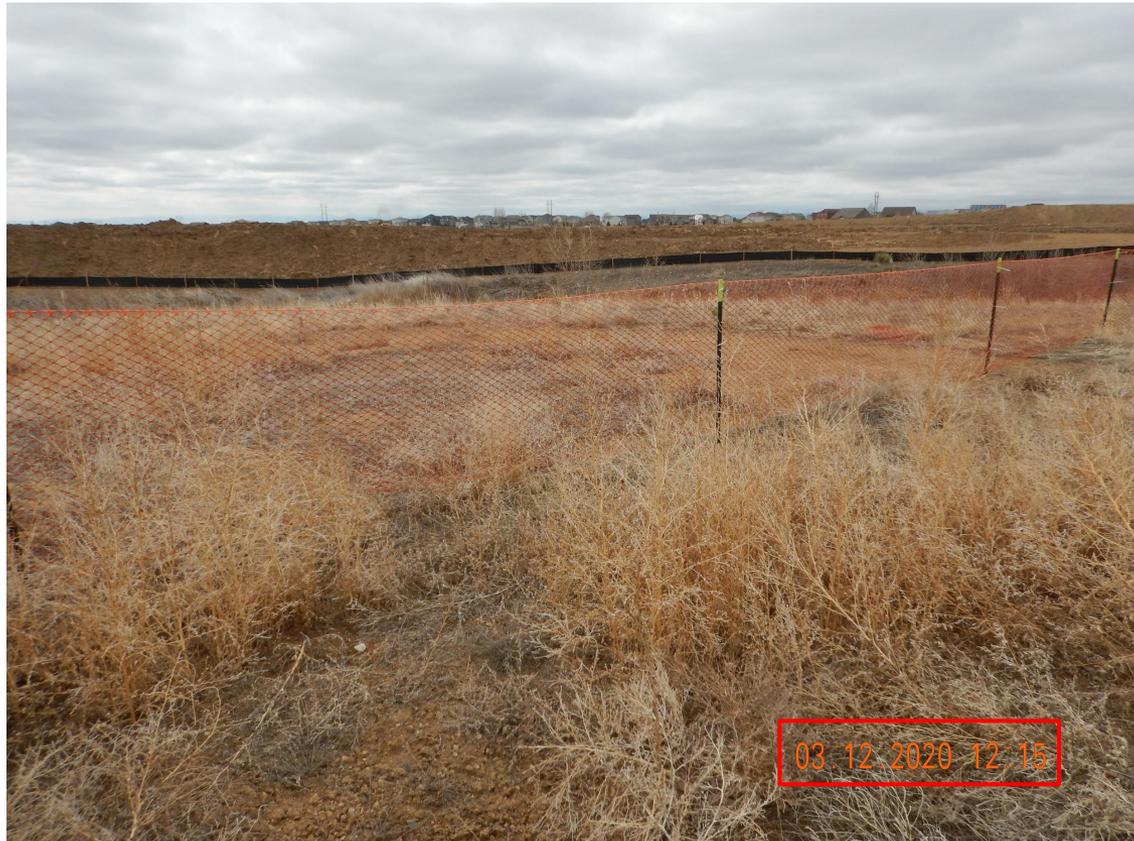
Photo 6. Photo taken from the well/battery location on 3/12/2020, facing South. See comments under Photo 5.
