Final Reclamation Inspection

Operator: FOUNDATION ENERGY MANAGEMENT LLC- #10112

Location ID: 453784

Inspection Photos
Location Name: Andrews Tank Battery
Location ID: 453784

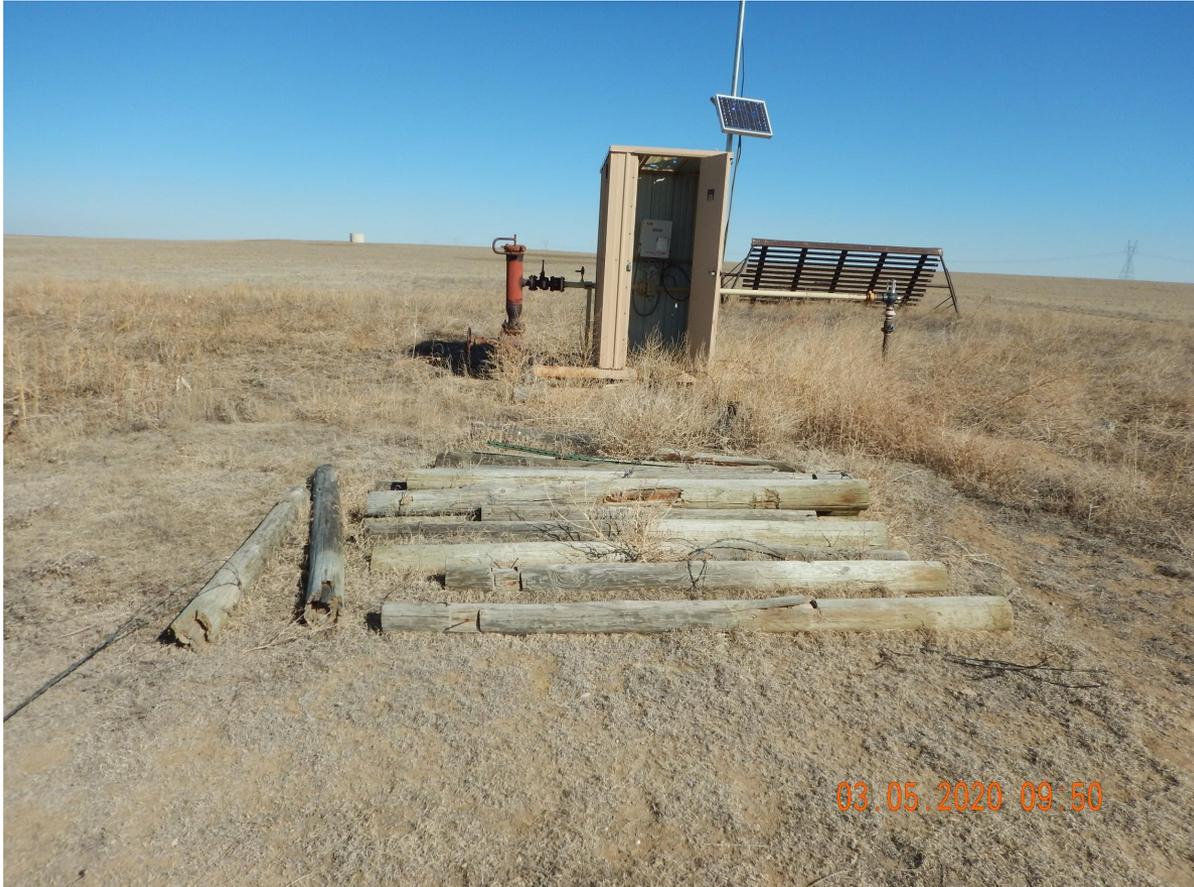
Photo 1. Photo taken from the southern tank battery location, facing North. Photo illustrates Operator has failed to remove equipment and debris from location and conduct reclamation of the location.

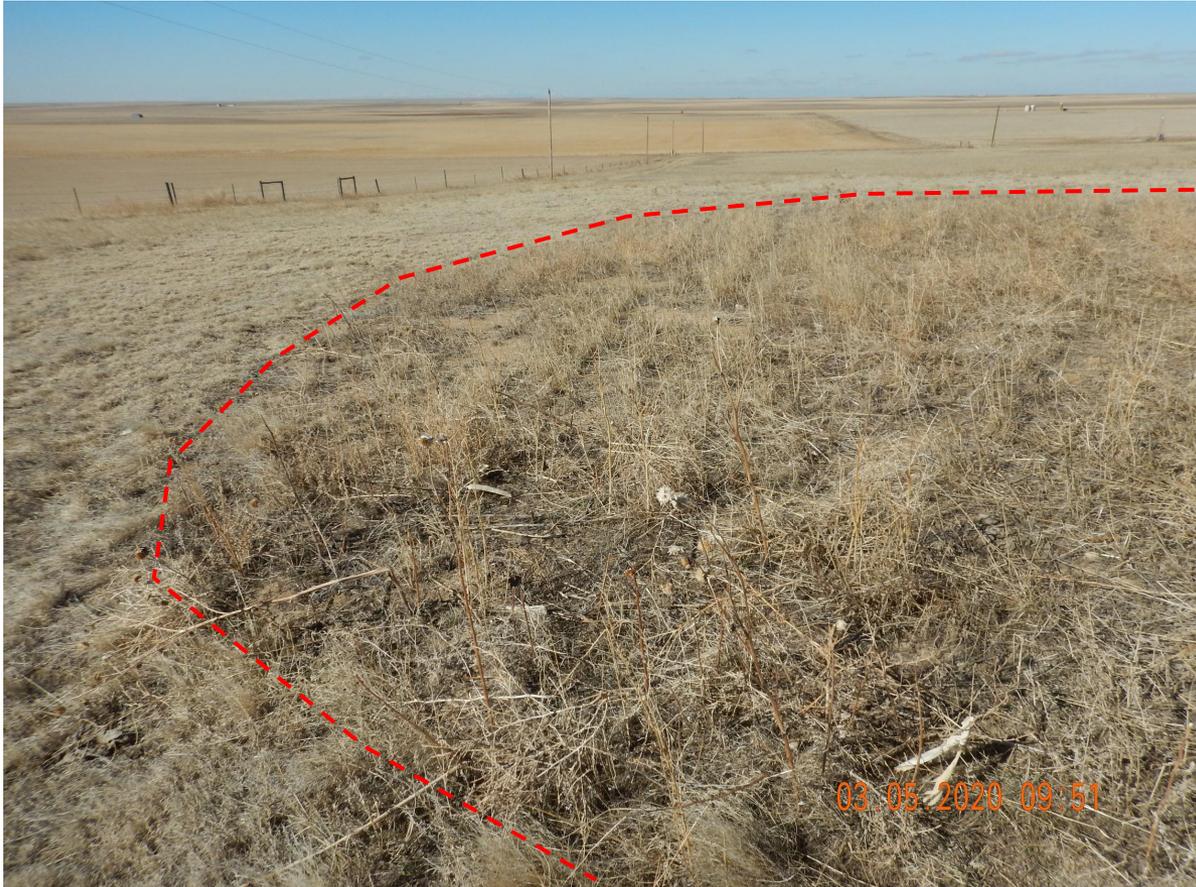
Photo 2. Photo taken from the pit, facing West. Photo illustrates Operator has backfilled the pit area (area inside the red-dashed line). The pit area consists mostly of weedy, annual vegetation which is not reflective of reference area vegetation.

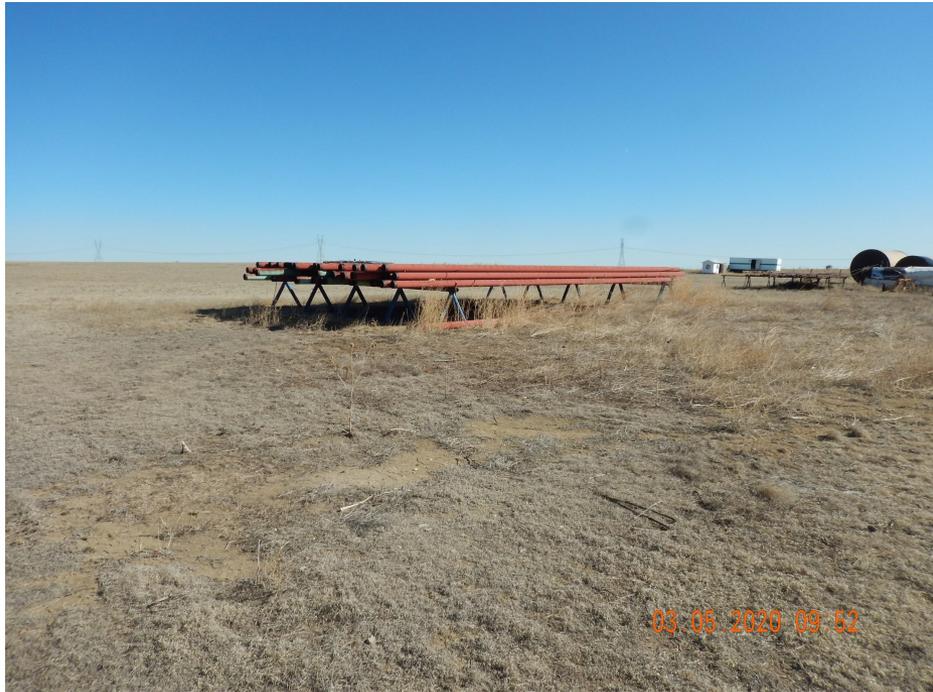
Photo 3. Photo taken from the tank battery location, facing Northeast. Photo illustrates Operator has failed to remove equipment and conduct reclamation of the location.

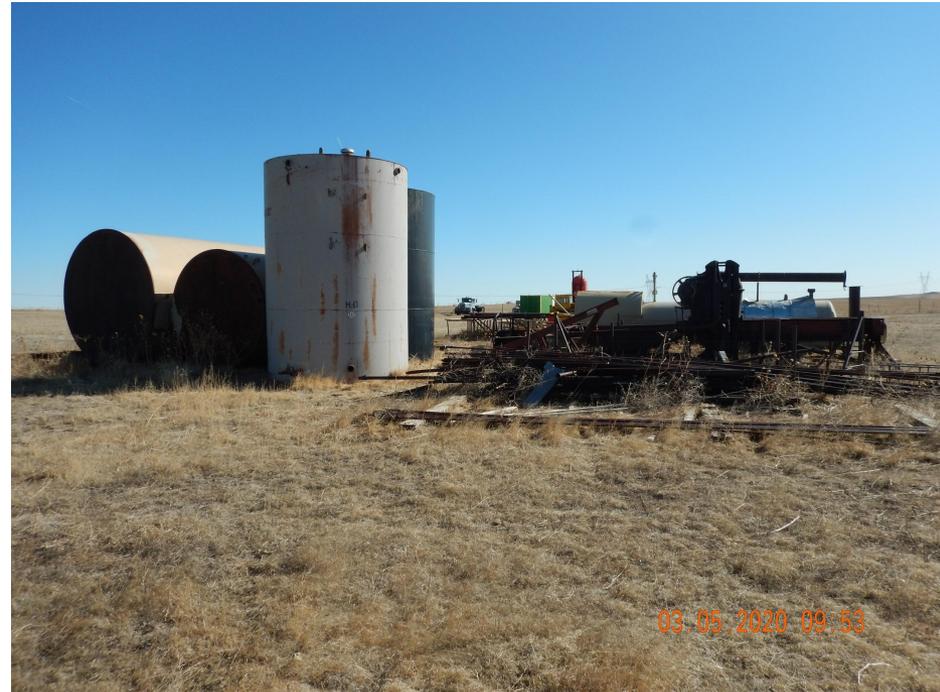
Photo 4. Photo taken from the tank battery location, facing East. See comments under Photo 3.

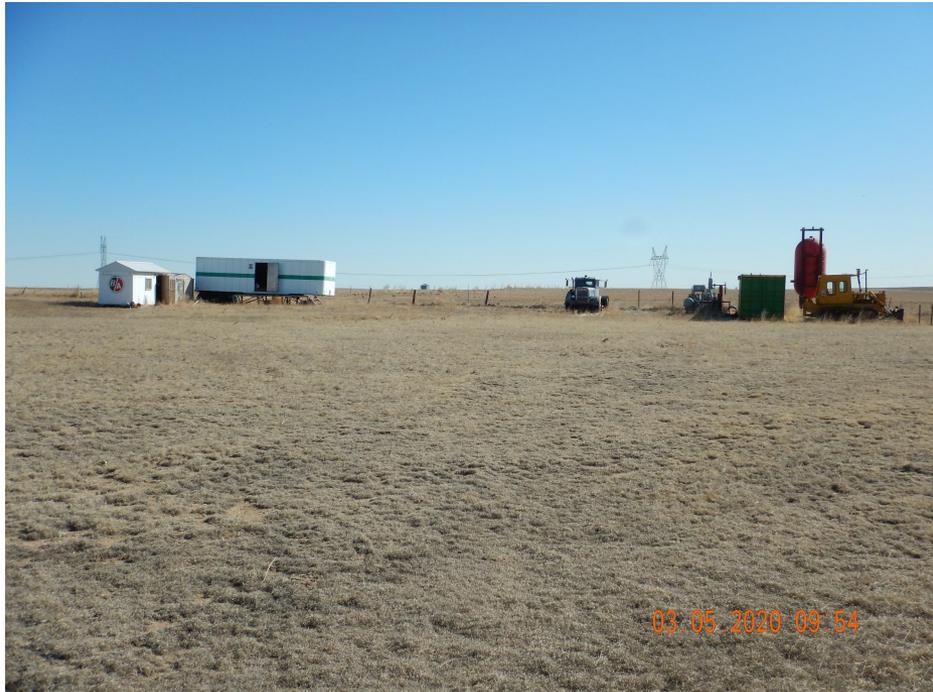
Photo 5. Photo taken from the tank battery location, facing East. See comments under Photo 3.

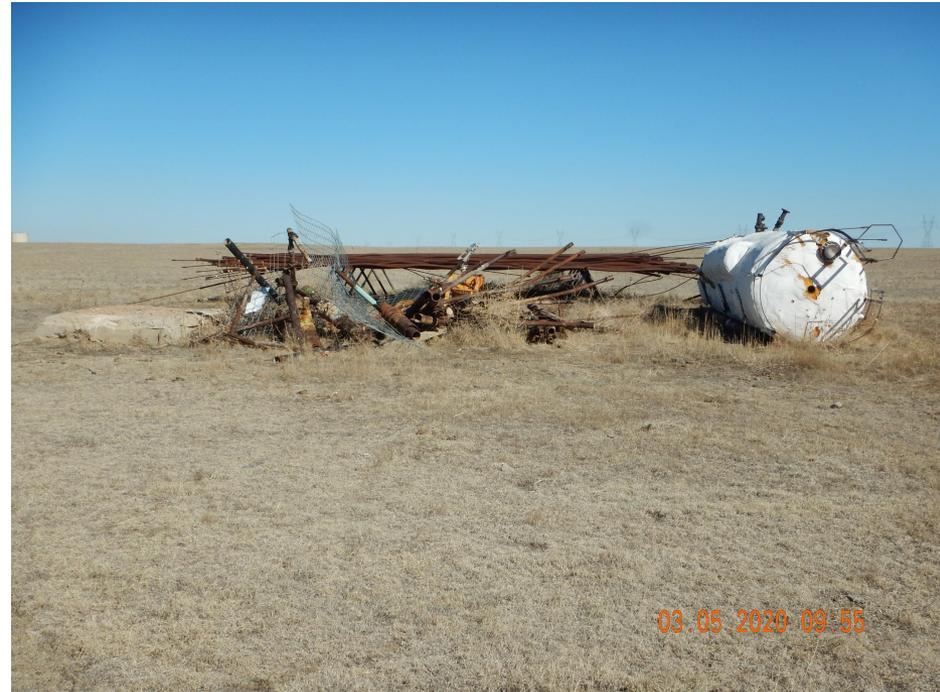
Photo 6. Photo taken from the tank battery location, facing North. See comments under Photo 3.

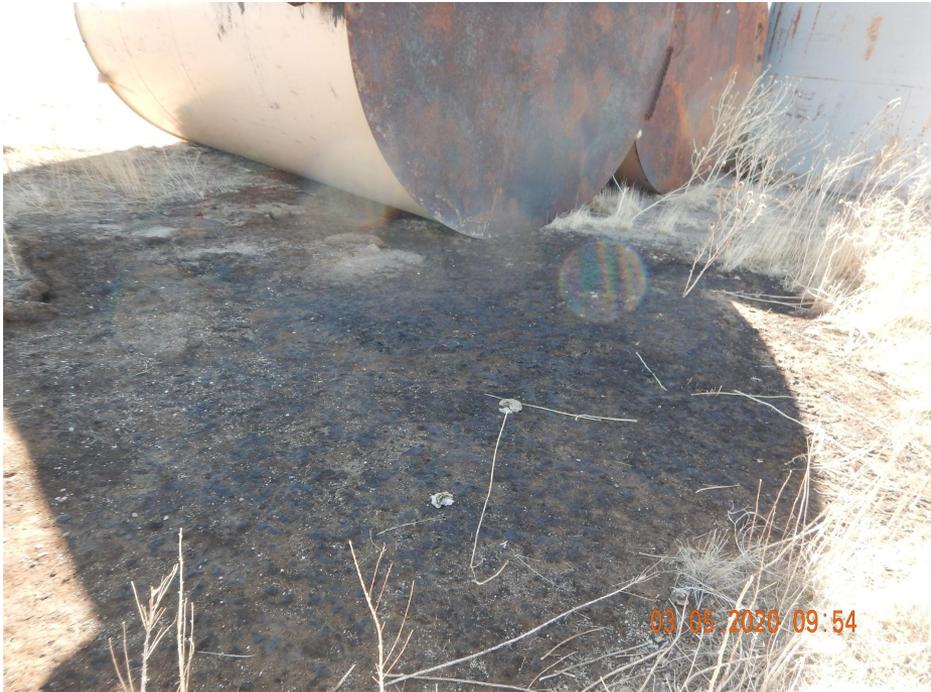
Photo 7. Photo taken from the tank battery location, facing East. Photo illustrates Operator has failed to clean up and remediate contaminated soils from a leaky tank.

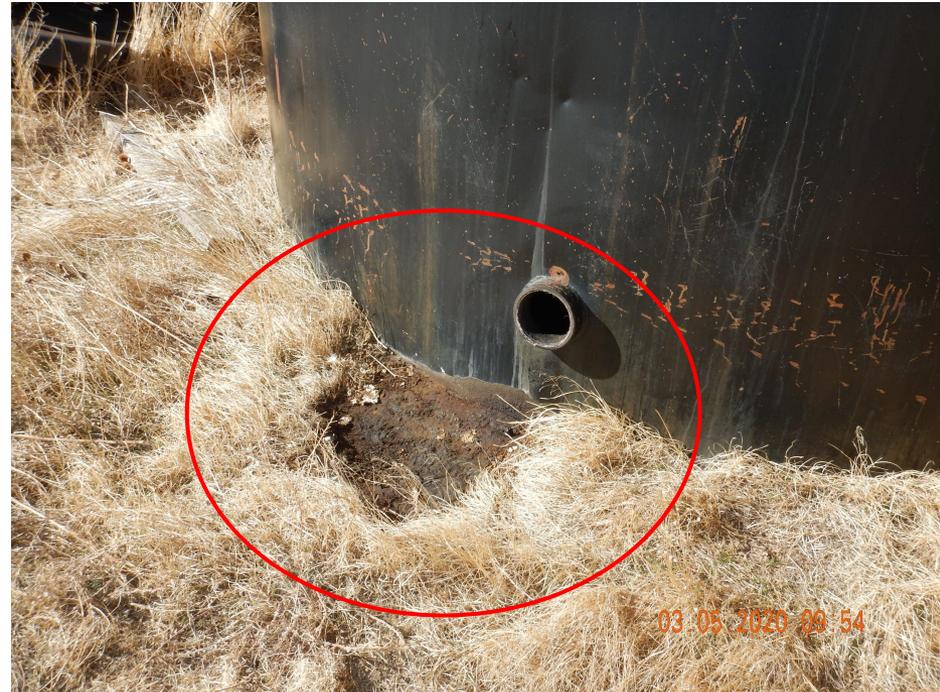
Photo 8. Photo taken from the tank battery location. See comments under Photo 7.
