# Final Reclamation Inspection

Operator: FOUNDATION ENERGY MANAGEMENT LLC- #10112

Location ID: 327492

Inspection Photos  
Location Name: ANDREWS #9-7  
Location ID: 327492

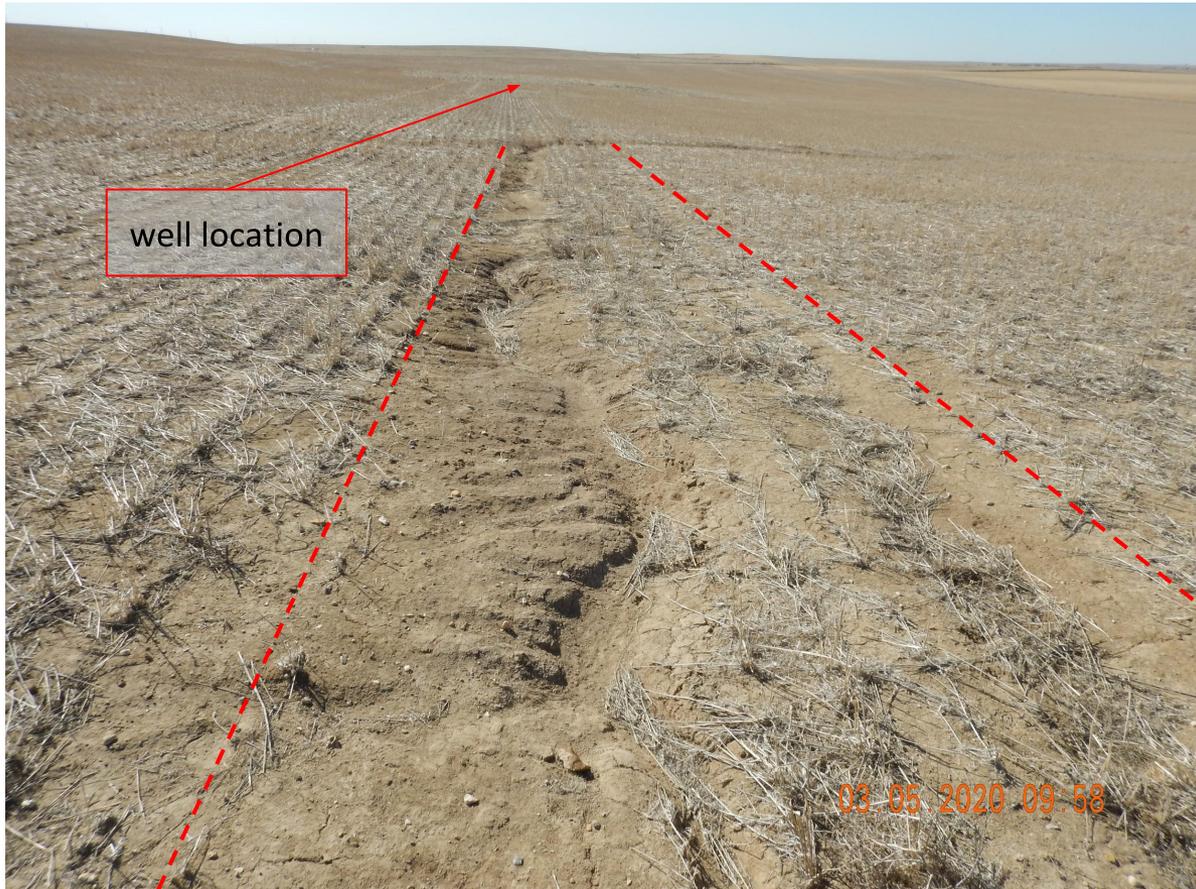
**Photo 1.** Photo taken from a portion of the well location access road, facing South. Photo illustrates erosion along the access road likely because the access road has not been properly contoured. Also, portions of the access road have little to no establishment of crop species.

Also, photo illustrates the well location in the background has not properly contoured to match the surrounding landscape.

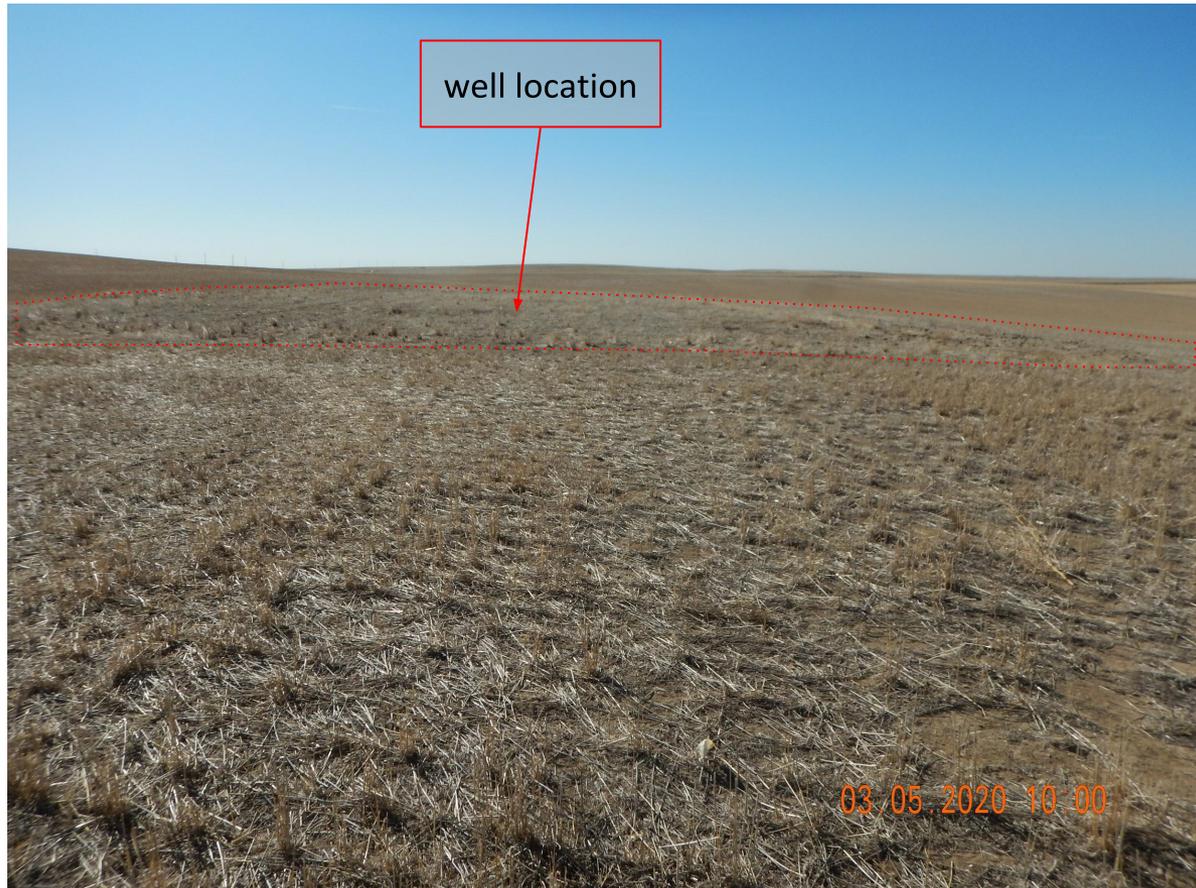
**Photo 2.** Photo taken from north of the well location, facing South. Photo illustrates Operator has not properly contoured the well location (within the red-dashed area) to match the surrounding landscape.

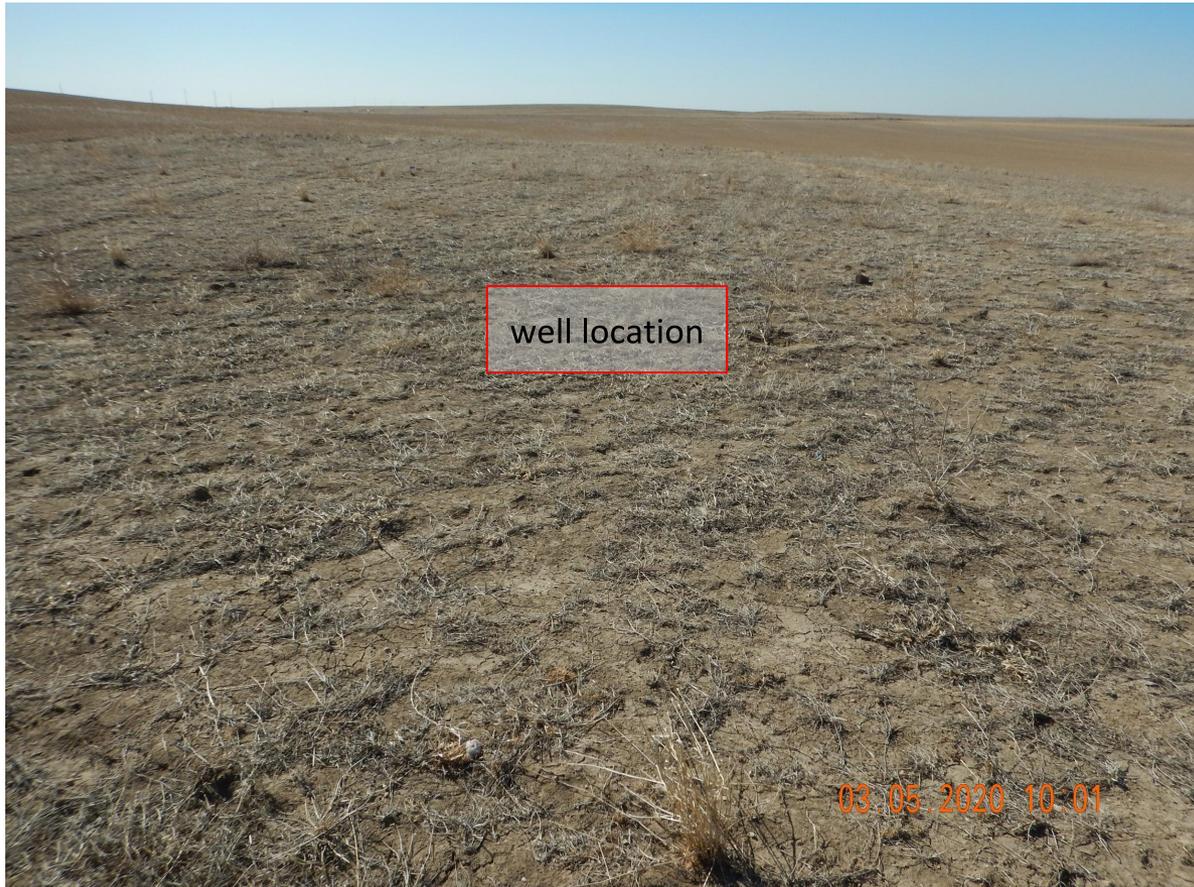
**Photo 3.** Photo taken from the northern well location, facing South. Photo illustrates there is little to no establishment of crop species.

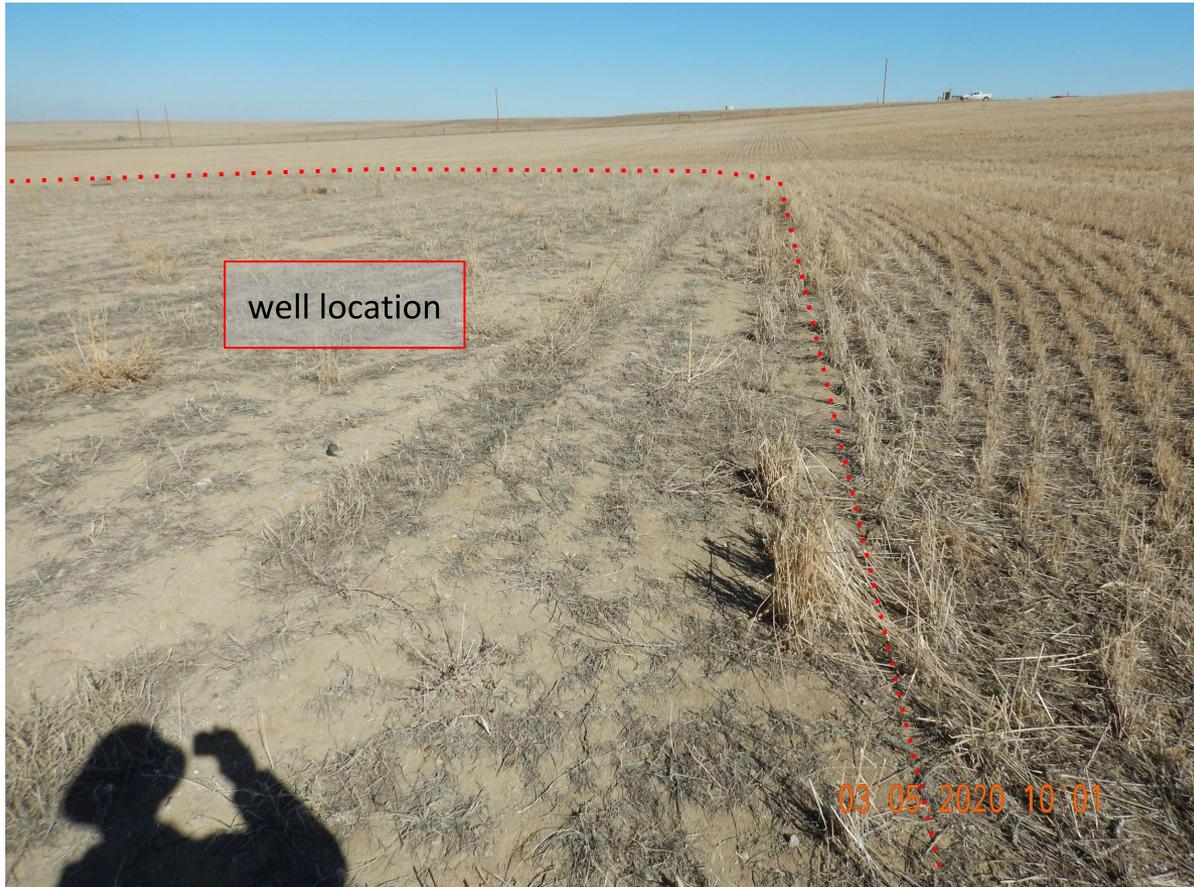
**Photo 4.** Photo taken from the eastern well location, facing North. Photo illustrates there is little to no establishment of crop species.

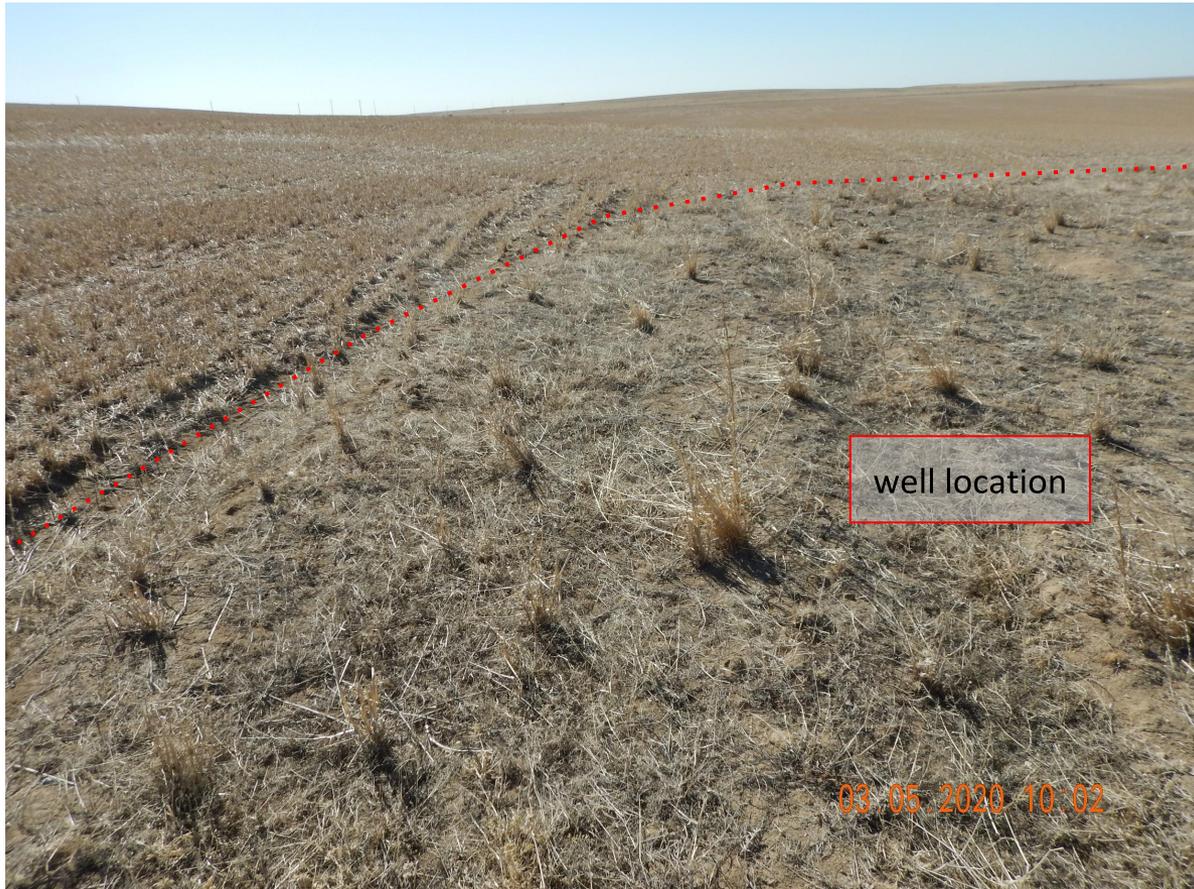
**Photo 5.** Photo taken from the eastern well location, facing South. See comments under Photo 4.

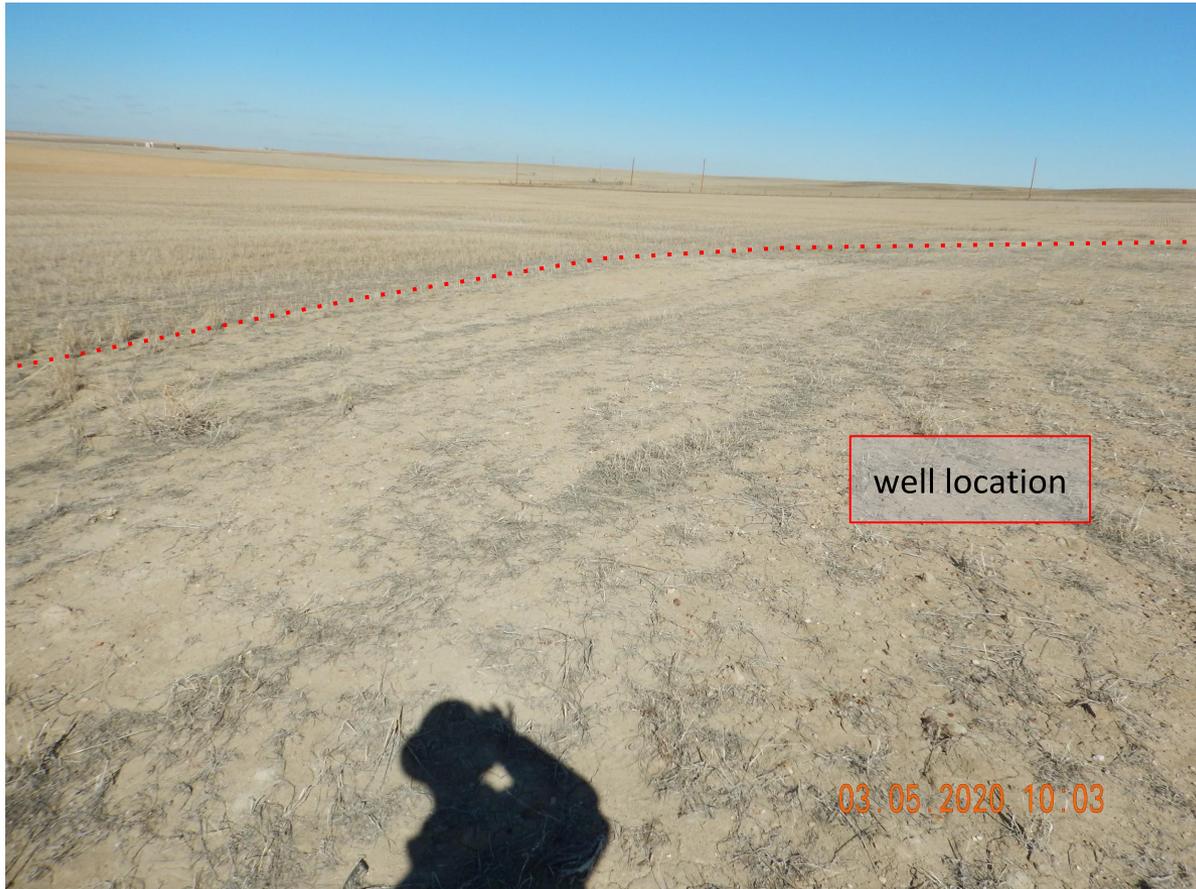
**Photo 6.** Photo taken from the western well location, facing Northwest. See comments under Photo 4.
