# Final Reclamation Inspection

March 5, 2020

Operator: FOUNDATION ENERGY MANAGEMENT LLC- #10112

Location ID: 327445

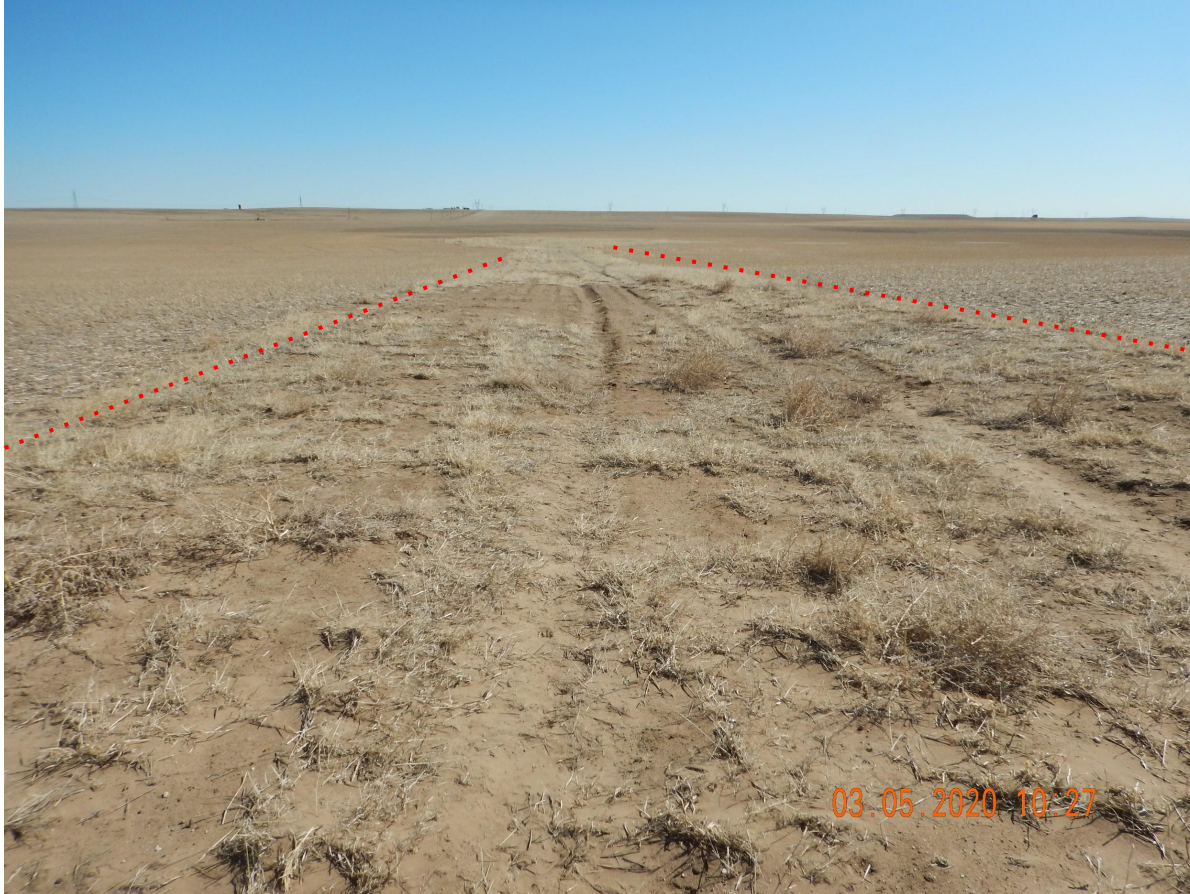
**Photo 1.** Photo taken from the western well location access road, facing East. Photo illustrates the access road has not been properly contoured to match the surrounding landscape. Refer to Photo #2 regarding contouring.

Also, it is unclear whether the access road/well location has been properly cross-ripped and whether it was seeded. Currently, there is no establishment of crop species observed throughout the access road and well location. Staff will have to make a future assessment during the active growing season to make a better assessment.

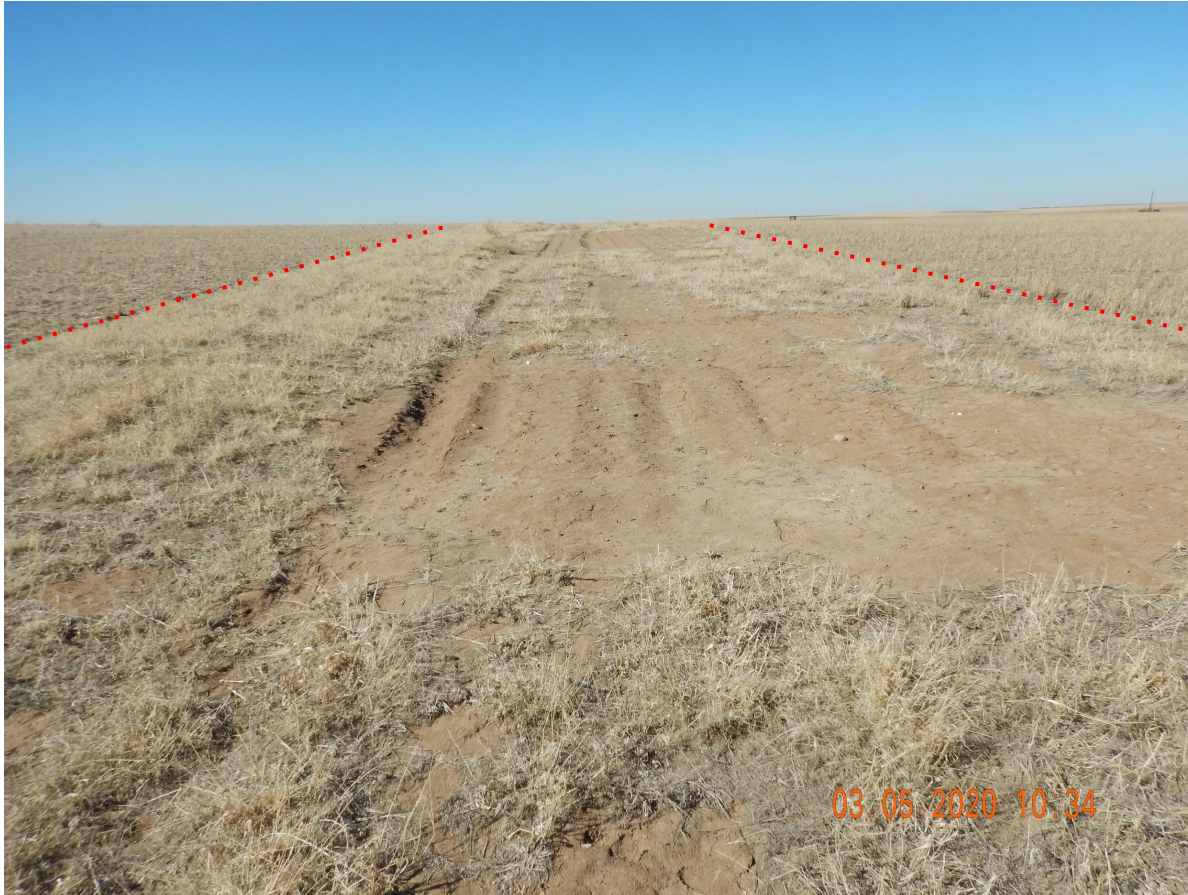
**Photo 2.** Photo taken from the central well location access road, facing West. Photo illustrates the access road has not been properly contoured. The access road is in the shape of a “v”.

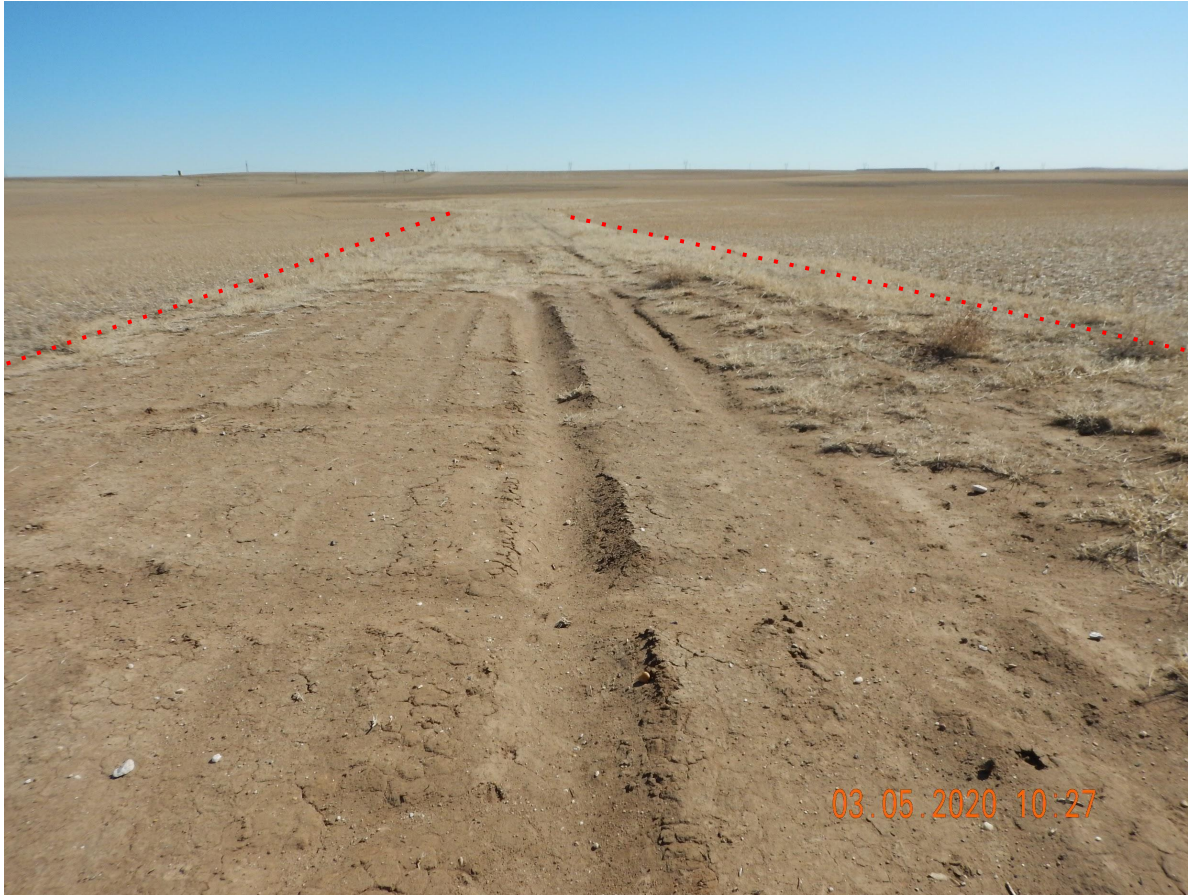
**Photo 3.** Photo taken from the central well location access road, facing East. See comments under Photo 1.

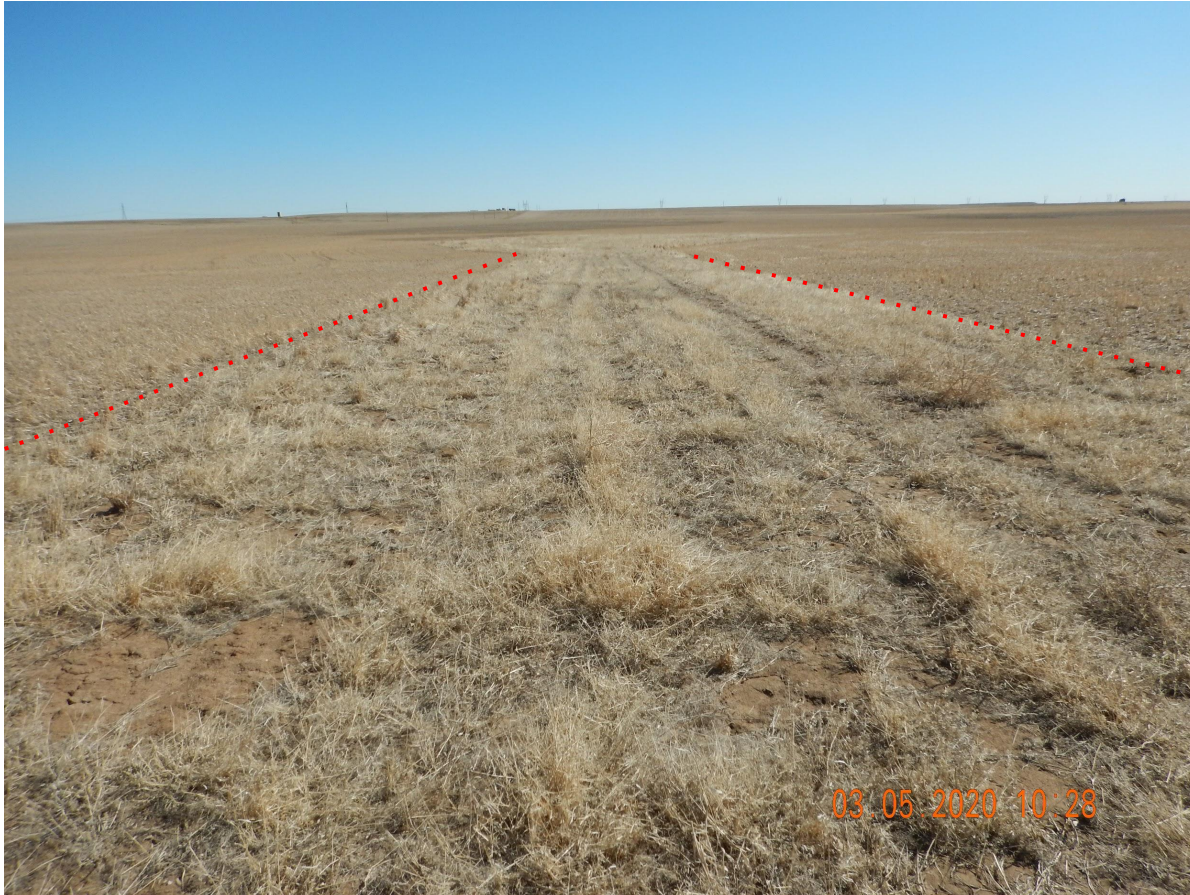
**Photo 4.** Photo taken from the eastern well location access road, facing East. Photo illustrates weedy, annual vegetation consisting of but not limited to: *Eragrostis cilianensis* (stinkgrass), *Kochia* and Russian thistle.

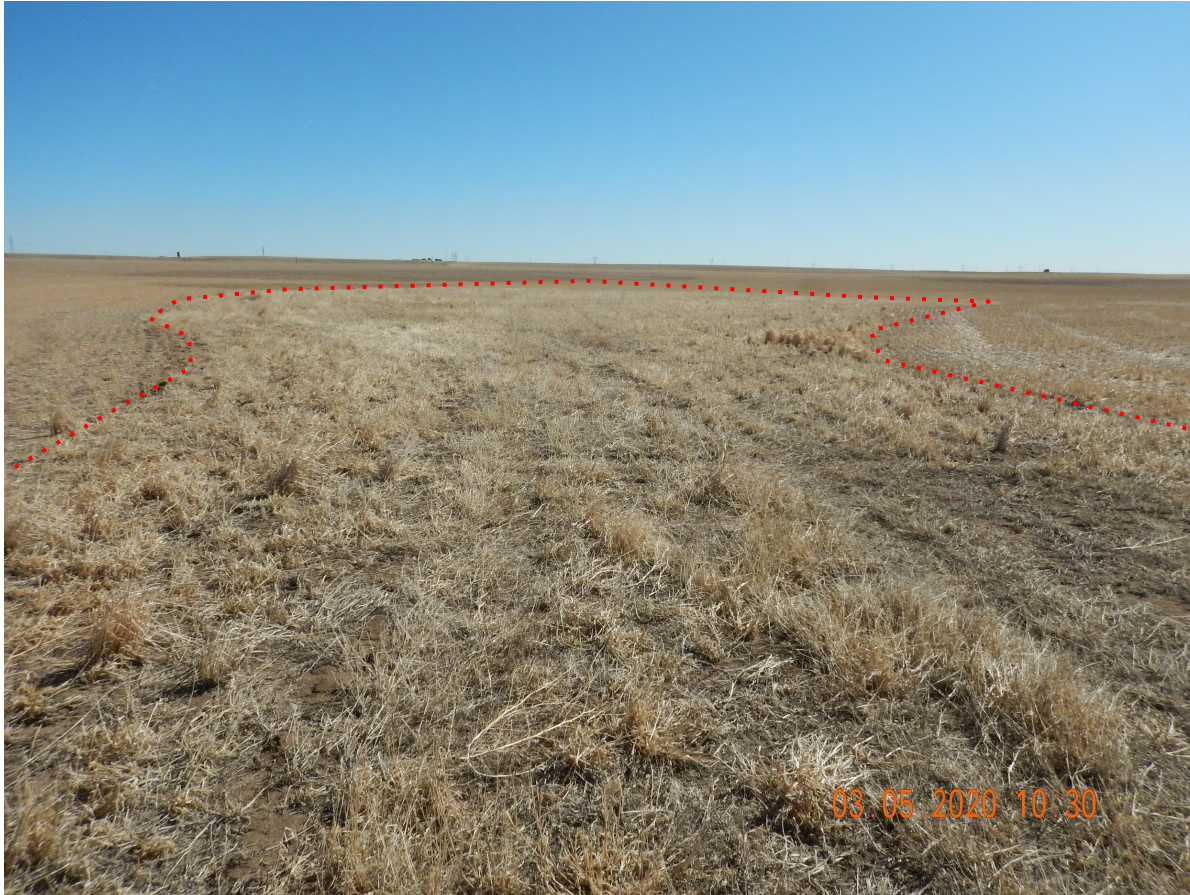
**Photo 5.** Photo taken from the western well location, facing East. See comments under Photo 1 and 4.

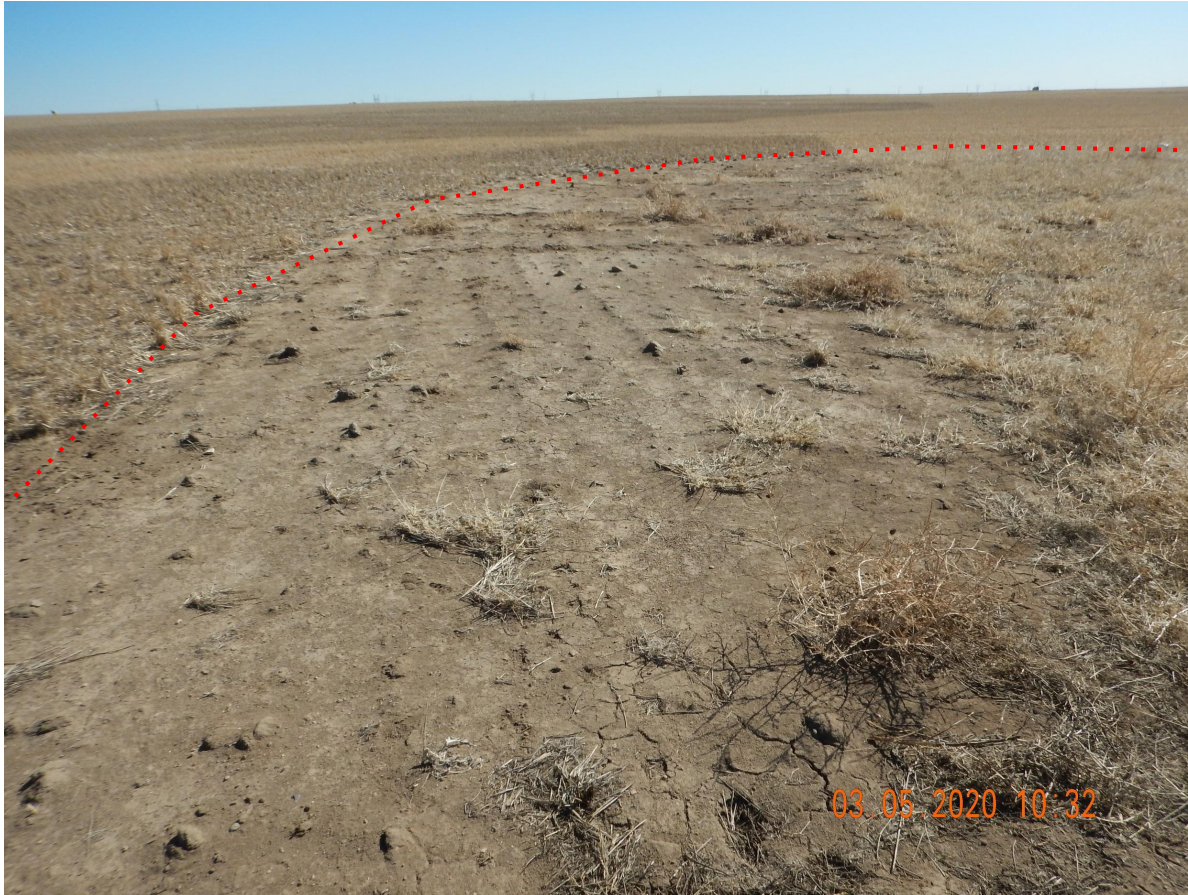
**Photo 6.** Photo taken from the northern well location, facing East. See comments under Photo 1 and 4.
