# Inspection Photos

Operator: RIO MESA RESOURCES INC - 74740

Location ID: 314813

Rio Blanco County, CO

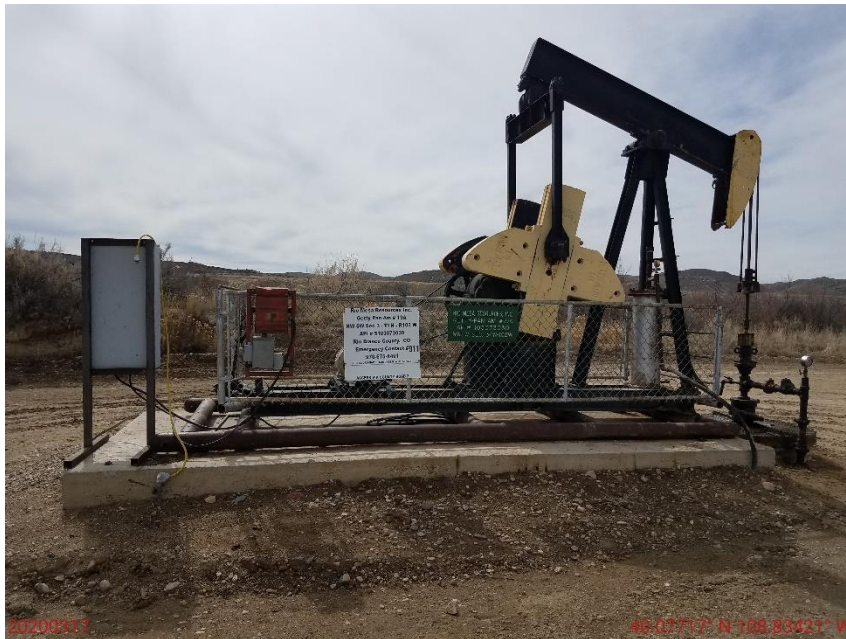
**Photo 1:** Photo taken from the well, facing south. Photo shows pumping unit and signage.

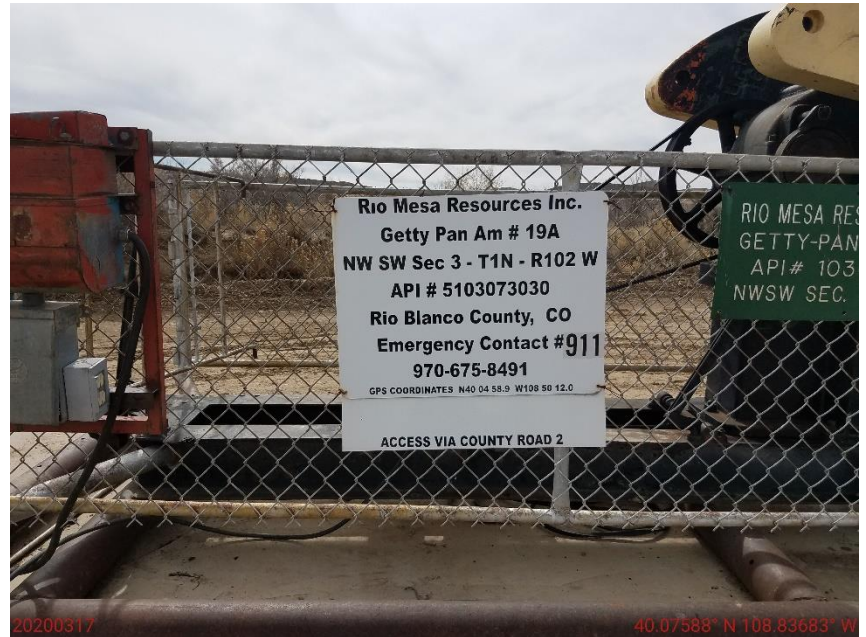
**Photo 2:** Continued from photo 1. Photo shows signage at well, including emergency contact; Inspector was unable to immediately contact Operator via the emergency contact number.

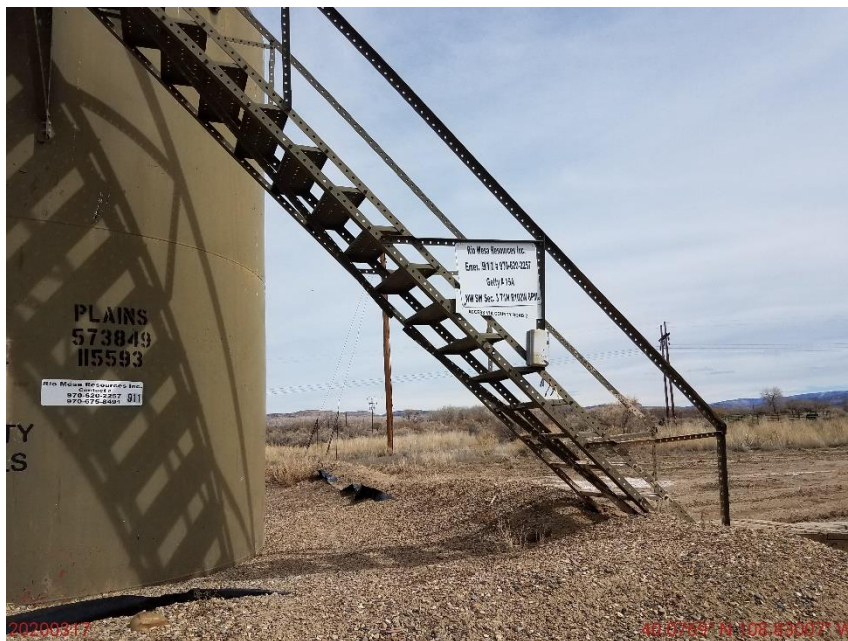
**Photo 3:** Photo taken from the battery, on the east end of the Location, facing east. Photo shows signage at battery, including two emergency contact numbers; Inspector was unable to immediately contact Operator via either the emergency contact number.

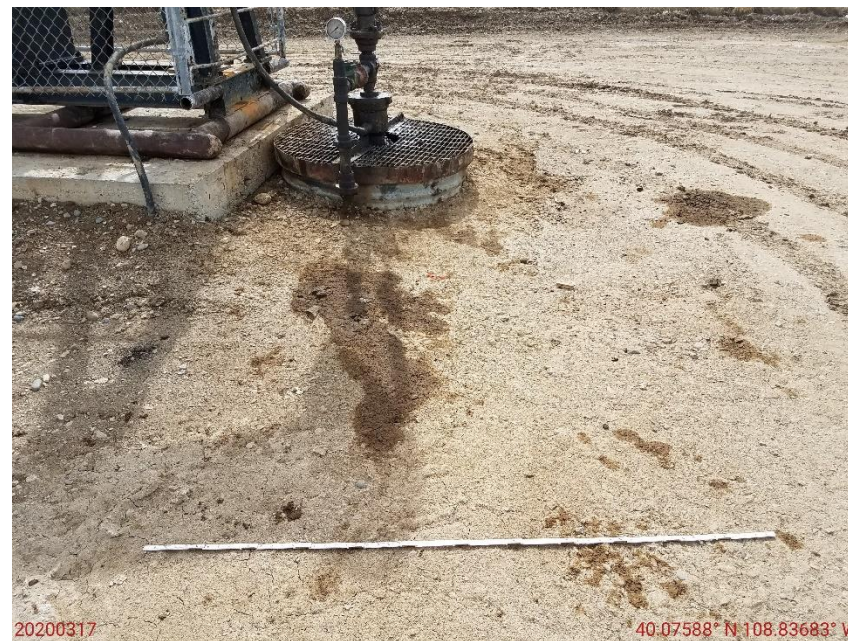
**Photo 4:** Photo taken from the wellhead, facing south. Photo shows stained soils around the well. 6 foot measuring stick for reference.

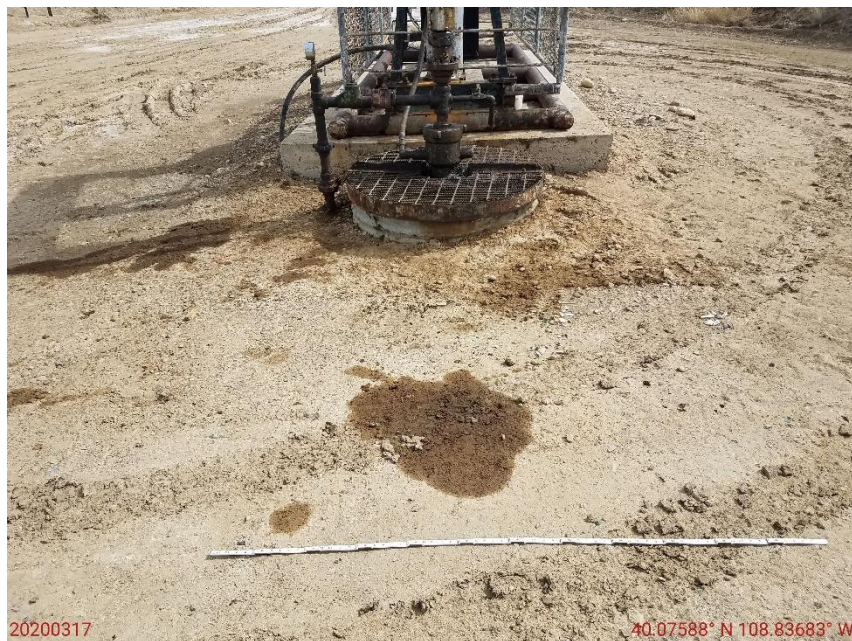
**Photo 5:** Photo taken from the wellhead, facing east. Photo shows stained soils around the well. 6 foot measuring stick for reference.

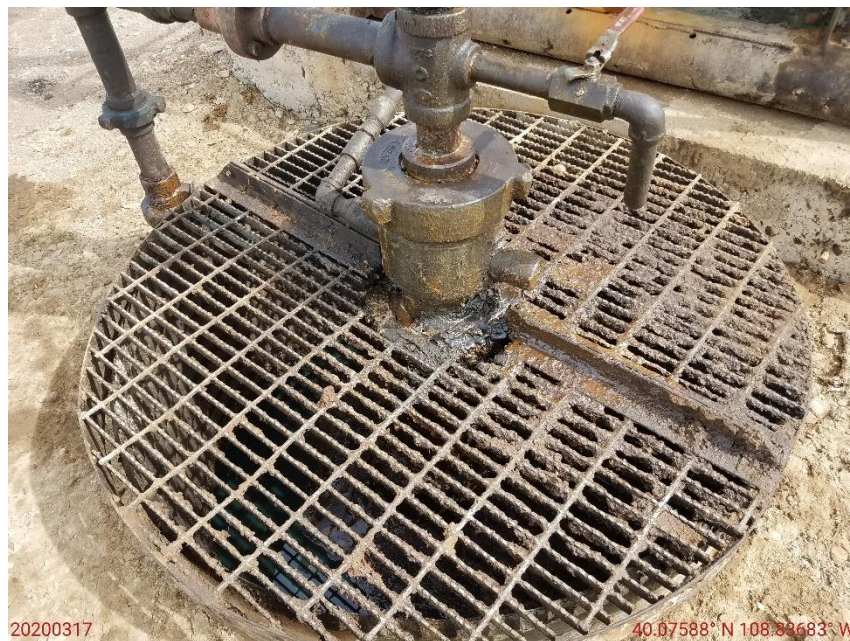
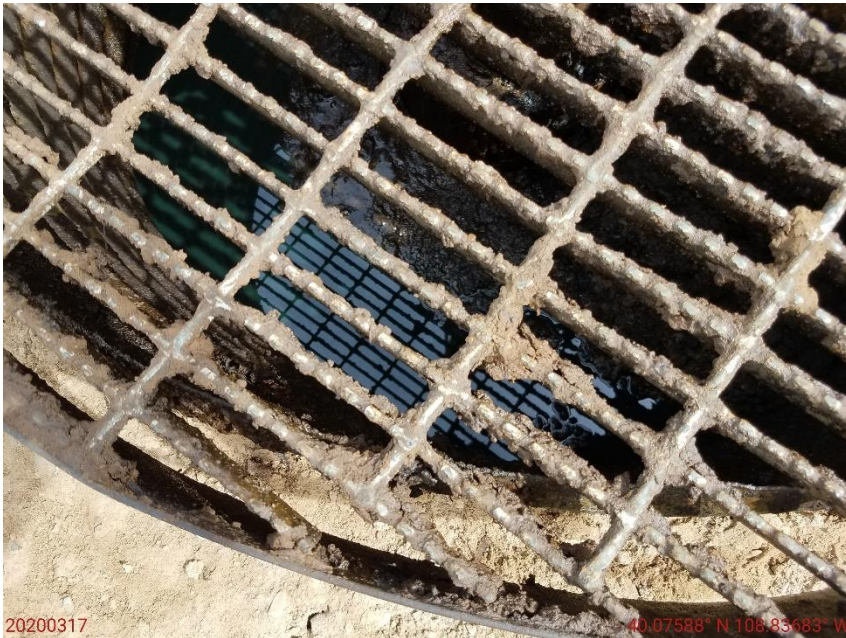
**Photo 6:** Photo taken at the well head. Photo shows containment cellar; various chemicals/fluids appear to have discharged into the containment BMP; chemicals/fluids require removal. Photo also shows various chemicals/fluids on the well/casing

**Photo 7:** See comments under photo 6.

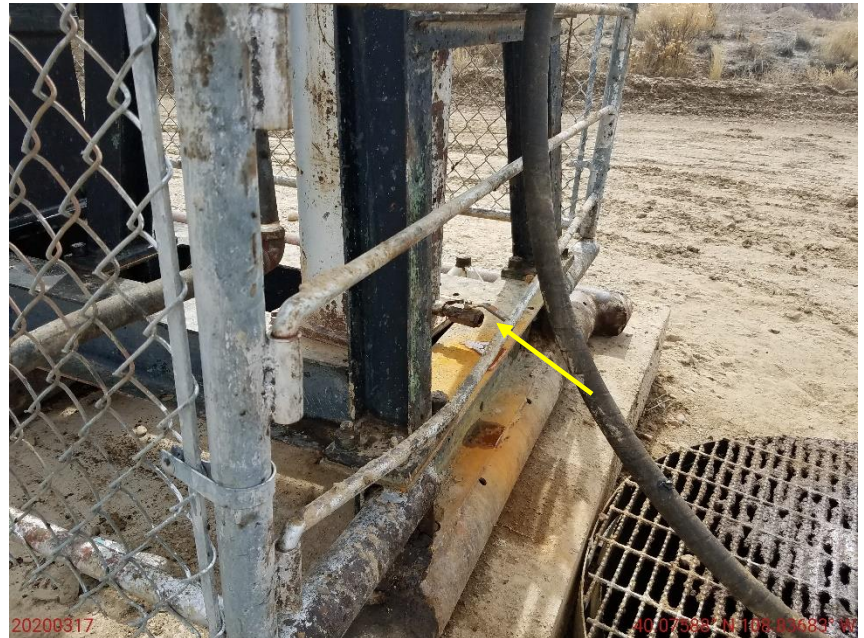
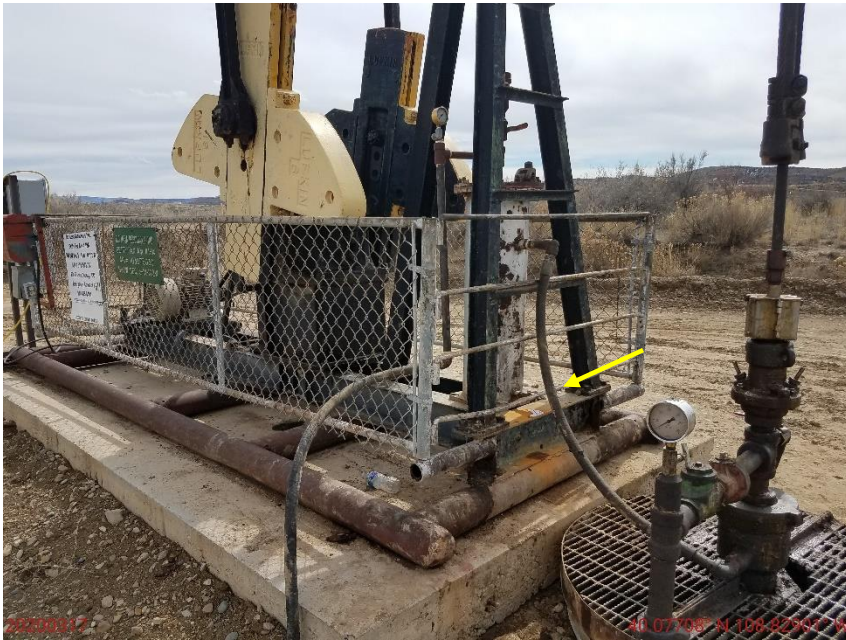
**Photo 8:** Photo taken from the well head. It was observed that gas appears to be venting from equipment attached to the bradenhead. Arrow shows open valve where gas appear to be venting from.

**Photo 9:** See comments under photo 8.

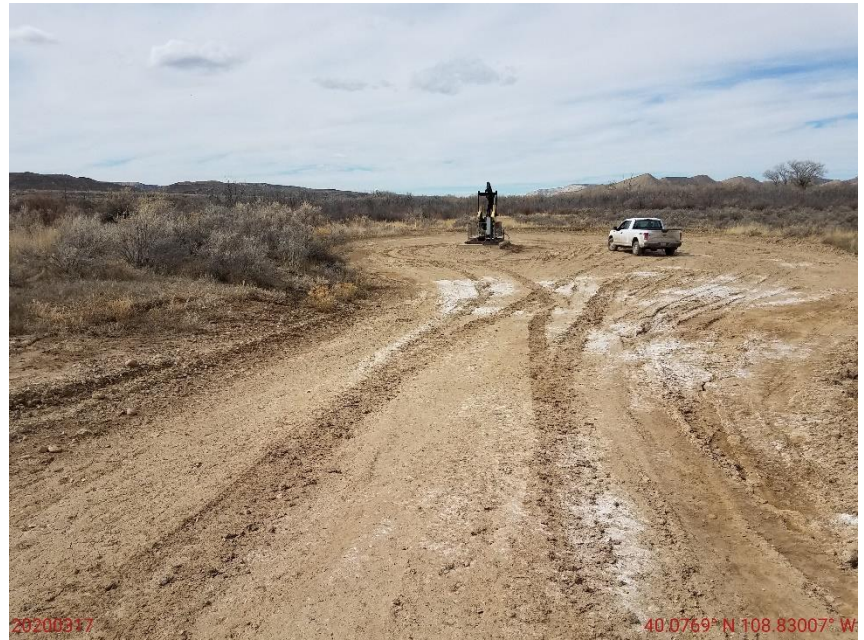
**Photo 10:** Photo taken from the east end of the Location, facing west. Photo shows overview of the Location.

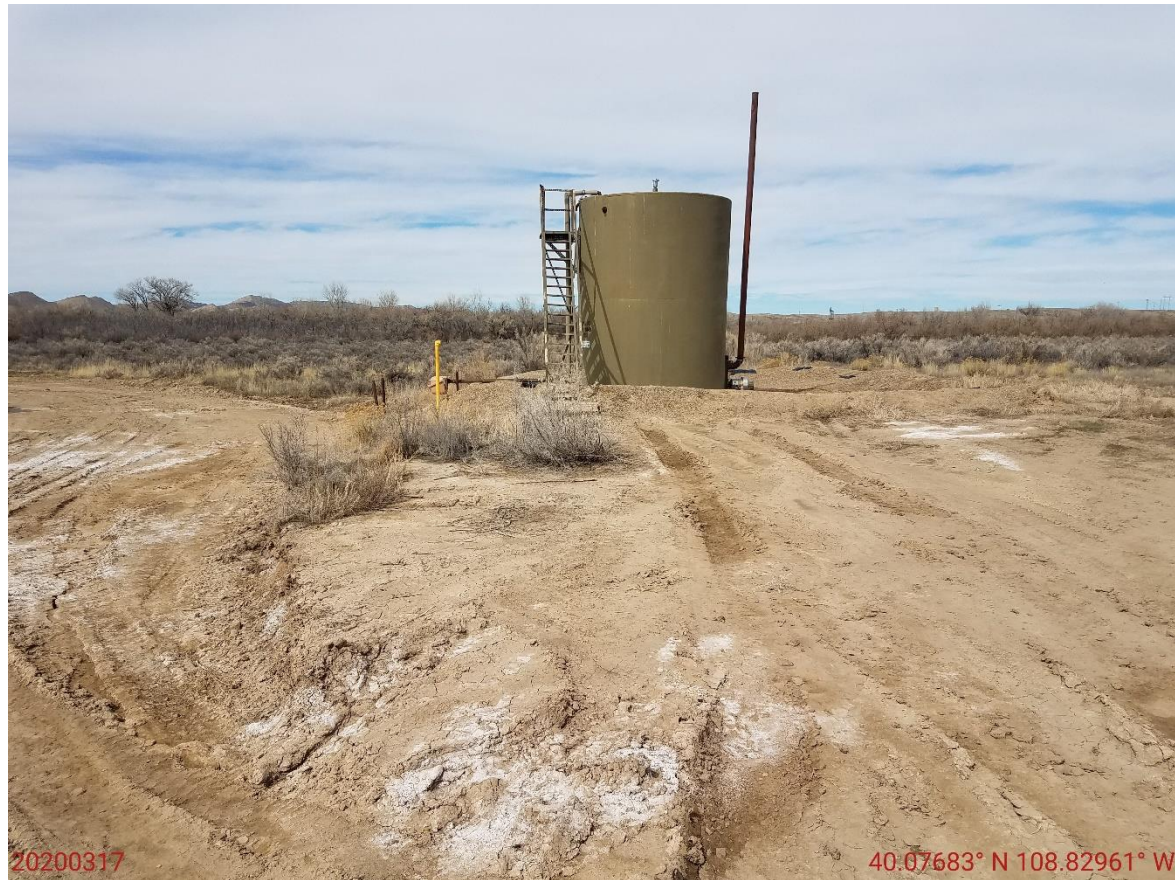
**Photo 11:** Photo taken from the east end of the Location, facing northwest. Photo provides overview of the Location.
