Inspection Photos

Operator: RIO MESA RESOURCES INC - 74740

Location ID: 397812

Rio Blanco County, CO

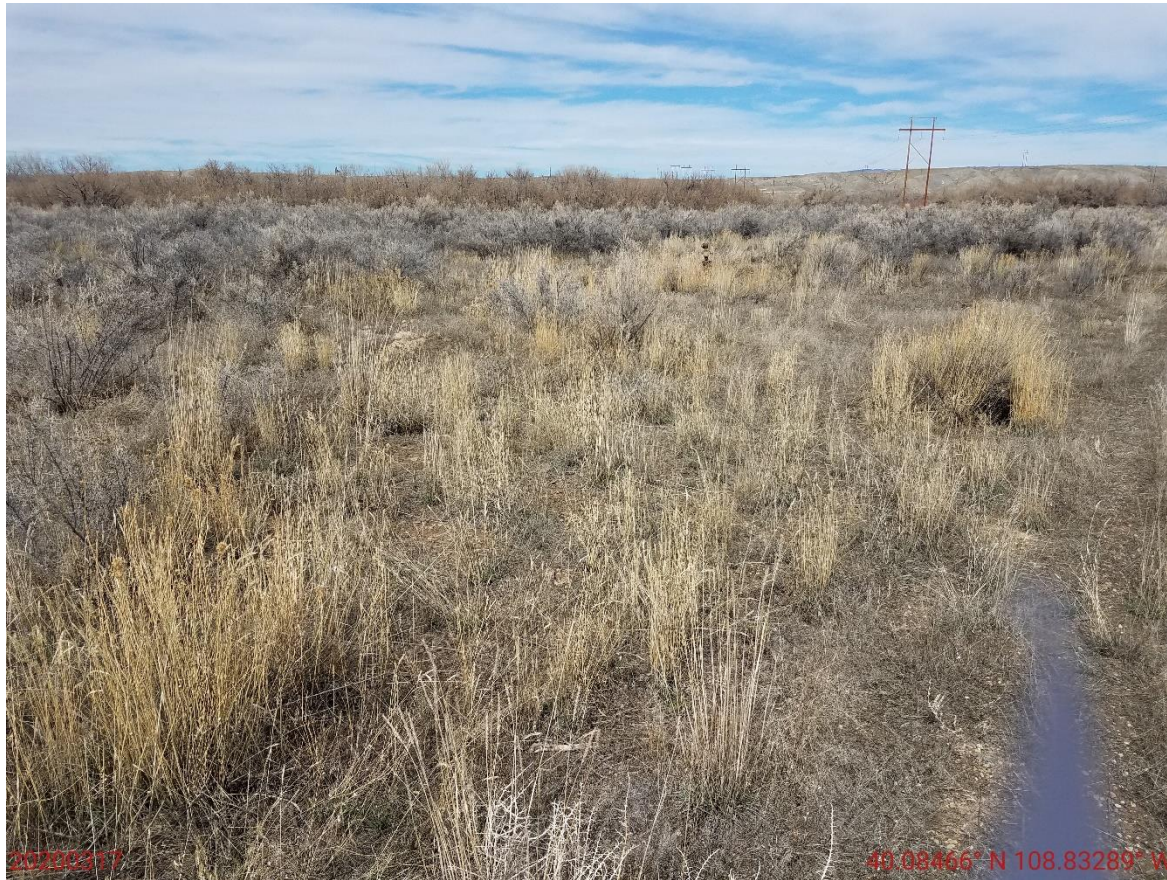
Photo 1: Photo taken from the south end of the Location, facing North. Photo shows well site.

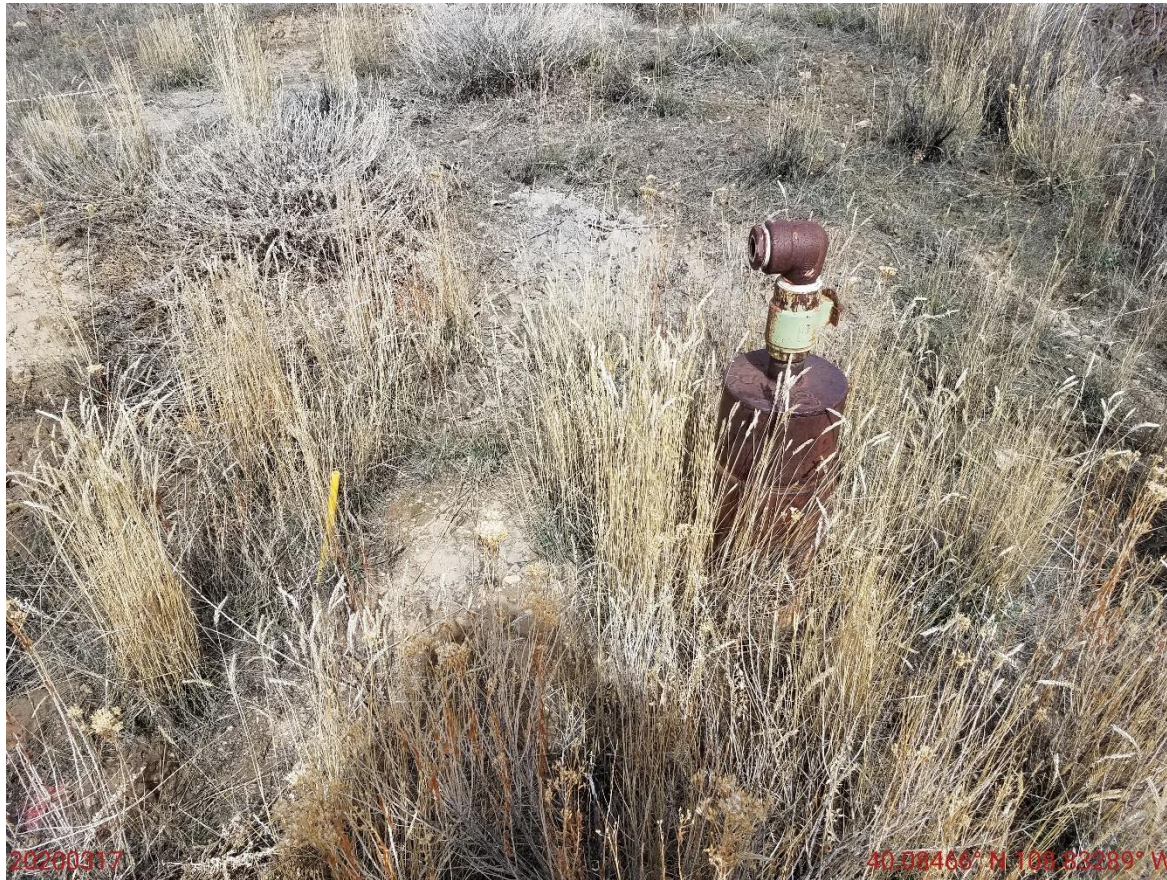
Photo 2: Photo shows well casing; Well does not appear to have been sufficiently plugged or cut/capped or in compliance with Rule 319.a.(5).

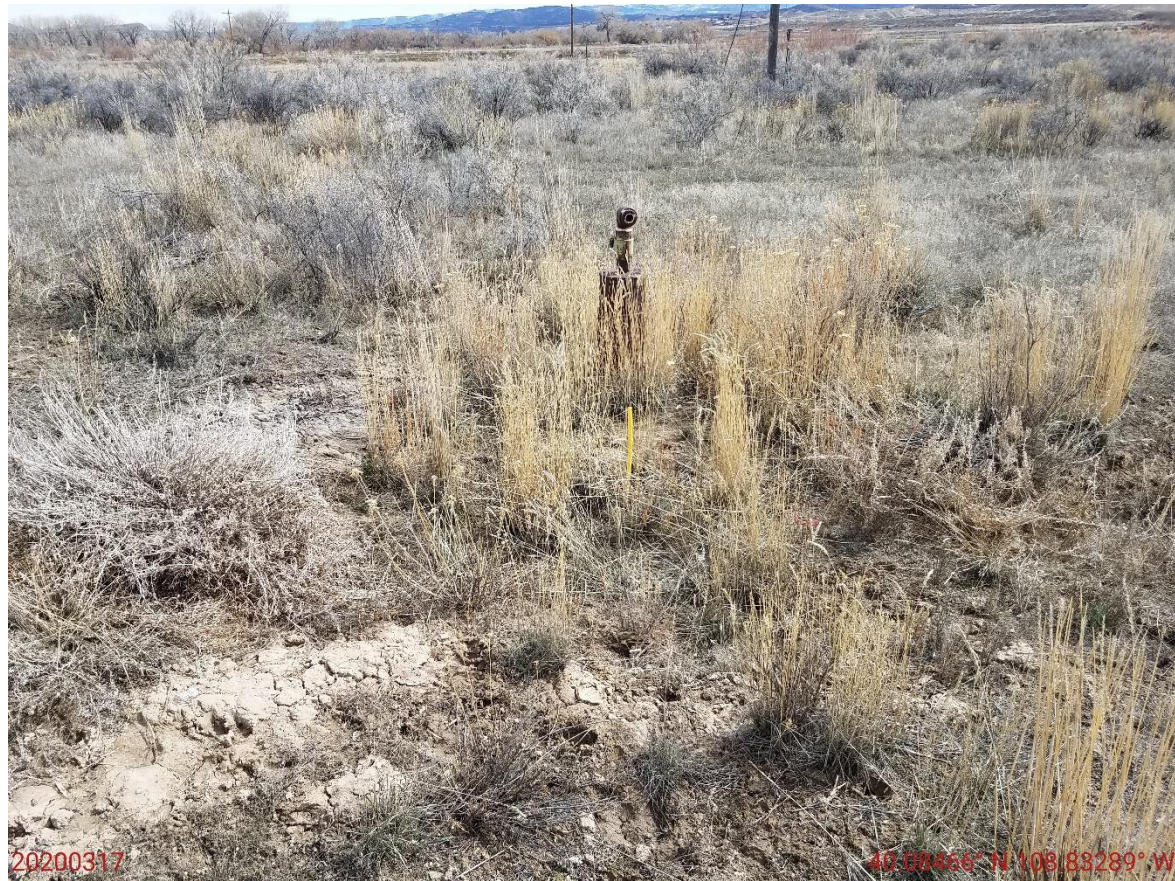
Photo 3: Photo taken from the well location, facing east. See comments under photo 2.

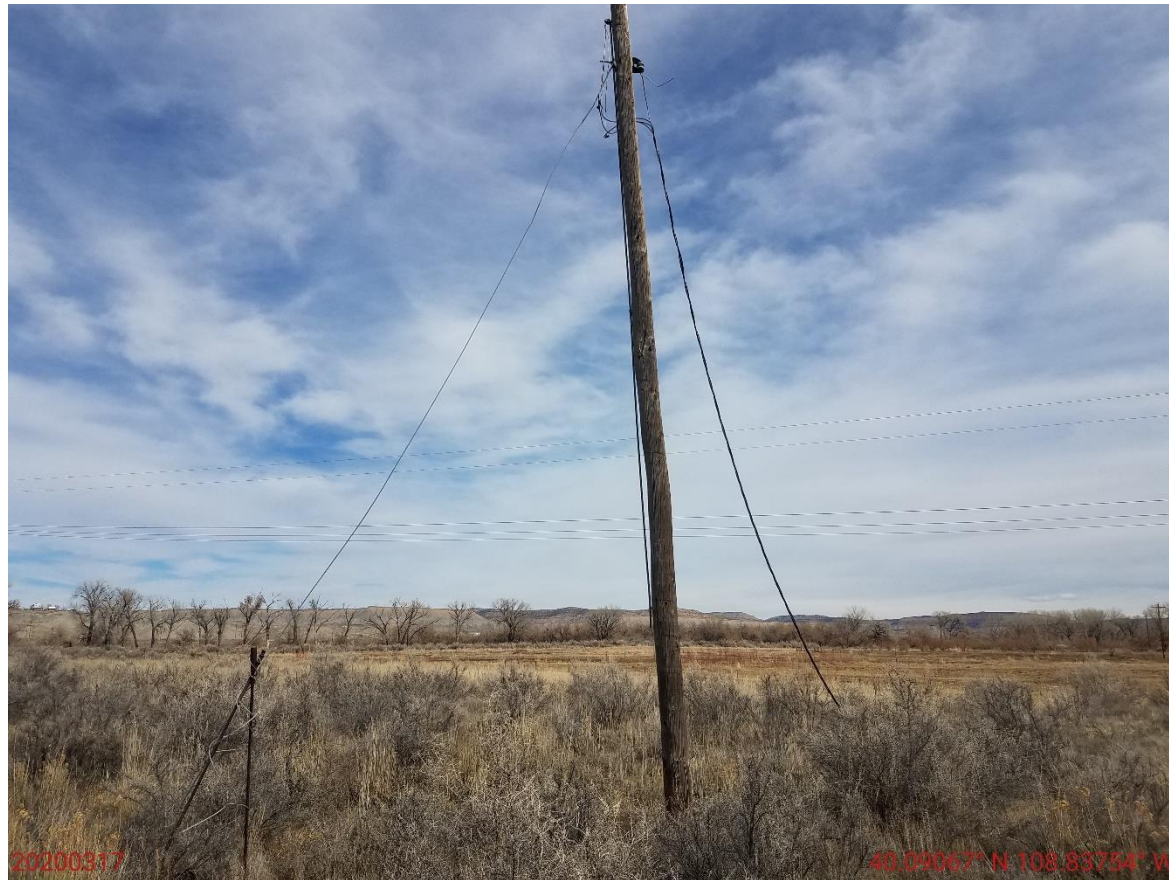
Photo 4: Photo taken from the east end of the Location, facing northeast. Photo shows Oil and Gas associated utility equipment remains on the Location.
