Inspection Photos

Location Name: VPR C NO. 84 CA DATE 4-18-20

API#: 05-071-07386

INSP. #: 695102301

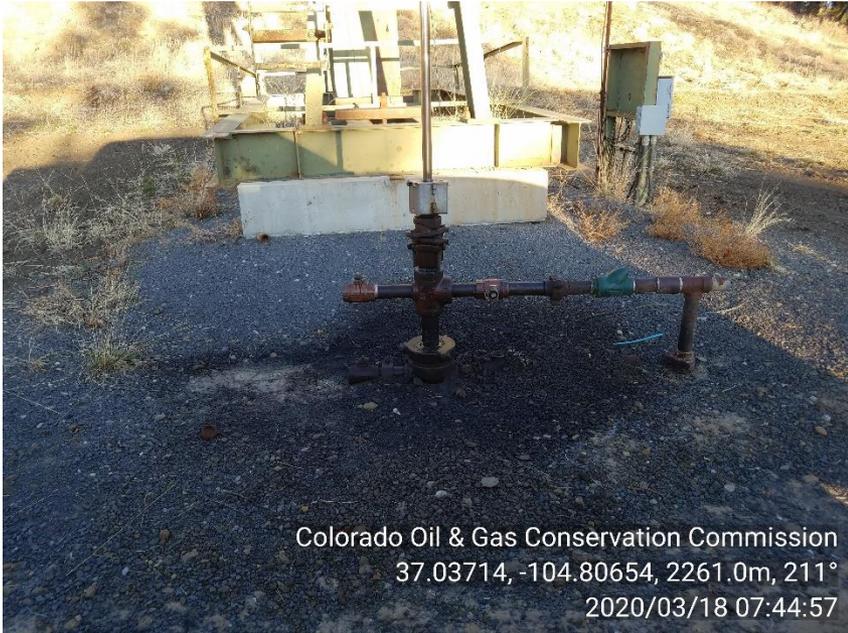
PHOTO 3: THERE IS AN AREA APP. 3' IN DIAMETER OF IMPACTED SOIL APPEARS TO BE COMING FROM POLISH ROD OILER. Conduct maintenance on equipment, cleanup stained material and review self inspection processes. CA DATE 4-18-20.
