# Inspection Photos

4/06/2020

Operator: LARAMIE ENERGY LLC - 10433

Location ID: 383264

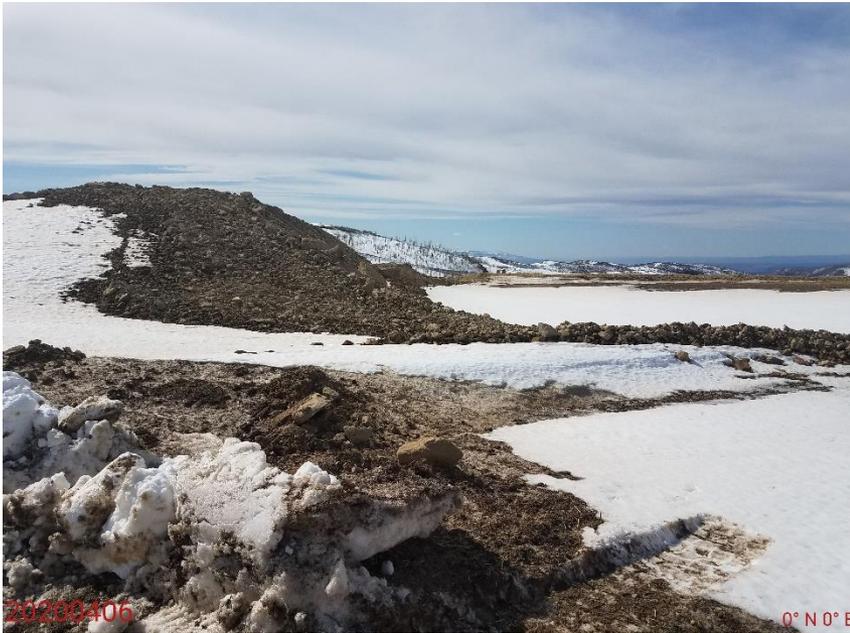
**Photo 1:** Photo taken from the northeast end of the Location, facing south. Photos 1-4 provide an overview of the Location from south, southwest, west to northwest. Location has been constructed, drilling activities have not been conducted.

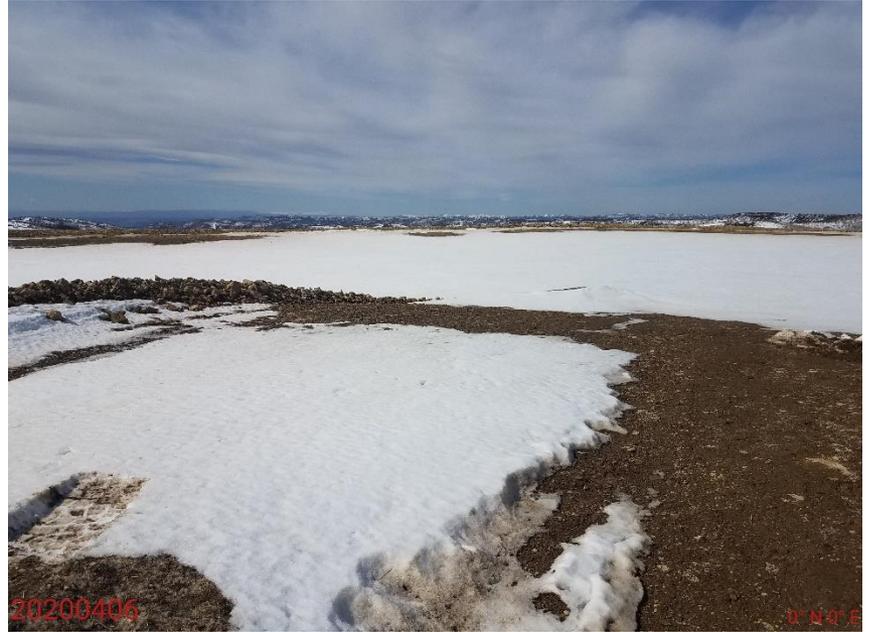
**Photo 2:** See comments under photo 1.

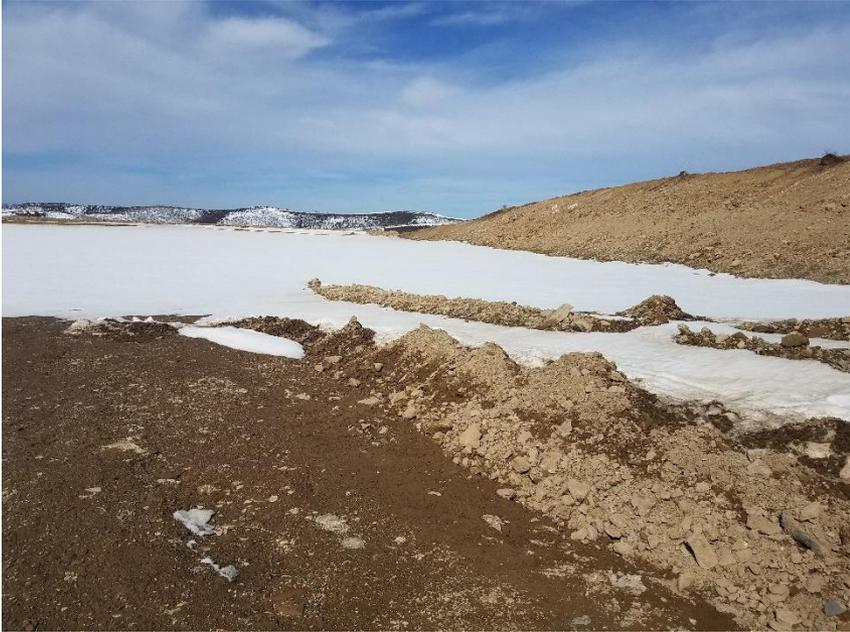
**Photo 3:** See comments under photo 1. Photo also shows topsoil stockpile on the north end of the Location; No stormwater or stabilization controls have been installed on the soil stockpiles in accordance with Rule 1002.f

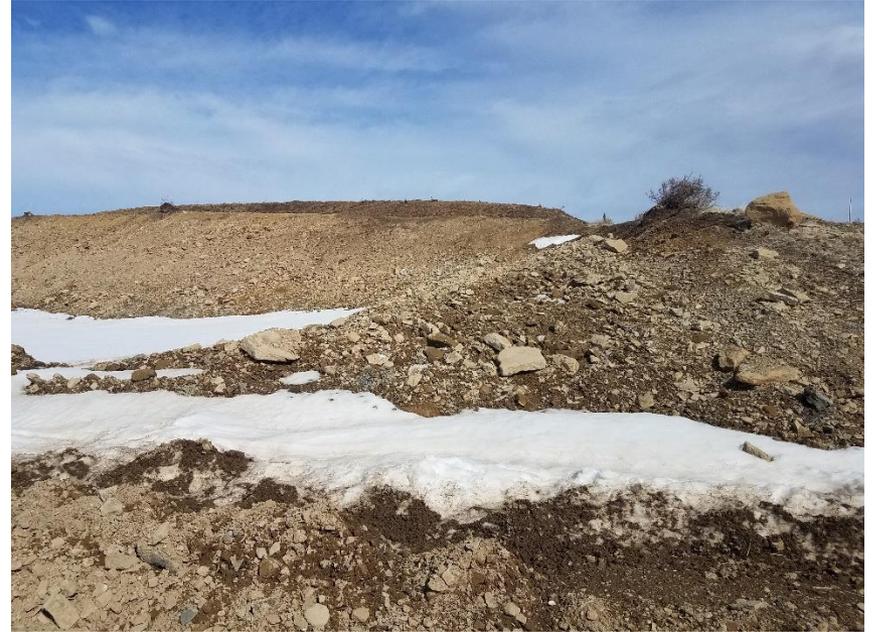
**Photo 4:** See comments under photo 1 and photo 3.

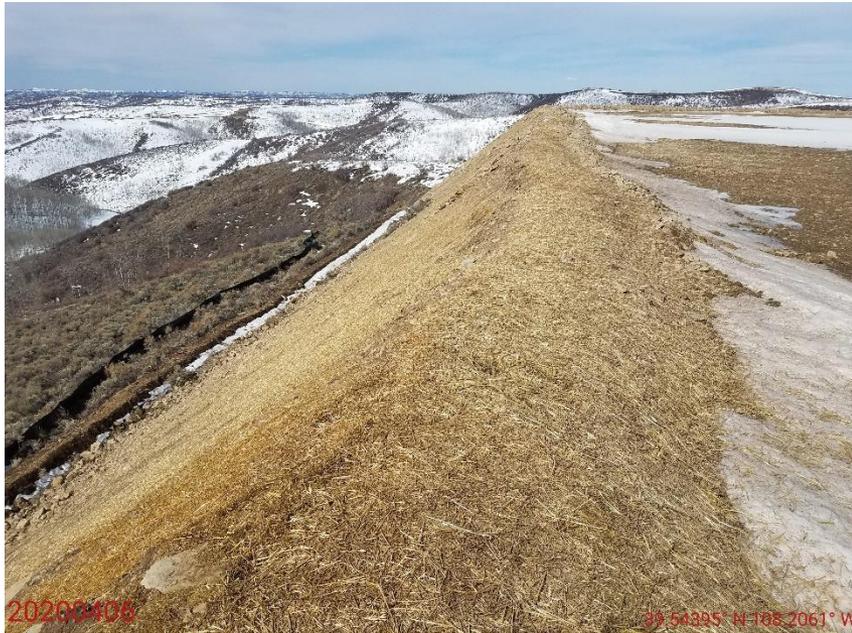
**Photo 5:** Photo taken from the south end of the Location, facing west. Photo shows straw mulch has been installed to stabilize and protect the fill slopes of the Location.

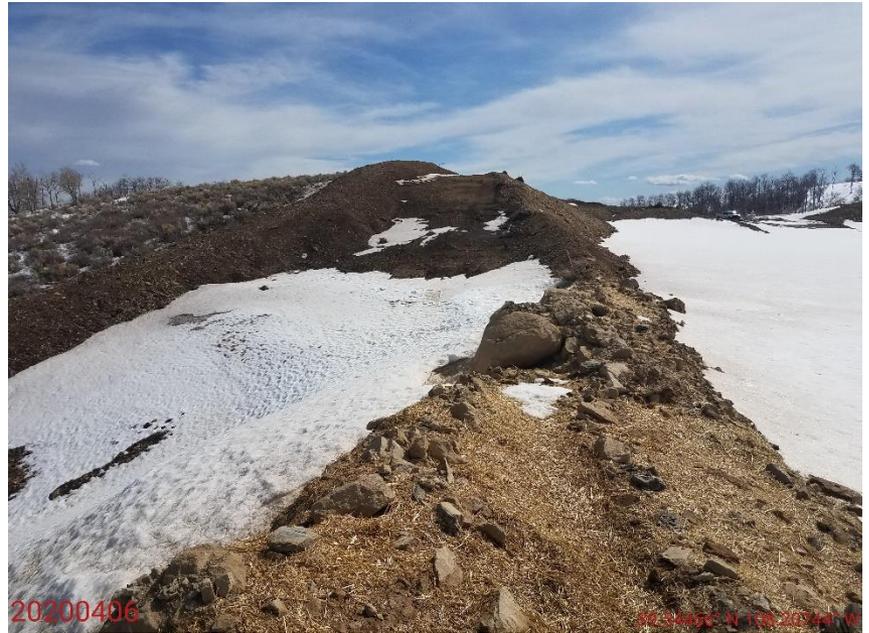
**Photo 6:** Photo taken from the northwest end of the Location, facing east. Photo shows topsoil stockpile on the north end of the Location; No stormwater or stabilization controls have been installed to protect the soil stockpiles in accordance with Rule 1002.f
