# Inspection Photos

Operator: BERRY PETROLEUM COMPANY LLC

Location ID: 335981

Garfield County, CO

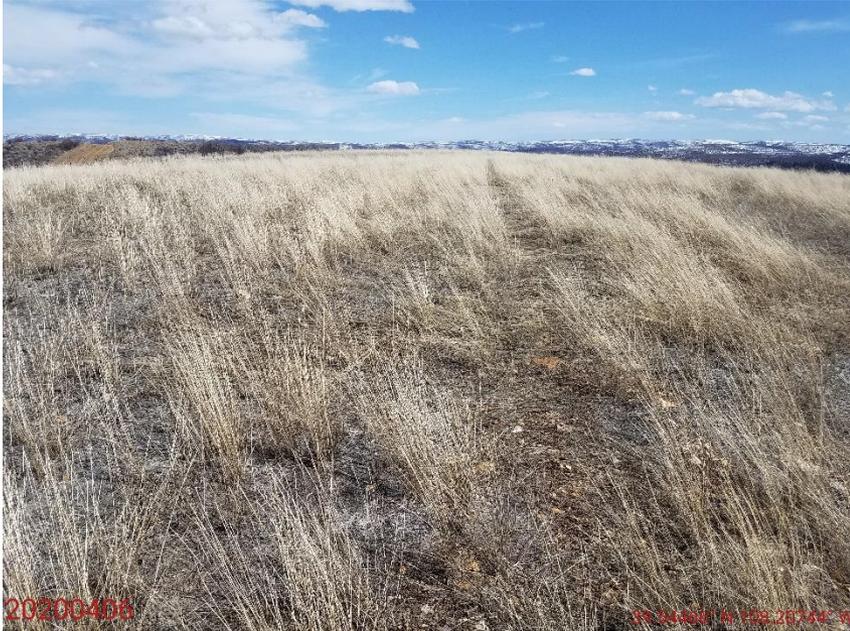
**Photo 1:** Photo taken from the northwestern areas of the Location, facing north. Photos 1-4 provide an overview of the Location facing north, east, south and west. Photos show vegetative establishment on the upland portions of the Location appears to be progressing towards reclamation requirements. However, vegetation on adjacent reference areas are predominantly sage brush and scrub oak; little shrub germination/establishment was observed.

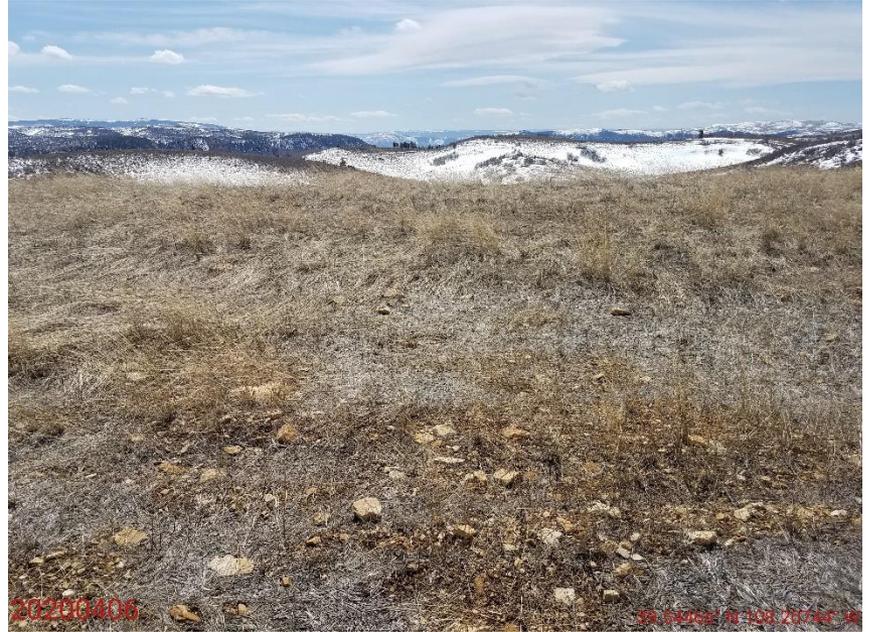
**Photo 2:** See comments under photo 1.

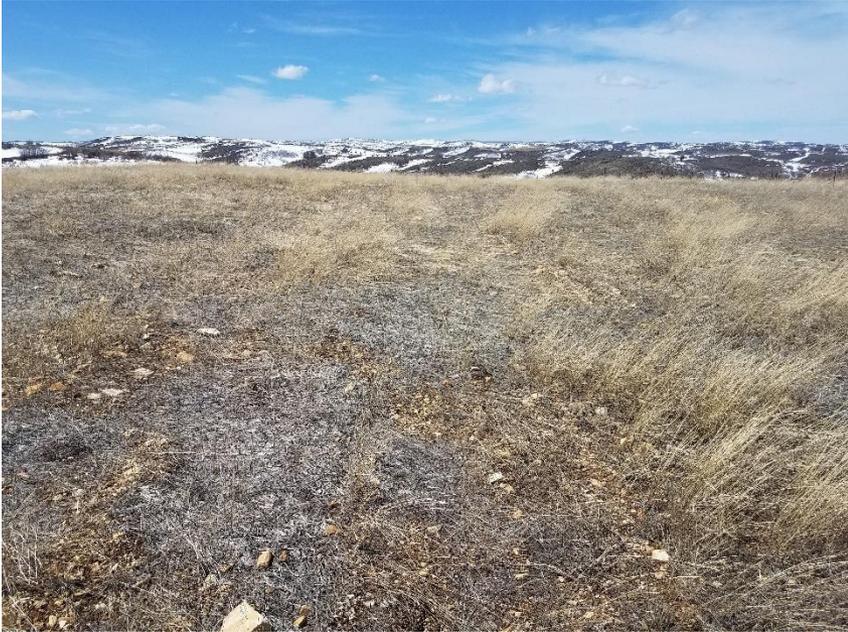
**Photo 3:** See comments under photo 1. .

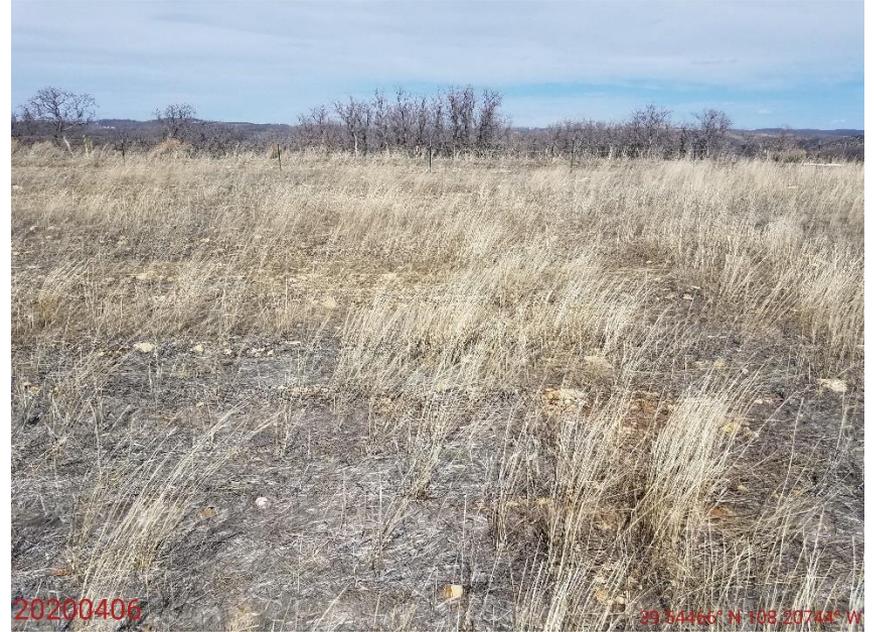
**Photo 4:** See comments under photo 1. .

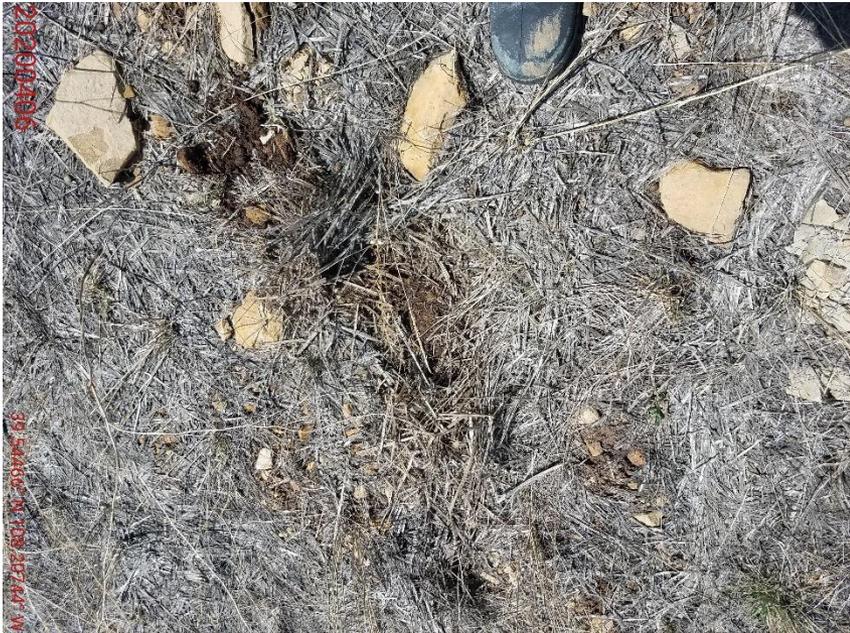
**Photo 5:** Photo taken from the slopes on the southern portion of the Location. Vegetation establishment is not as uniform as observed on the northern areas. Photo shows straw mulch appears to have been over-applied and may be hindering reclamation.

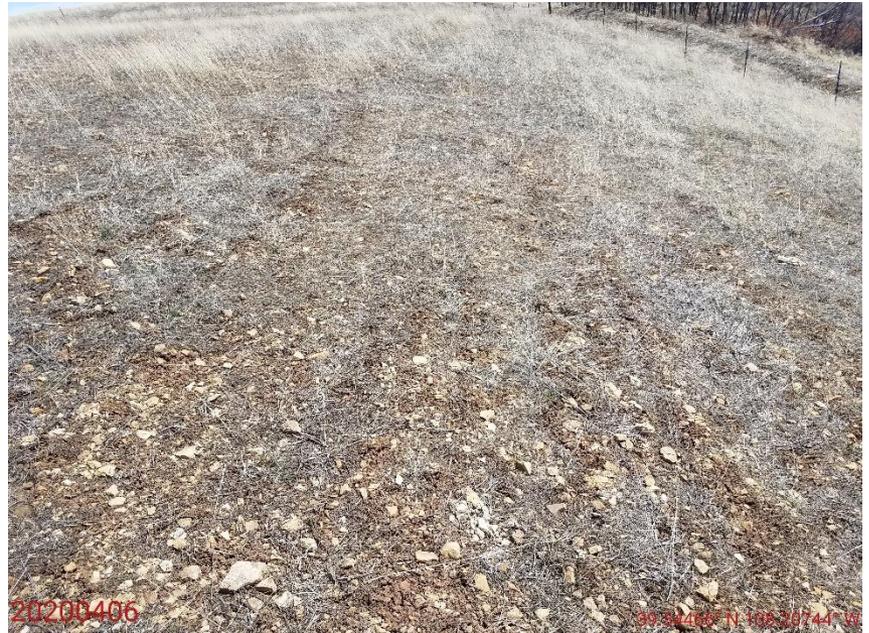
**Photo 6:** Photo taken from the slopes on the southern portion of the Location, facing east. See comments under photo 5.

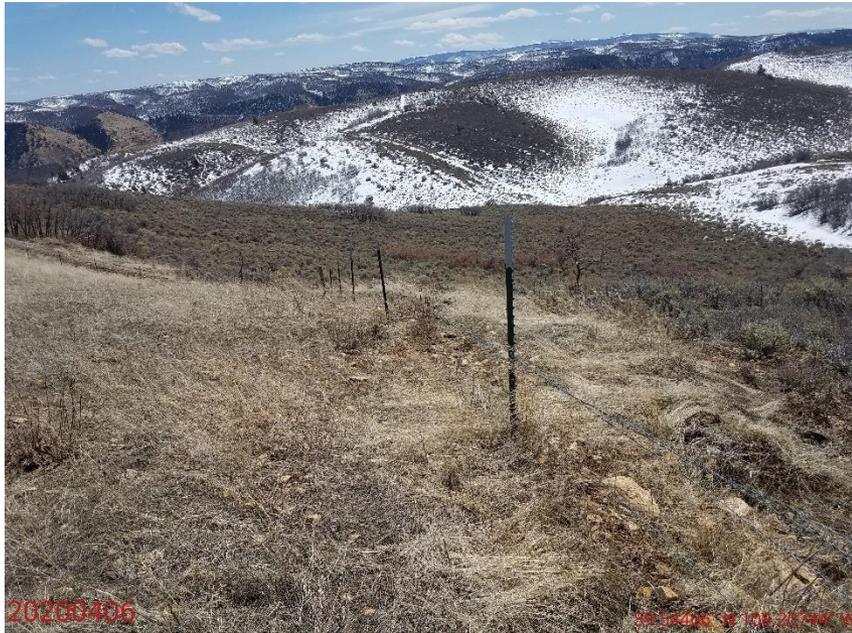
**Photo 7:** Photo taken from the fence on the south end of the Location. Photo shows fence is in disrepair.

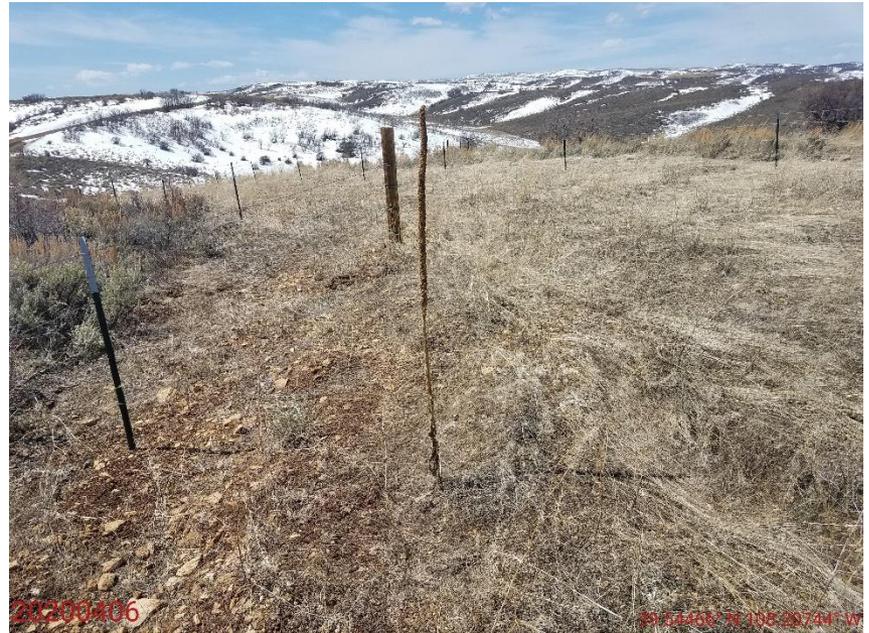
**Photo 8:** Photo taken from the west end of the Location; Photo shows noxious weeds (*Verbascum Thapsus*, *Carduus nutans*) are evident on the Location.

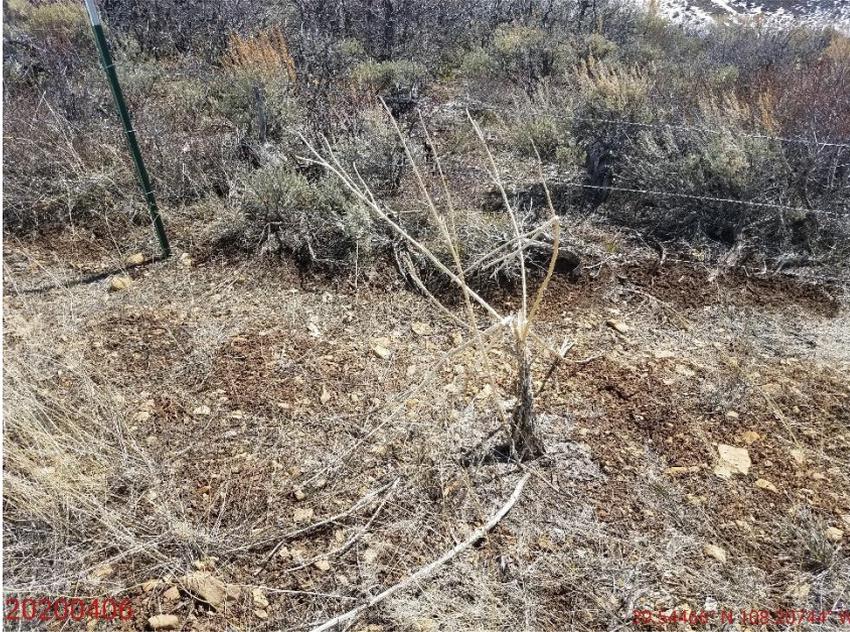
**Photo 9:** Photo taken from the west end of the Location; Photo shows noxious weeds (Verbascum Thapsus, Carduus nutans) are evident on the Location.

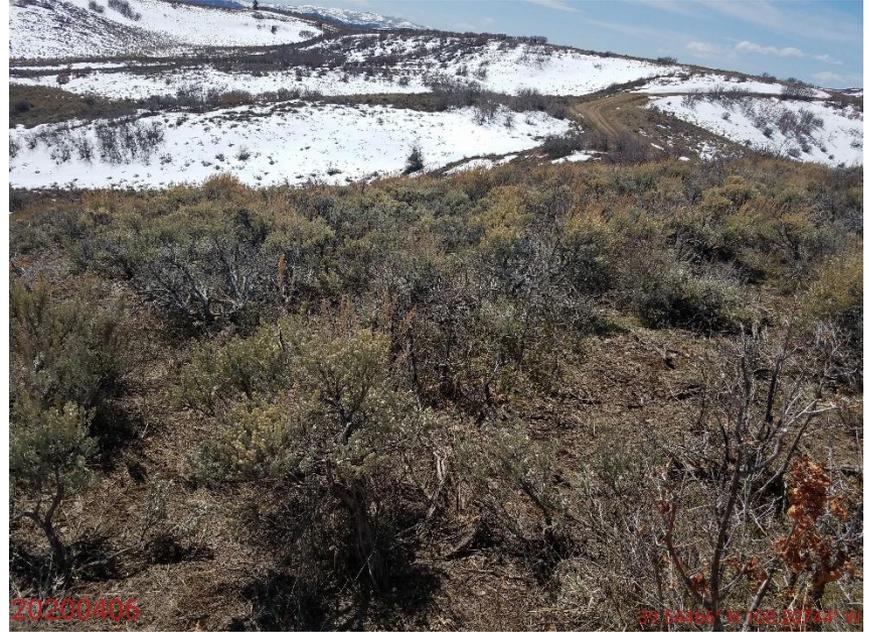
**Photo 10:** Photo taken from the reference area. Photo shows vegetation on the reference.
