Final Reclamation and Stormwater Inspection

Operator: GREAT WESTERN OPERATING COMPANY LLC- #10110

Location ID: 320328

Inspection Photos
Location Name: EHLER #2-4
Location ID: 320328

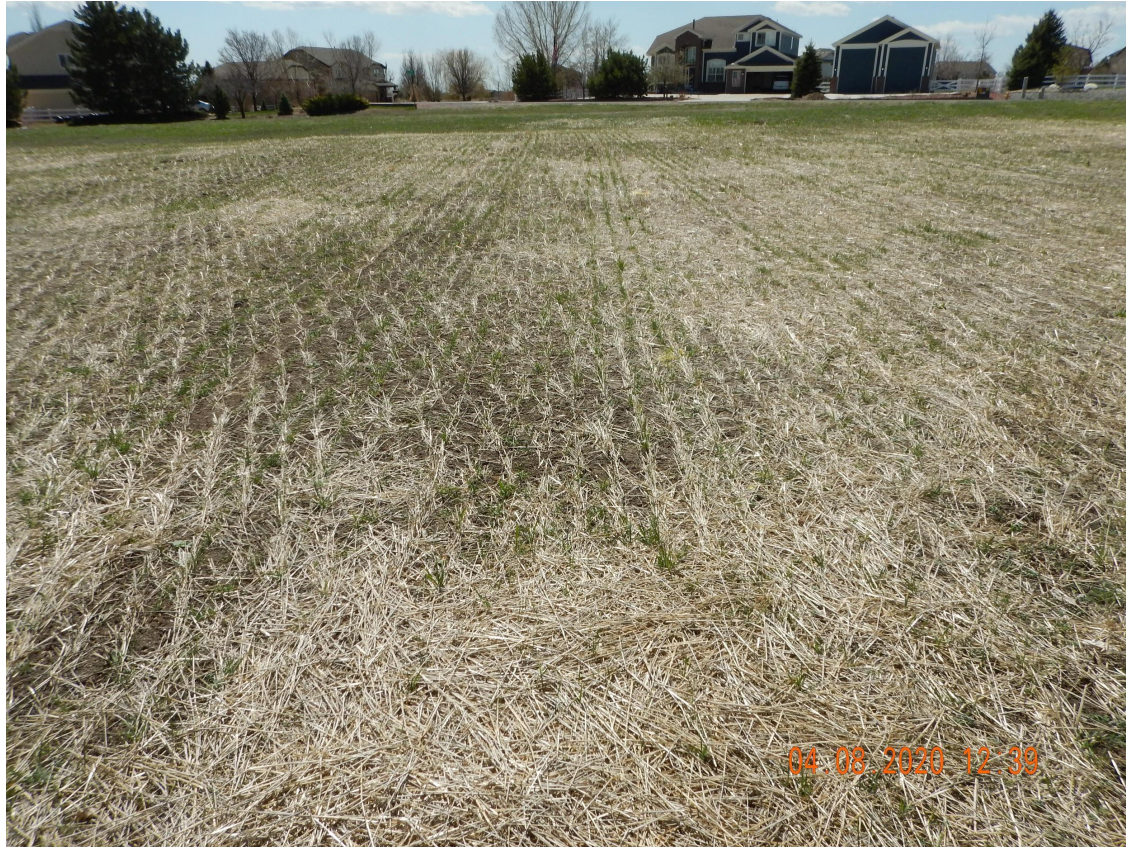
Photo 1. Photo taken from the well and battery location, facing South. Photo illustrates Operator has performed final reclamation activities with the evidence of drill rows, straw crimped mulch, and germination.

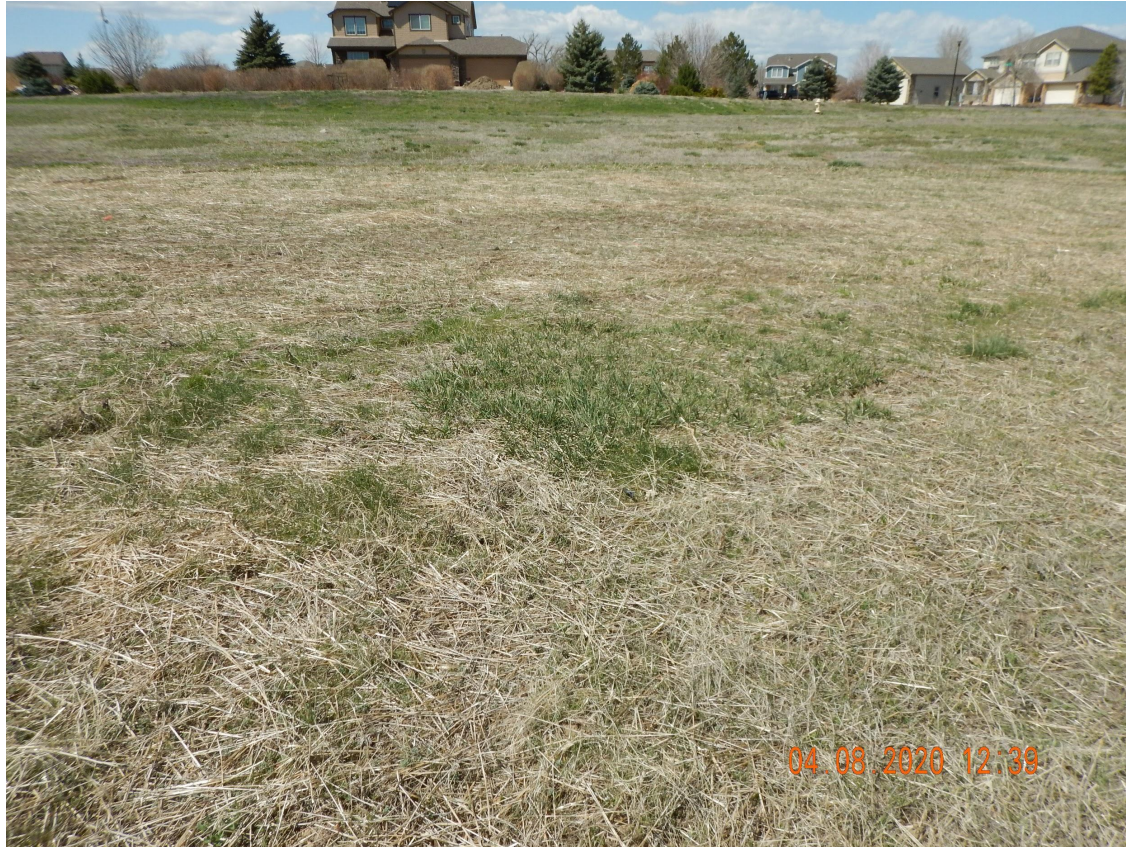
Photo 2. Photo taken from the well and battery location, facing West. See comments under Photo 1.

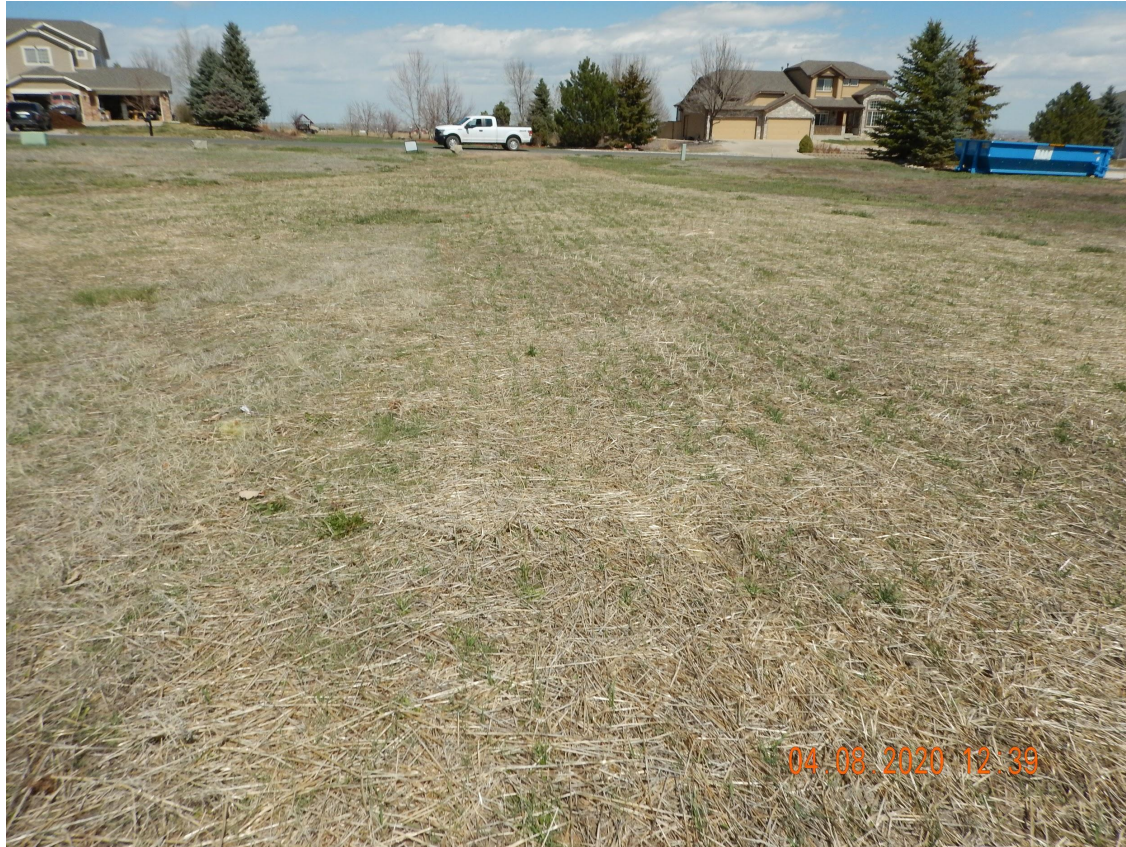
Photo 3. Photo taken from the well and battery location, facing North. See comments under Photo 1.

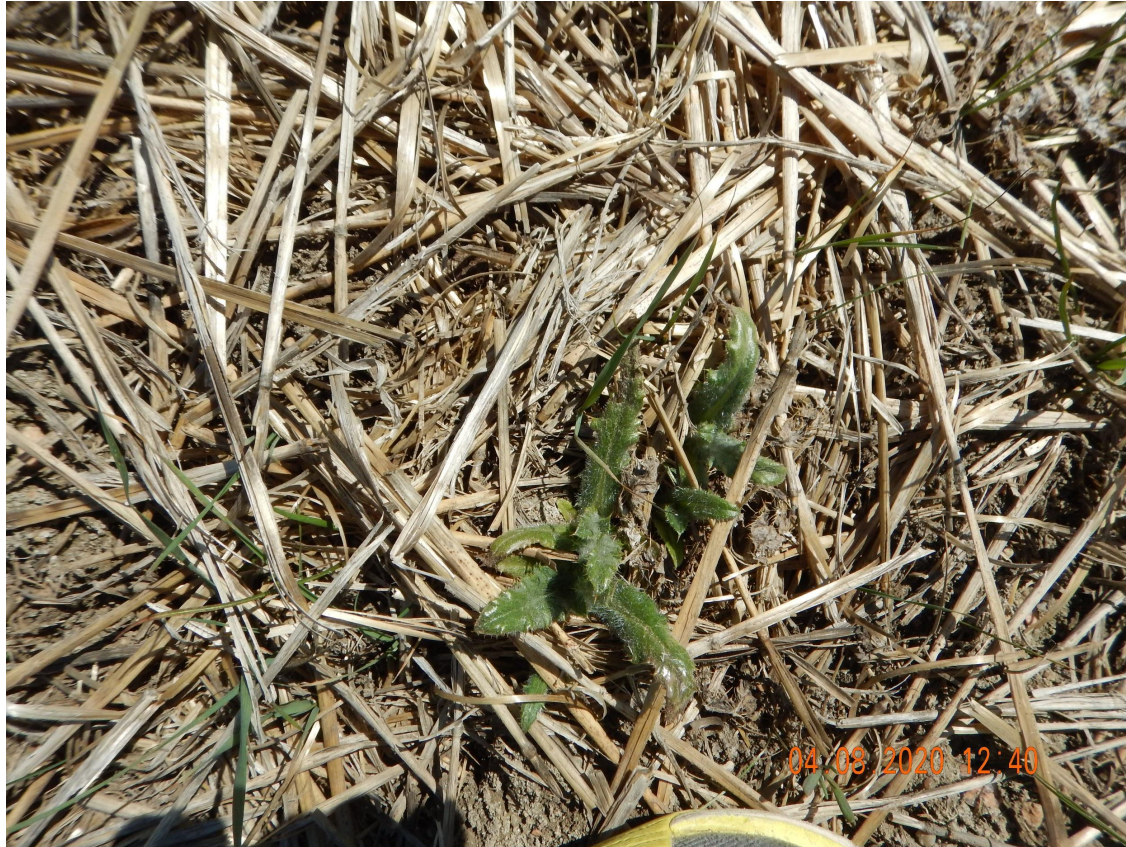
Photo 4. Photo taken from the well and battery location. Photo illustrates Canada thistle rosettes. Operator shall continue to monitor and control all weed species.
