# Inspection Photos

Operator: TEP ROCKY MOUNTAIN LLC - 96850

Location ID: 322524

Garfield County, CO

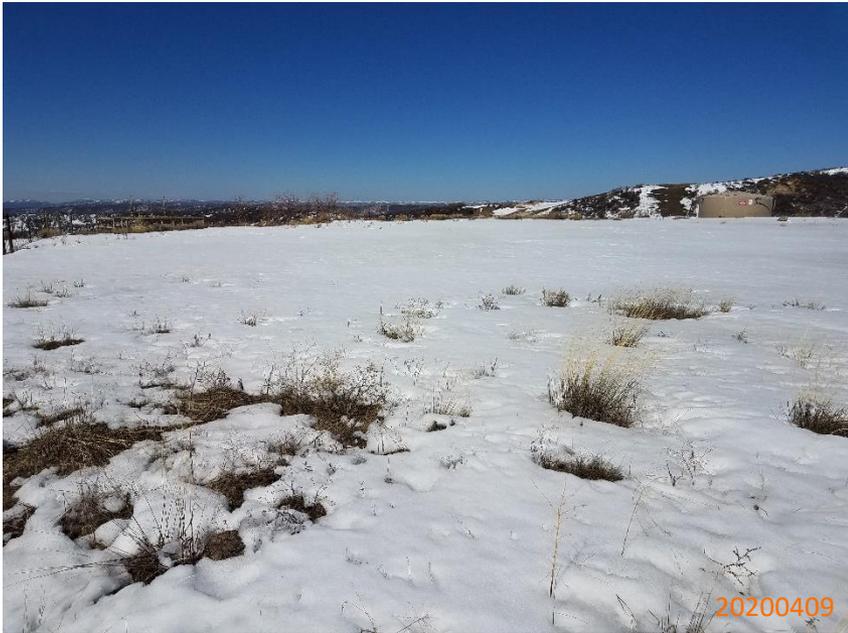
20200409

**Photo 1:** Photo taken from the south end of the Location facing west. Photos 1-3 provide an overview of the Location from west, north, to northeast. Two Locations exist within areas of the pad; Location #453726 on the west remains active with production equipment owned/operated by Nonsuch. The remaining areas east of the Location not needed for production by Nonsuch, where TEP's Well exists, remain subject to final reclamation requirements under TEP. Noxious weeds observed throughout both areas of the Location.

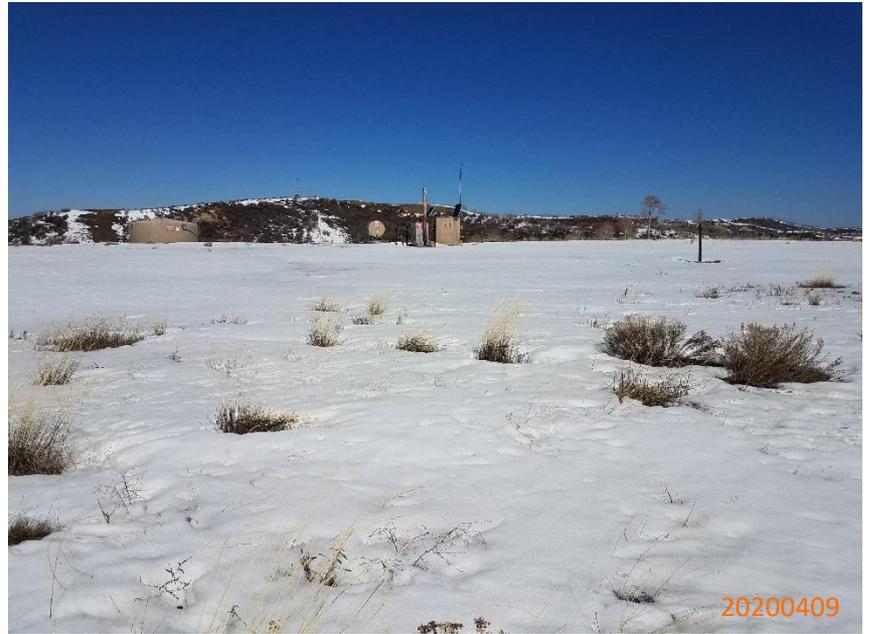
20200409

**Photo 2:** See comments under photo 1.

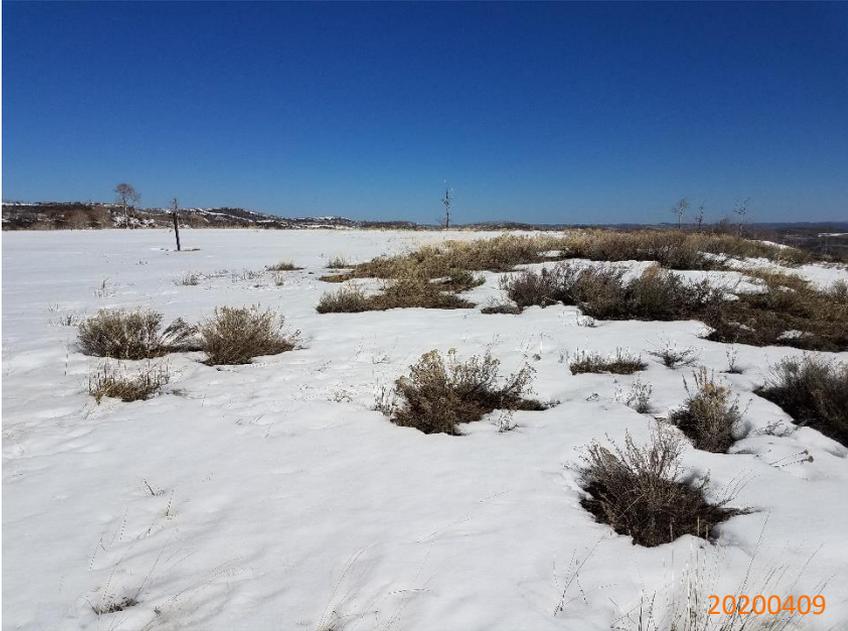
**Photo 3:** See comments under photo 1.

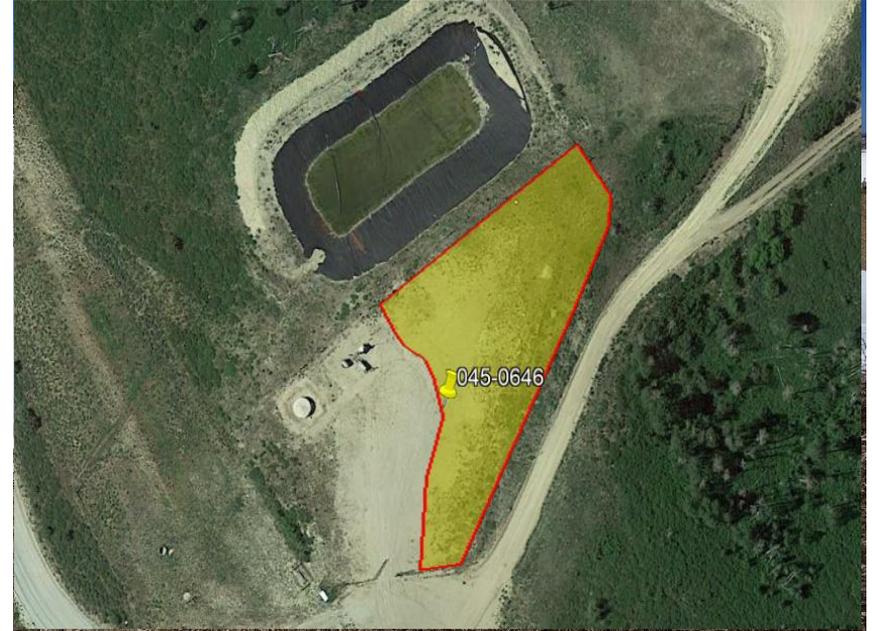
**Photo 4:** See comments under photo 1. Yellow polygon represents areas of the Well Location that remain subject to 1004 final reclamation under TEP.

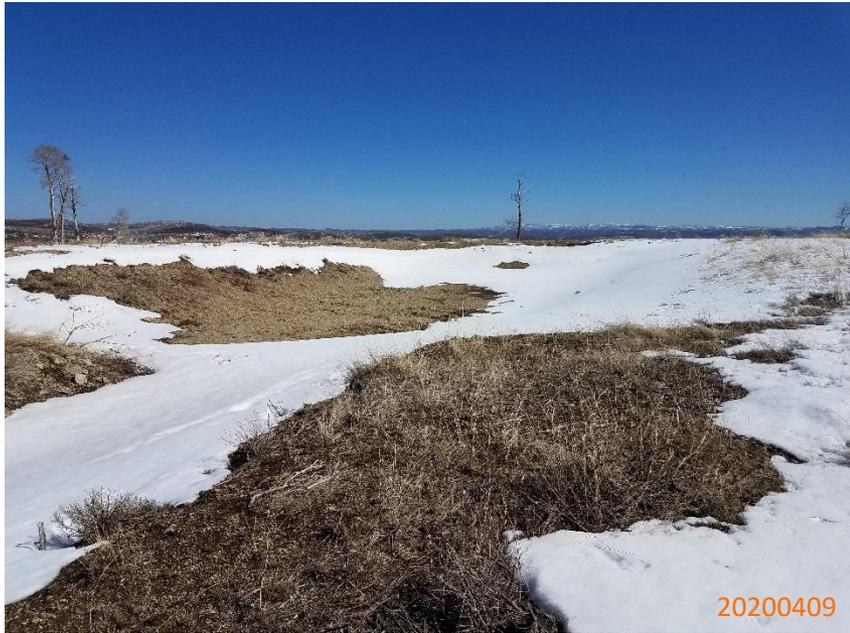
**Photo 5:** Photo taken from the southwest corner of the Oil & Gas associated freshwater pit. Photo shows pit remains open. Pit is no longer in use and requires reclamation.

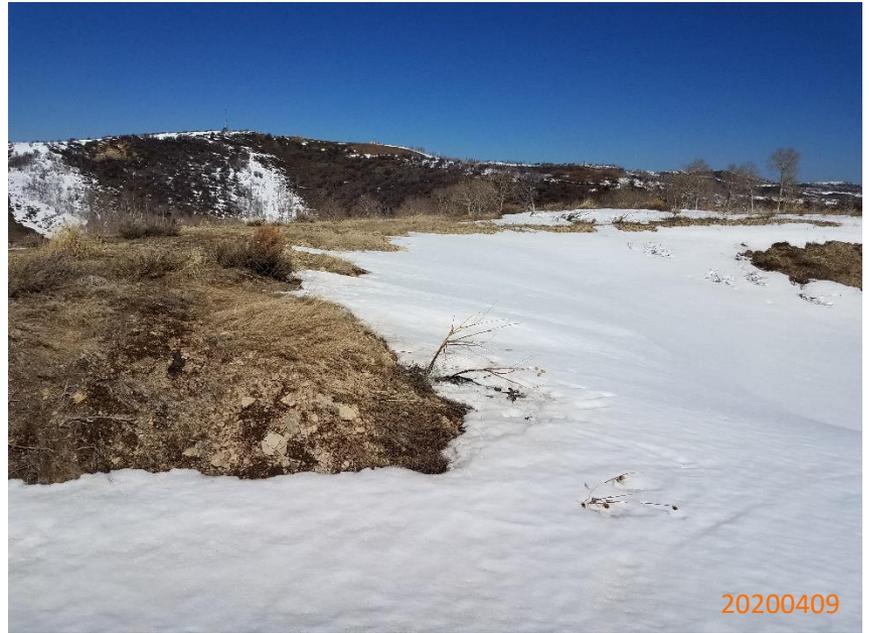
**Photo 6:** Photo shows Musk thistle on pit.
