Interim Reclamation and Stormwater Inspection

Operator: PHOENIX RESOURCES LLC - #10691

Location ID: 420020

Inspection Photos
Location Name: Cass Farms #11-25H
Location ID: 420020

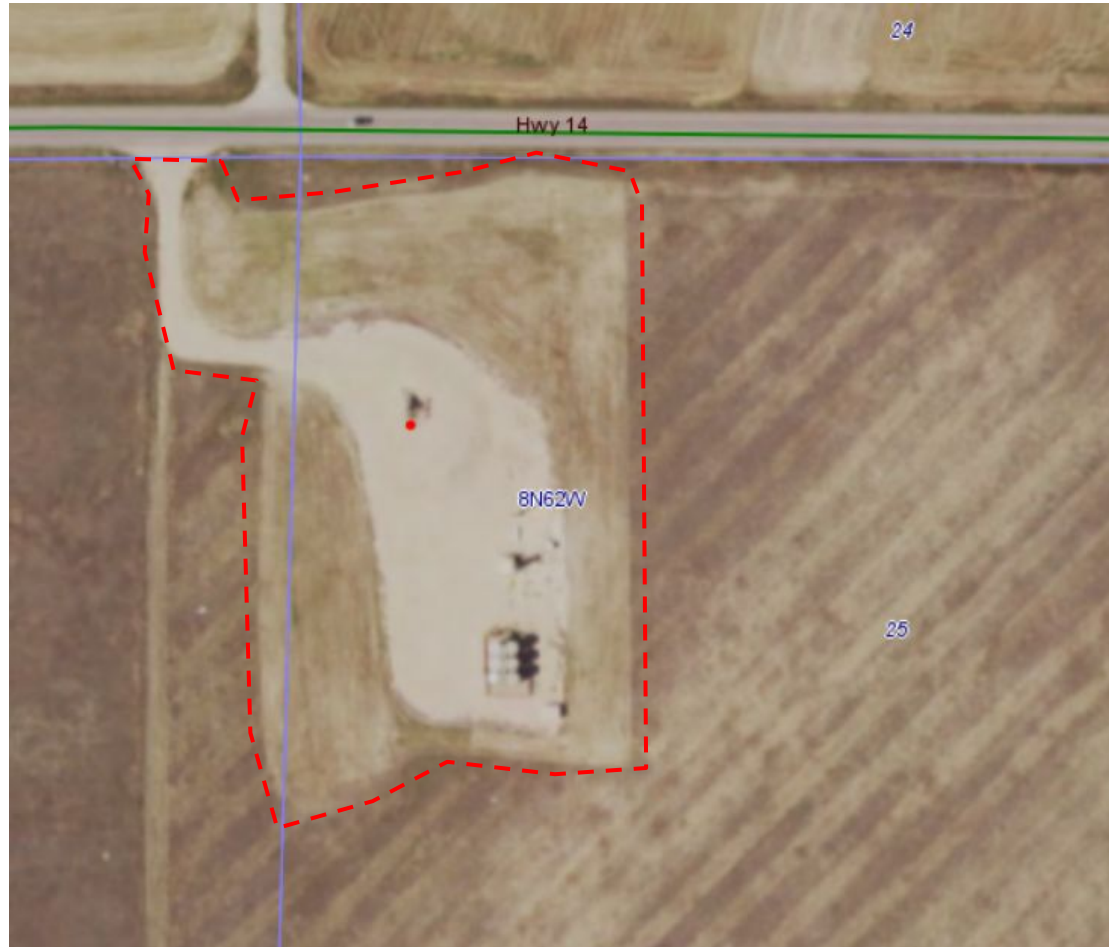
Photo 1. COGCC GISOnline aerial imagery from 2017 illustrates the total disturbance area. Operator recently performed weed management but did not perform work throughout the entire disturbance area.

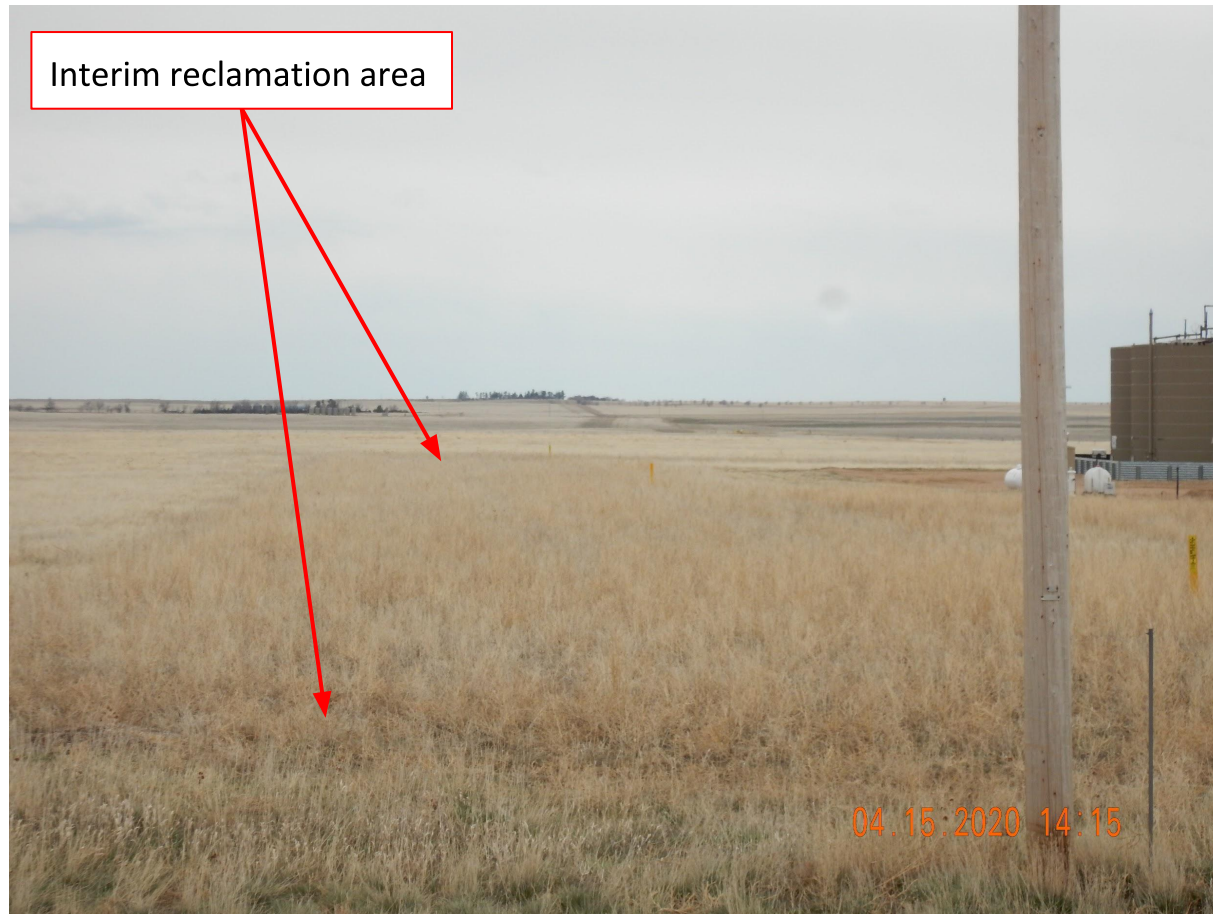
Photo 2. Photo taken north of the eastern interim reclamation area, facing South. Photo illustrates Operator did not perform weed management throughout the entire disturbance area.

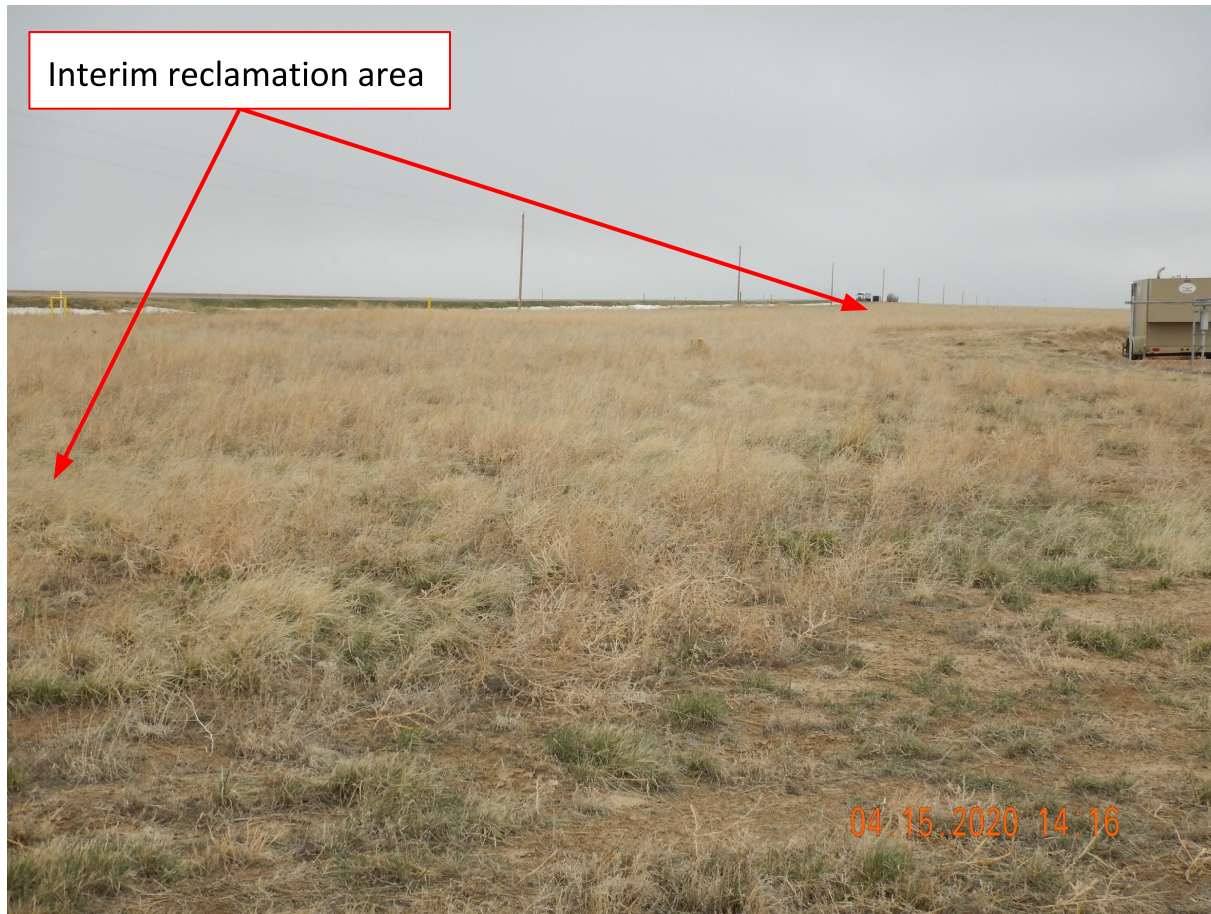
Photo 3. Photo taken from the entrance of location, facing East. See comments under Photo 2.

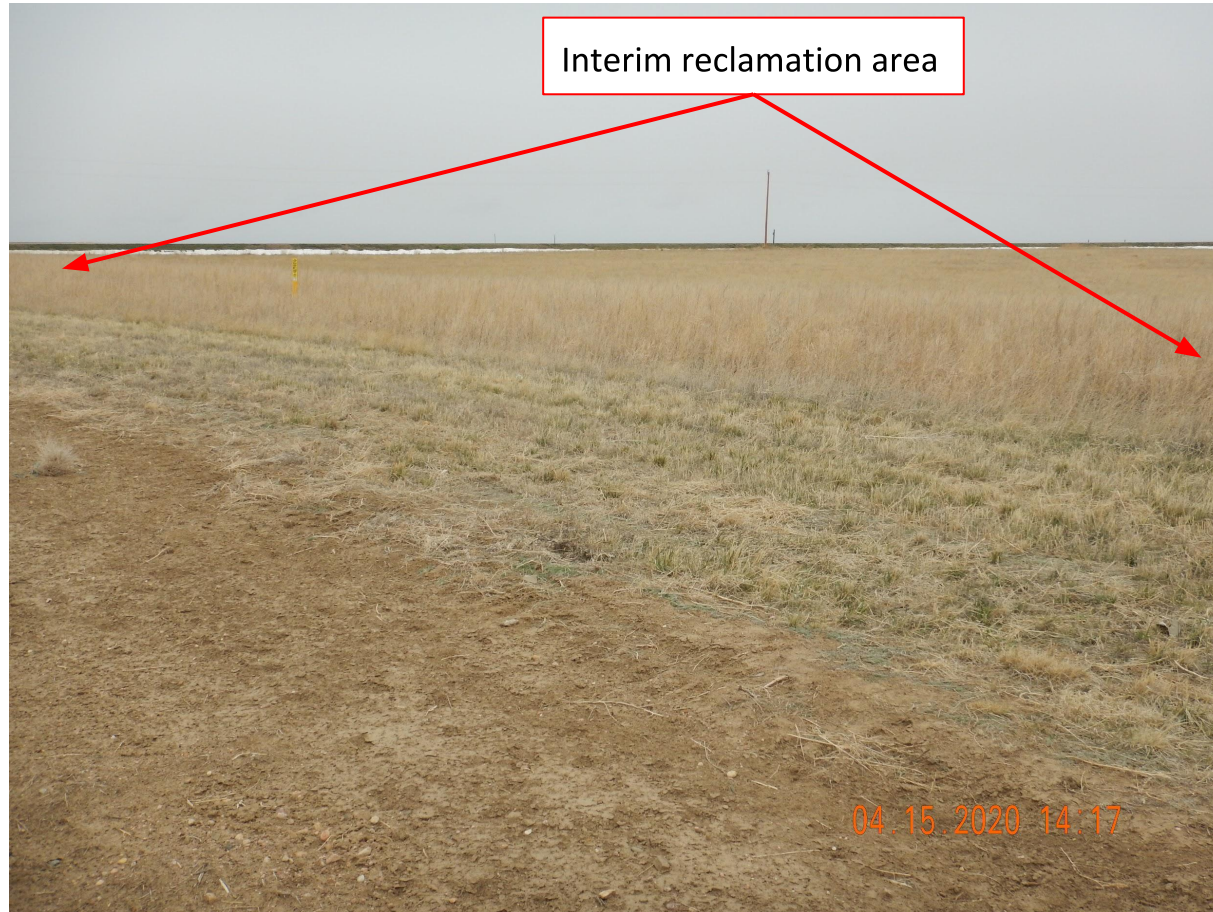
Photo 4. Photo taken from the eastern interim reclamation area, facing Northeast. Photo illustrates the Operator only performed weed management on an approximate ~20-25' width. There is still another 35-40' of interim area that needs to be managed for weeds.

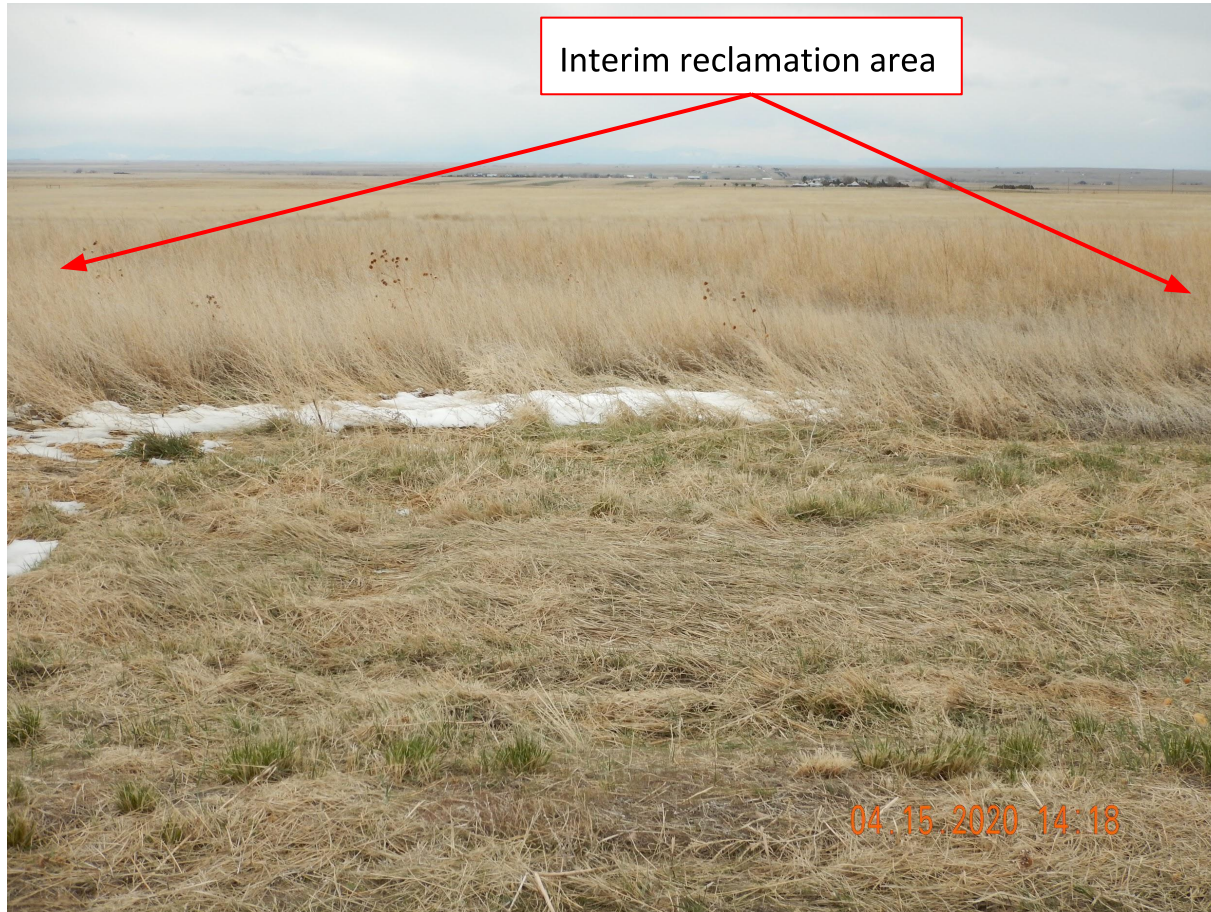
Photo 5. Photo taken from the western interim reclamation area, facing West. See comments under Photo 4.
