## Inspection Photos

Location Name: GOLDEN EAGLE 28-07X FOLLOW UP

API#: 05-071-08732

INSP. #: 695102712

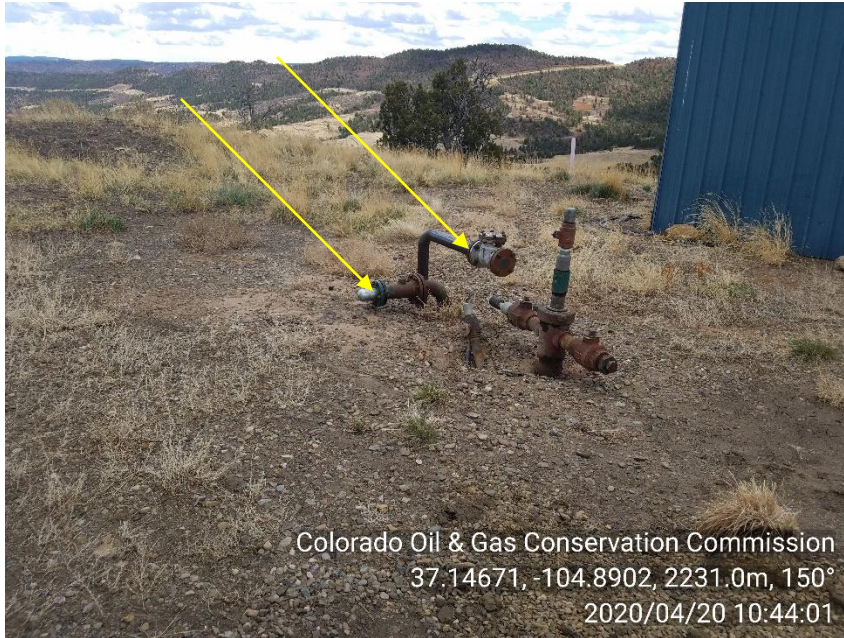
**PHOTO 3: TWO UNMARKED UNUSED RISERS NEAR X WELLHEAD. REMOVE UNUSED RISER IN ACCORDANCE WITH NTO AND RULE 603.f. THIS IS SECOND NOTICE CA'S DUE IMMEDIATELY.**

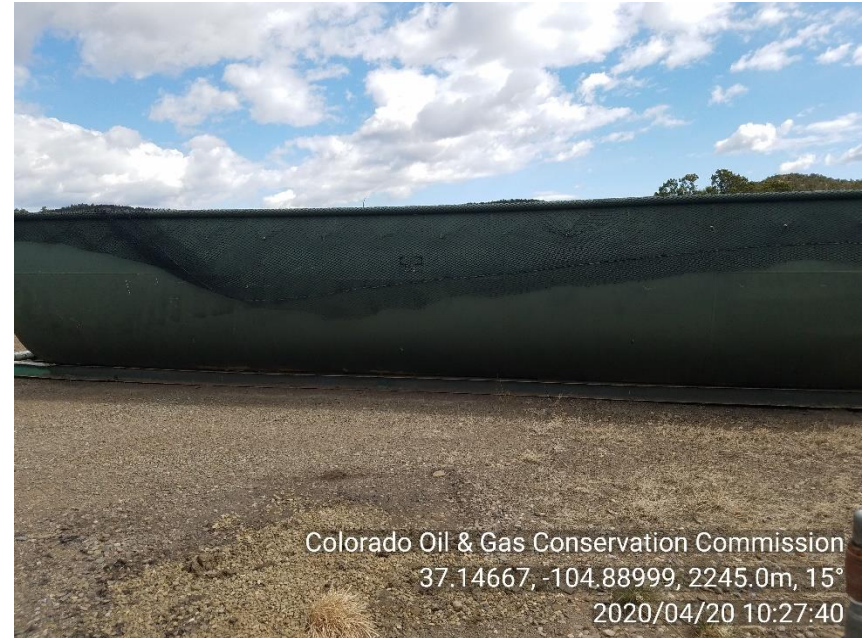
**PHOTO 4: UNUSED EQUIPMENT STORED ON LOCATION. COMPLY WITH RULE 603.f. (REMOVE UNUSED EQUIPMENT) CA DATE 5-20-20**

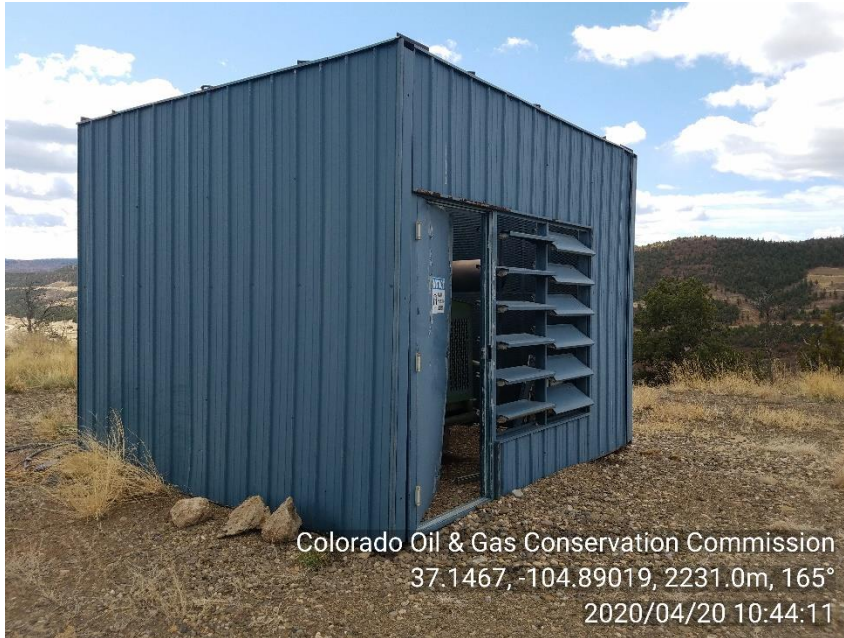
**PHOTO 5: UNUSED EQUIPMENT STORED ON LOCATION (SOUND WALLS AND ALL EQUIPMENT INSIDE SOUND WALLS). **COMPLY WITH RULE 603.f. (REMOVE UNUSED EQUIPMENT) CA DATE 5-20-20****

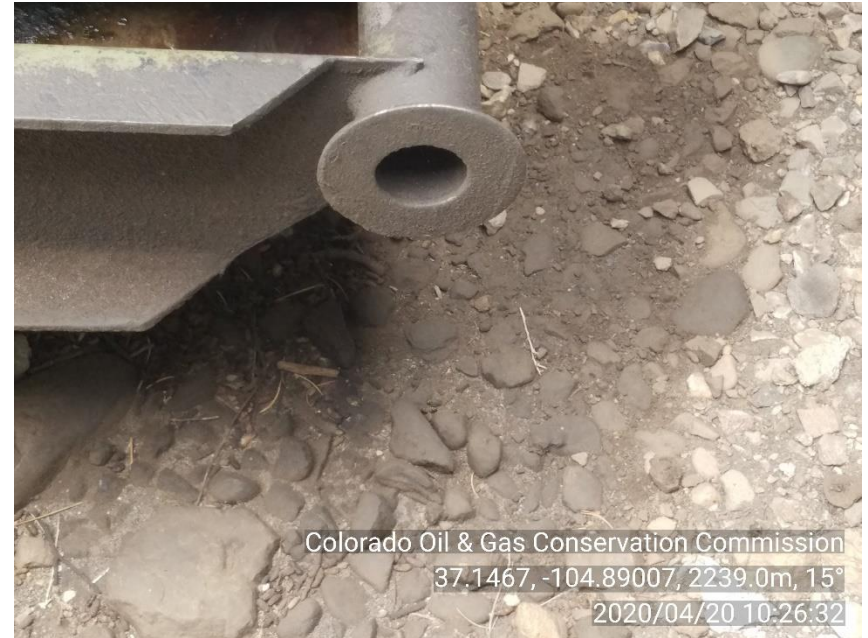
**PHOTO 6: AREA OF IMPACTED SOIL NEAR ENGINE SKID INSIDE SOUND WALLS ON GE 28-07X WELL. **Conduct maintenance on equipment, cleanup stained material and review self inspection processes. THIS IS SECOND NOTICE TO REMOVE IMPACTED SOIL IMMEDIATELY****

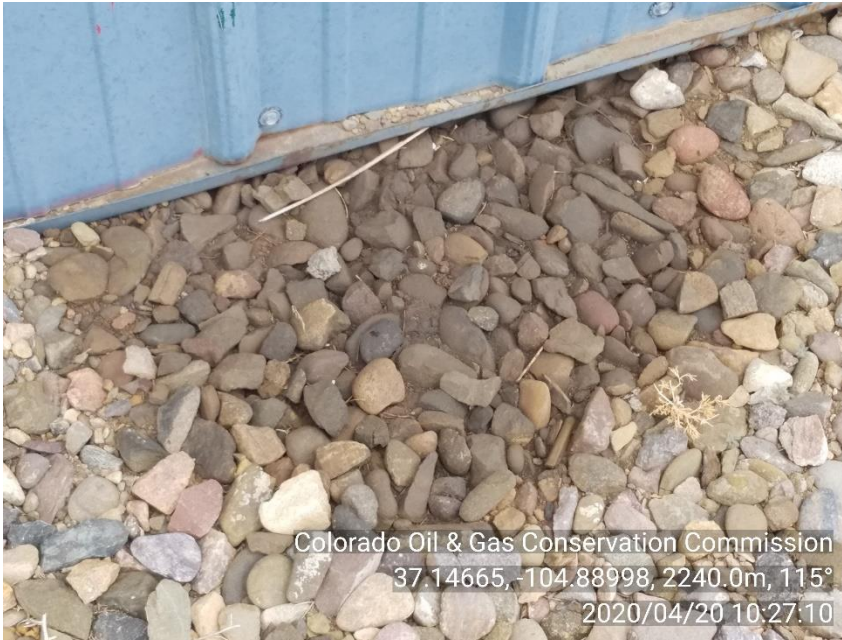
**PHOTO 7: PHOTO 6: AREA OF IMPACTED SOIL NEAR SOUNDWALL ON WEST SIDE OUTSIDE SOUND WALLS ON GE 28-07X WELL. Conduct maintenance on equipment, cleanup stained material and review self inspection processes. THIS IS SECOND NOTICE TO REMOVE IMPACTED SOIL IMMEDIATELY**

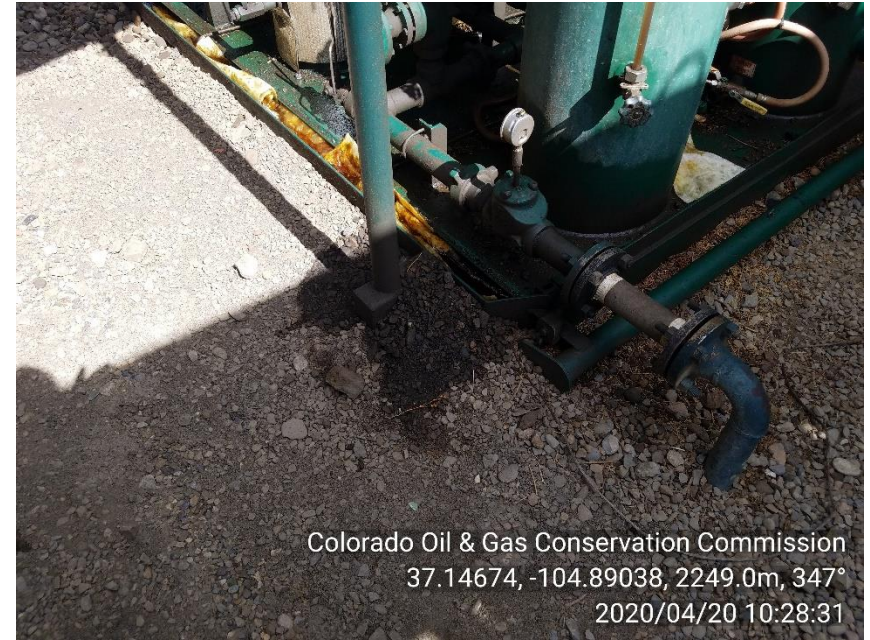
**PHOTO 8: AREA OF IMPACTED SOIL NEAR ENGINE SKID INSIDE SOUND WALLS ON GE 28-07 WELL. Conduct maintenance on equipment, cleanup stained material and review self inspection processes. CA DATE 4-25-20**

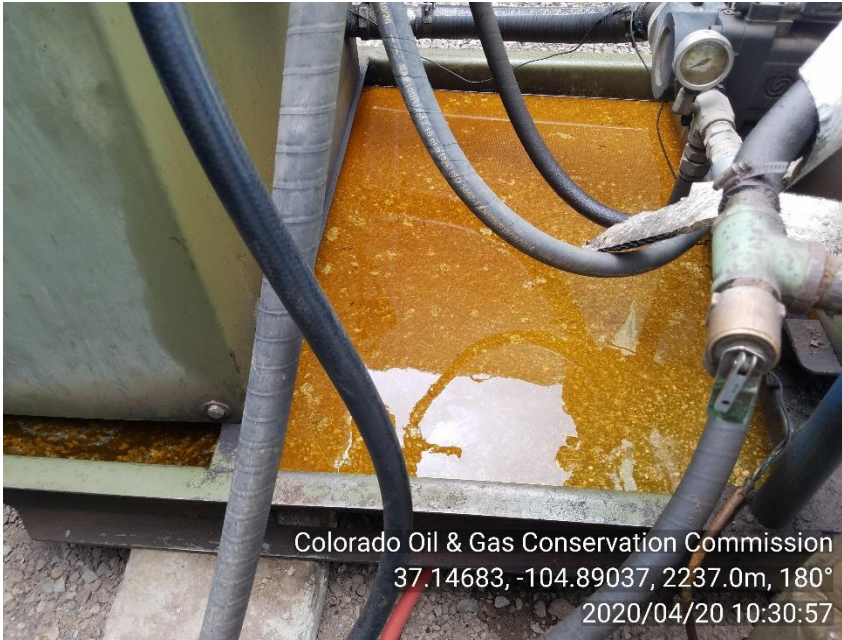
**PHOTO 9: STANDING OILY WATER INSIDE ENGINE SKID ON GE 28-07 WELL. Comply with general provisions of the oil and gas act for wildlife protection. CA DATE 4-30-20**

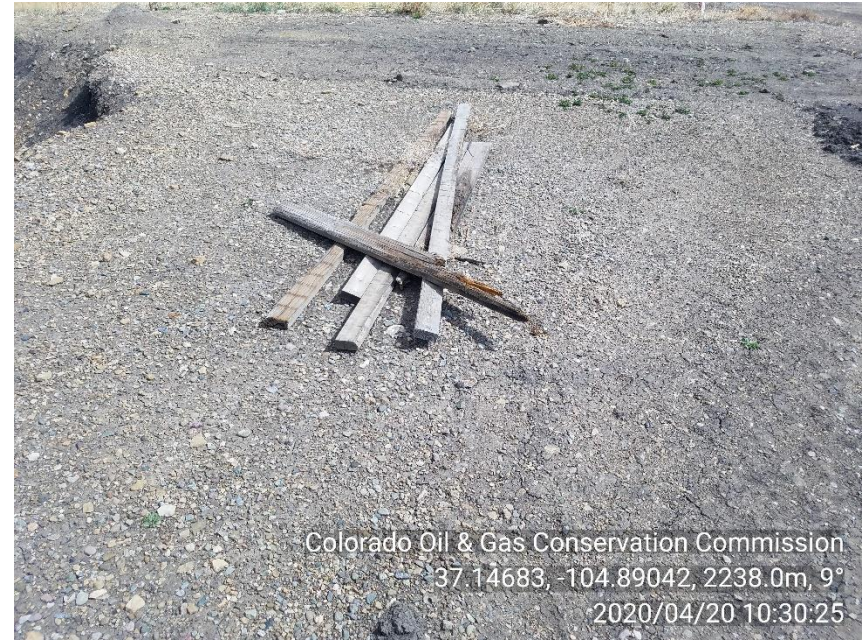
**PHOTO 10: TRASH ON LOCATION NEAR PIT FOR GE 28-07 PIT. COMPLY WITH RULE 603.f. CA DATE 4-27-20**
