Inspection Photos

Location Name: GOLDEN EAGLE 20-7

API#: 05-071-08052

INSP. #: 695102727

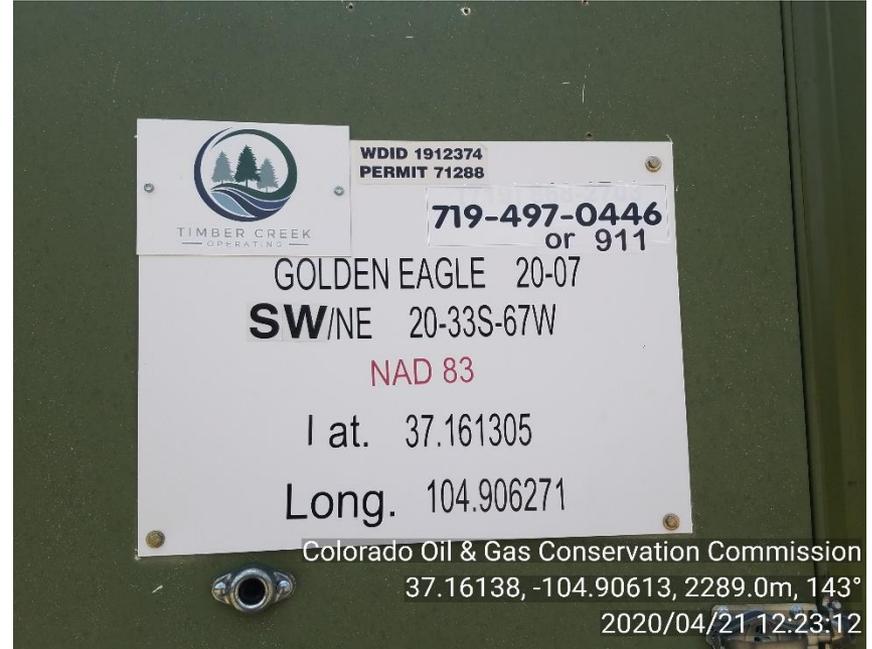
PHOTO 2: WELL SIGN

WDID 1912374  
PERMIT 71288  
**719-497-0446**  
or 911  
GOLDEN EAGLE 20-07  
**SW/NE** 20-33S-67W  
NAD 83  
Lat. 37.161305  
Long. 104.906271

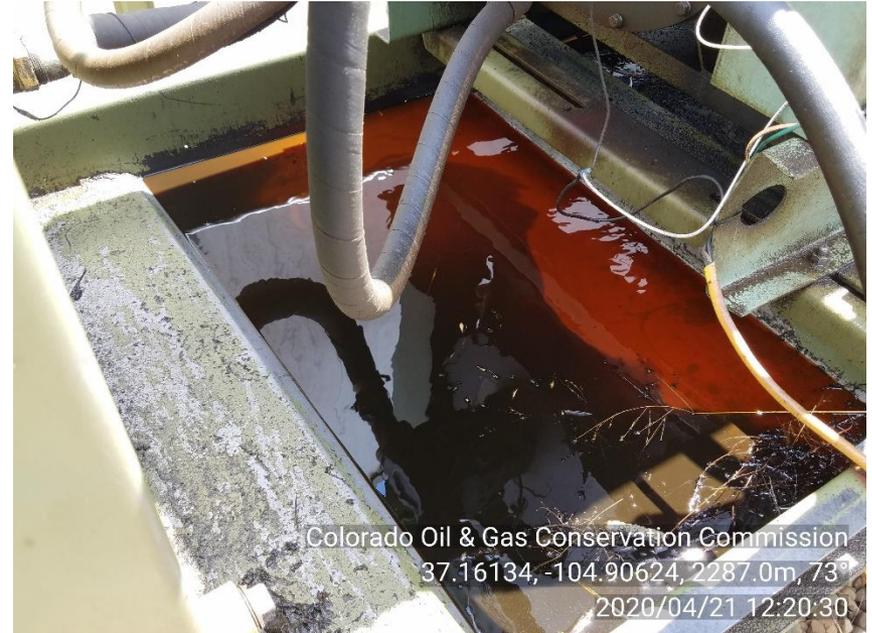
PHOTO 4: STANDING OIL IN ENGINE SKID (APPEARS THAT ENGINE OIL IS BEING DRAINED INTO ENGINE SKID). **Comply with general provisions of the oil and gas act for wildlife protection. CA DATE 5-21-20.**

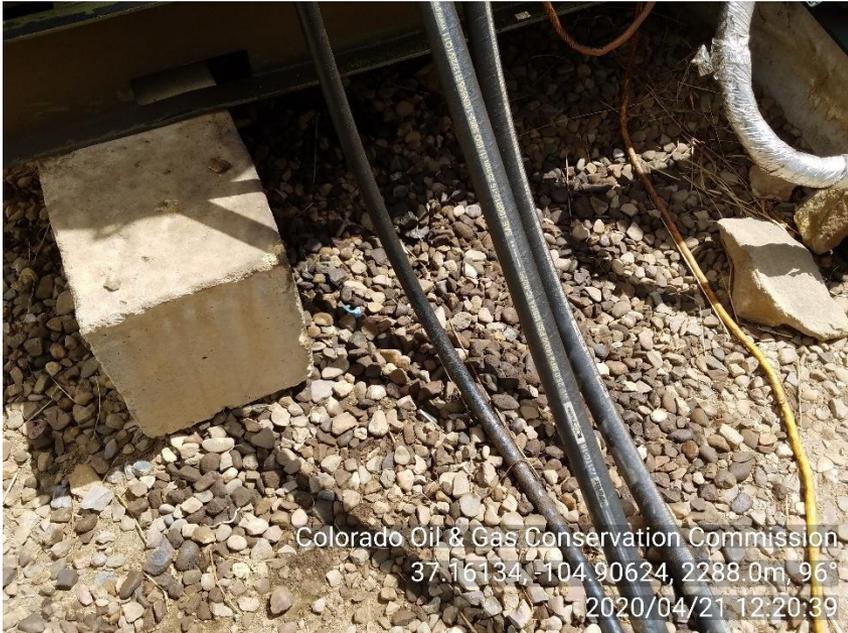
**PHOTO 5: AREA OF IMPACTED SOIL NEAR ENGINE SKID. Conduct maintenance on equipment, cleanup stained material and review self inspection processes. CA DATE 4-26-20.**

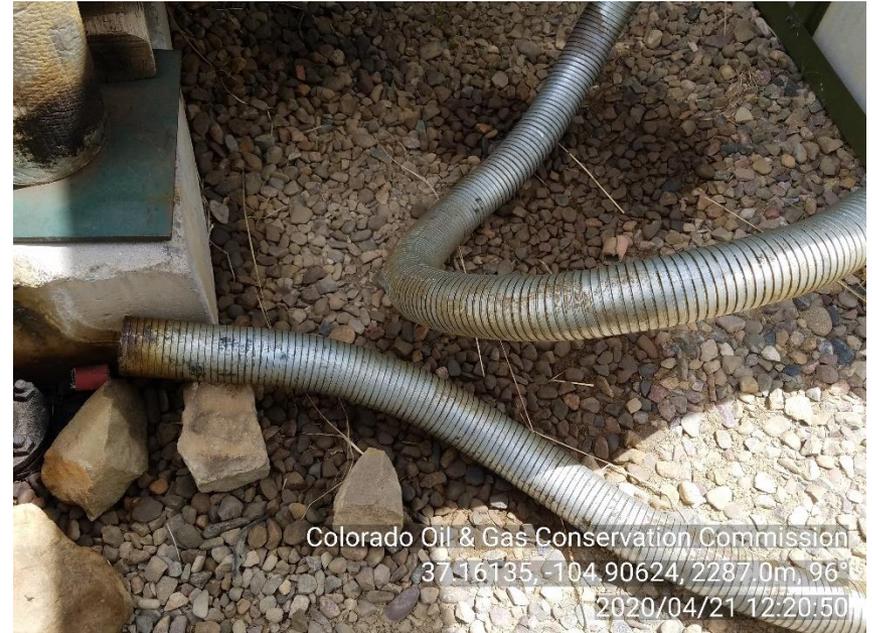
**PHOTO 6: AREA OF IMPACTED SOIL NEAR ENGINE SKID. Conduct maintenance on equipment, cleanup stained material and review self inspection processes. CA DATE 4-26-20.**

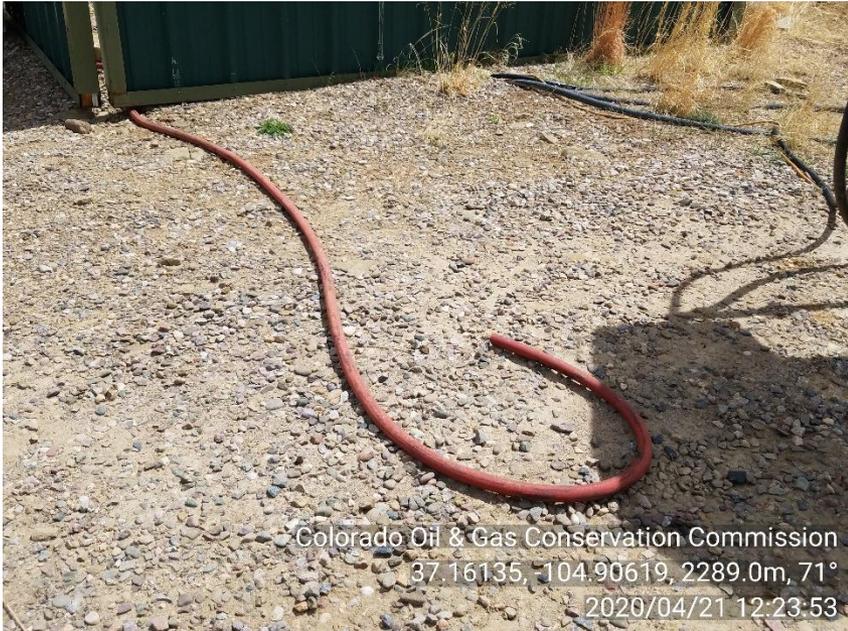
**PHOTO 7: UNUSED EQUIPMENT STORED ON LOCATION. COMPLY WITH RULE 603.f. CA DATE 5-6-20**

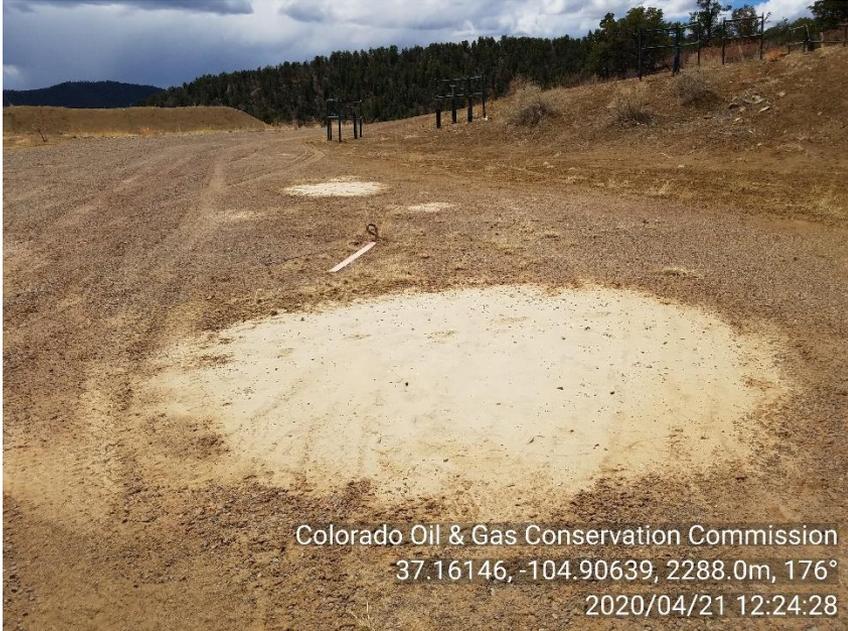
**PHOTO 9: APPEARS TO BE TWO PILES OF FRAC SAND ON LOCATION. Immediately comply with material handling and guidance per MSDS or product data sheet. Submit document, procedures, and waste disposal manifest to COGCC field inspector. CA DATE 5-1-20**

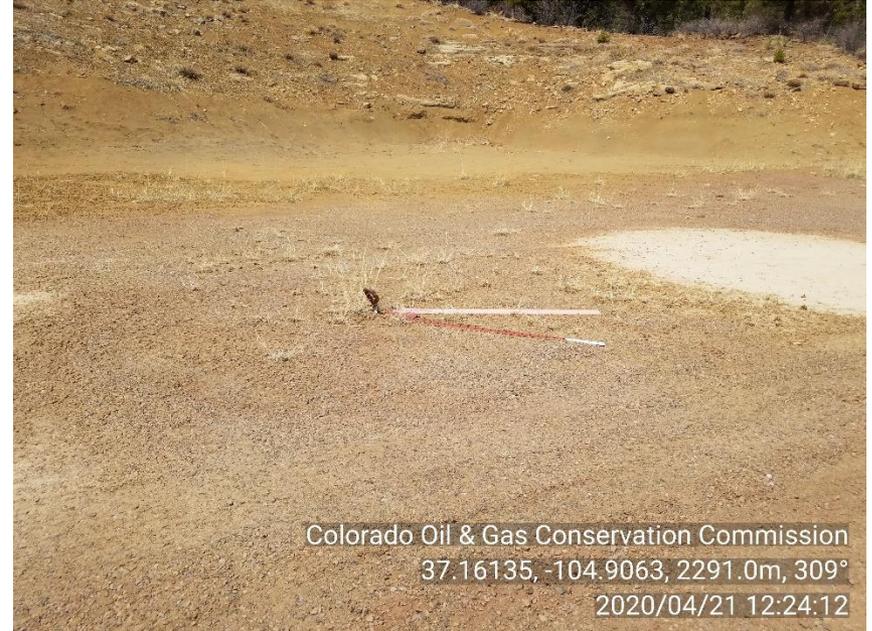
**PHOTO 10: GUY LINE ACHOR MARKER IS DOWN. Install proper guy line markers per Rule 1003.a CA DATE 5-5-20**
