Inspection Photos

Operator: BAYSWATER EXPLORATION &
PRODUCTION LLC - 10261

Location ID: 315536

Rio Blanco County, CO

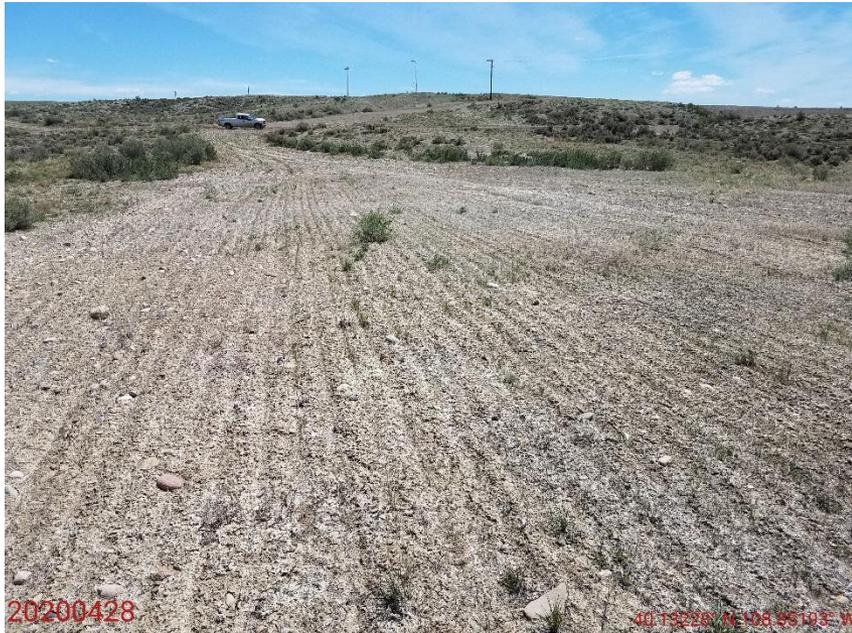
Photo 1: Photo taken from the north end of the Location, facing east. Photos 1-3 provide an overview of the reclamation from east, to south to west.

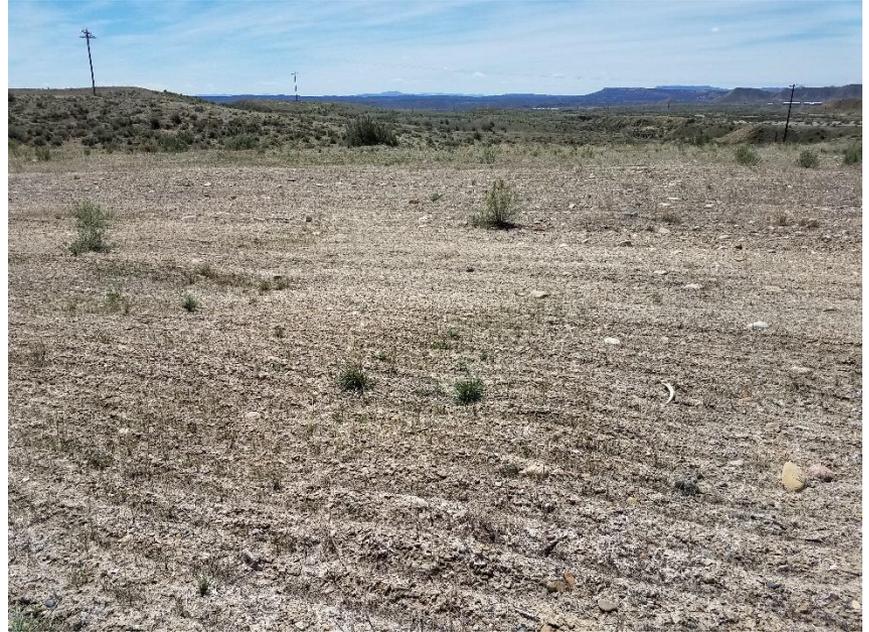
Photo 2: See comments under photo 1.

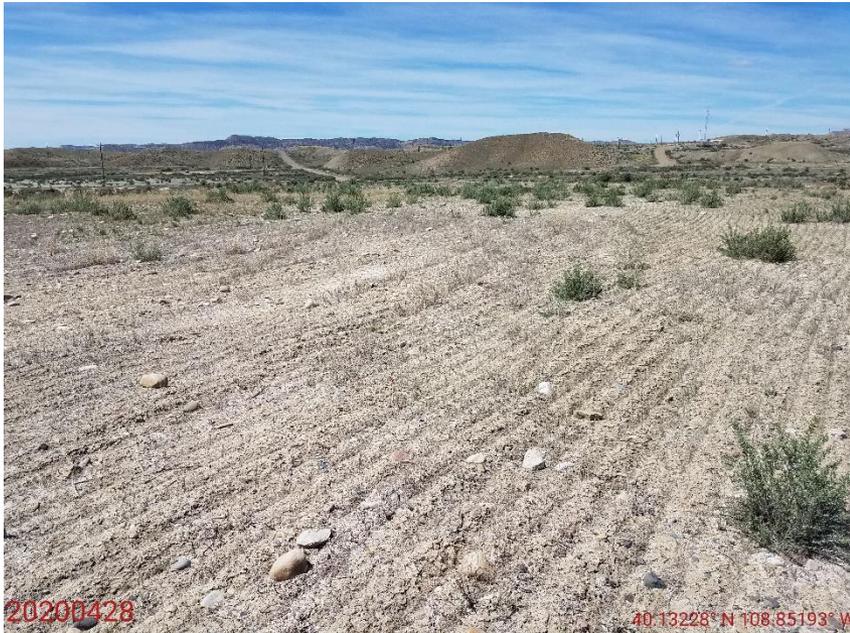
Photo 3: See comments under photo 1.

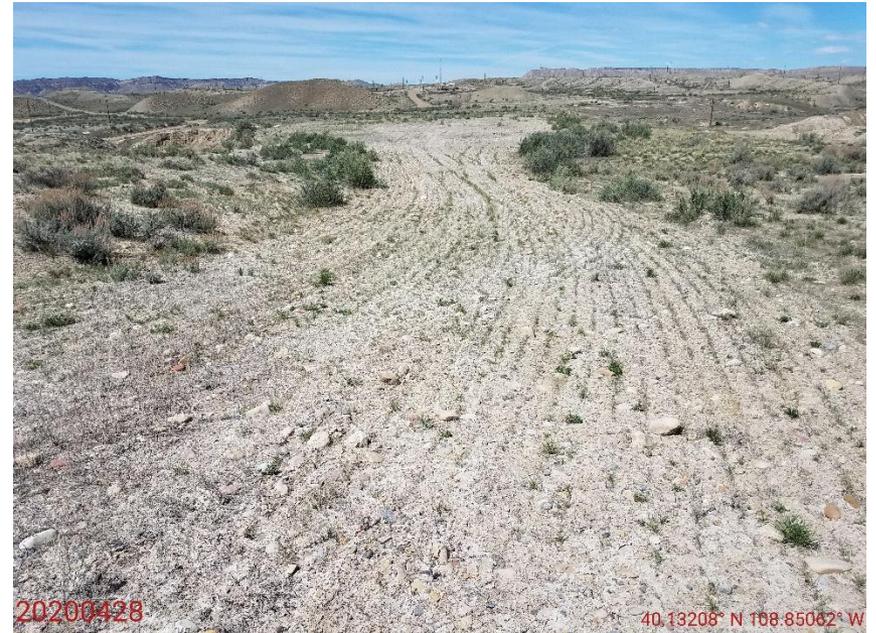
Photo 4: Photo taken from the access road, facing west. Photo shows reclamation in process.

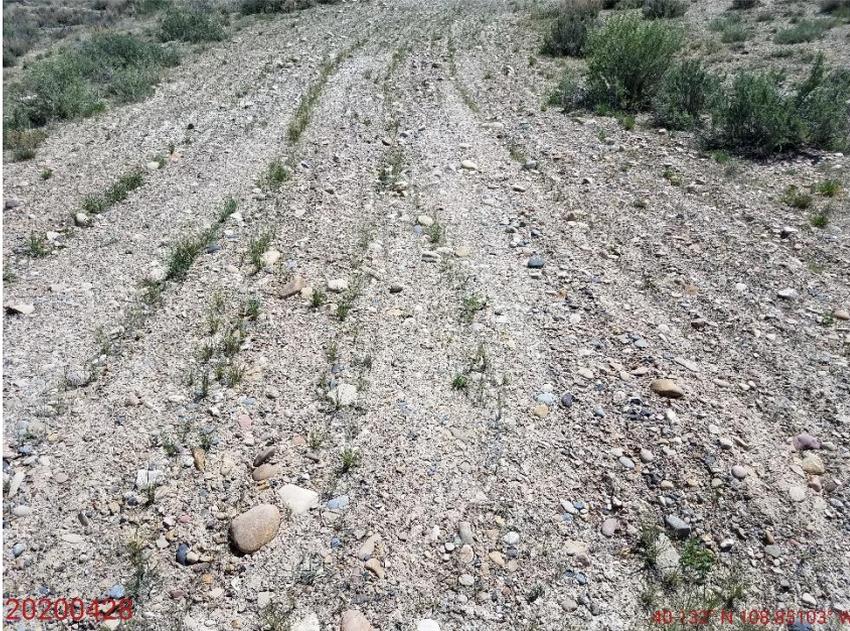
Photo 5: Photo taken from the access road. Photo shows road base/rock material on the access road; material may not be conducive to reclamation. If it is determined that the rock material is hindering vegetative establishment, a corrective action will be applied for it's removal per 1004.a

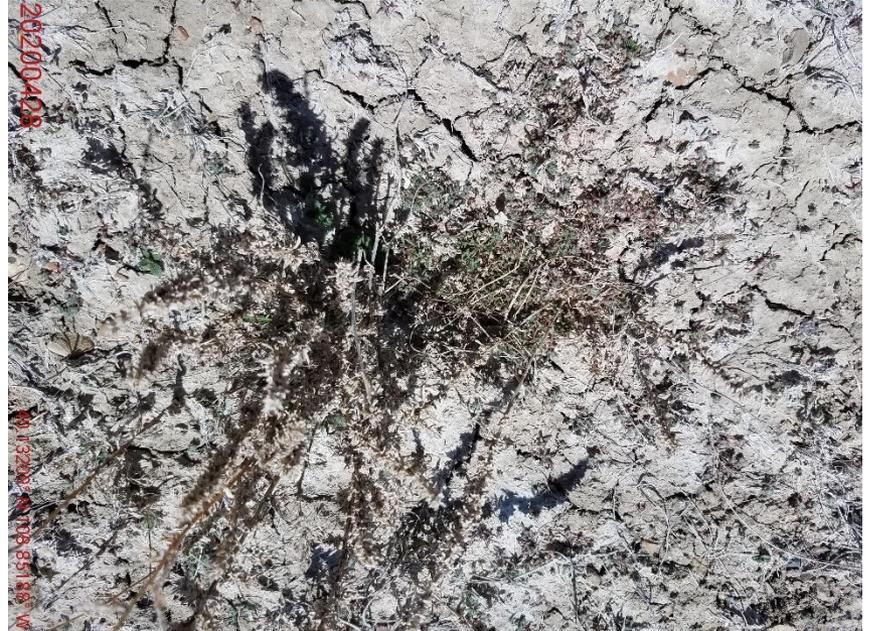
Photo 6: Photo taken from the Location. Photo shows a remnant Halogeton plant from the 2019 growing season. Photo shows what appears to be Halogeton plant germination occurring. Due to the early timing of the growing season, and difficulty distinguishing young halogeton plants from other weedy species (e.g. Russian Thistle), a follow up inspection will need to be conducted when vegetation growth has progressed to allow accurate identification, and to determine compliance with 1004.e
