Inspection Photos

5/04/2020

Operator: TEP ROCKY MOUNTAIN LLC - 96850

Location ID: 335106

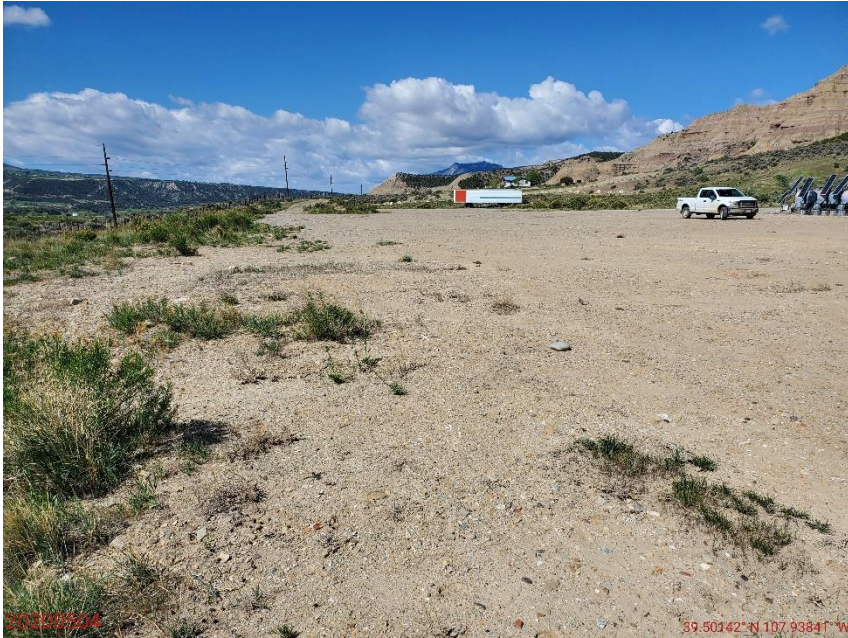
Photo 1: Photo taken from the southeast end of the Location, facing west. Photos 1-2 provide an overview of the Location from west, to north.

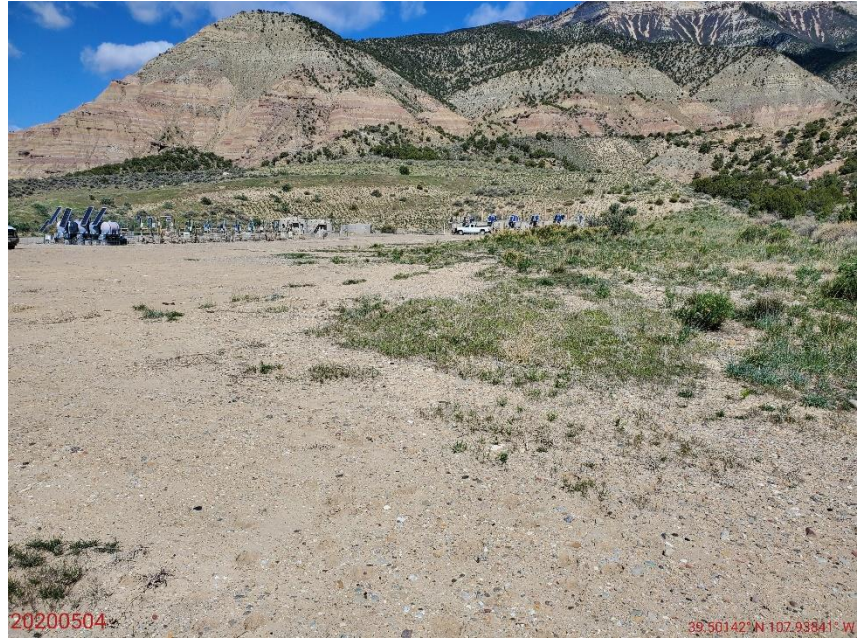
Photo 2: See comments under photo 1.

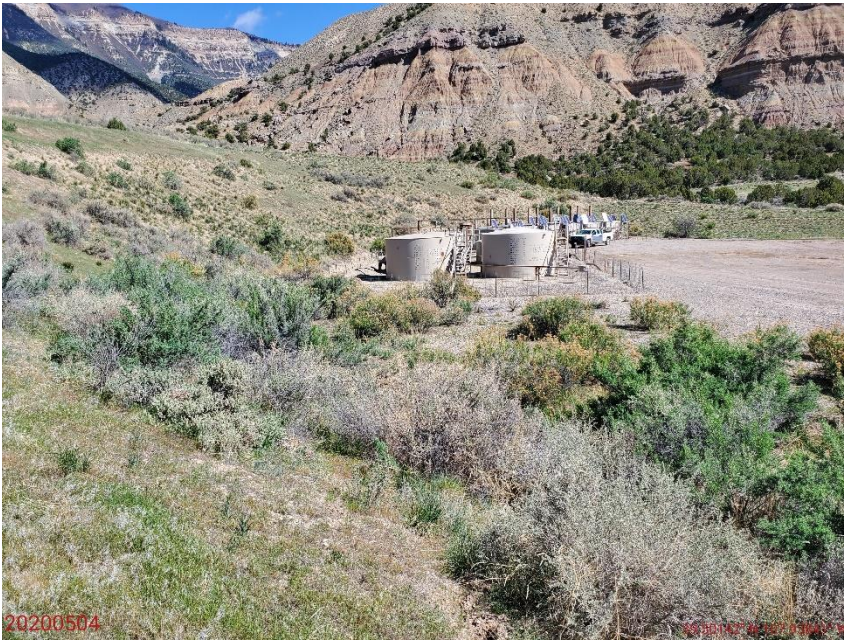
Photo 3: Photo taken from the northwest area of the Location, facing northeast. Photos 3-5 provide an overview of the Location from northeast, east, south, to southwest.

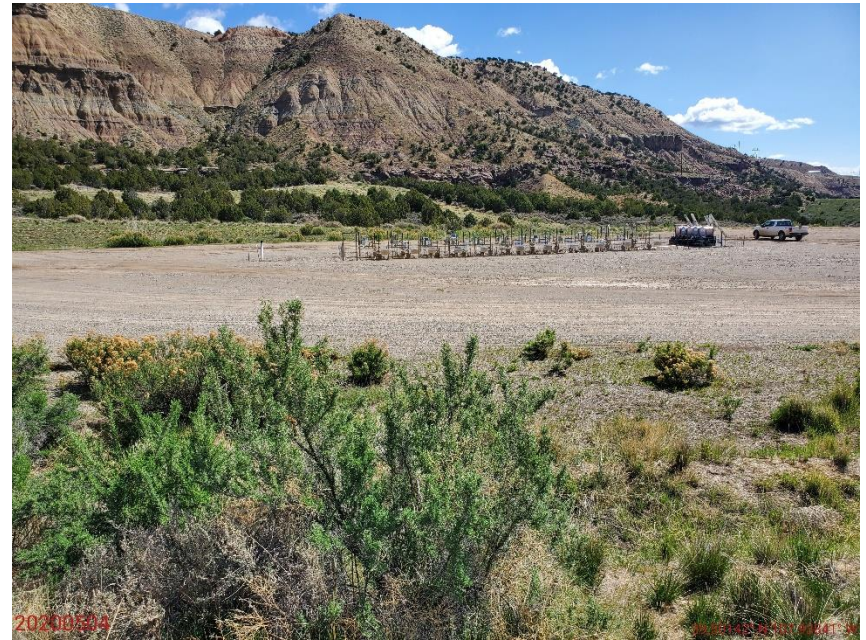
Photo 4: See comments under photo 3.

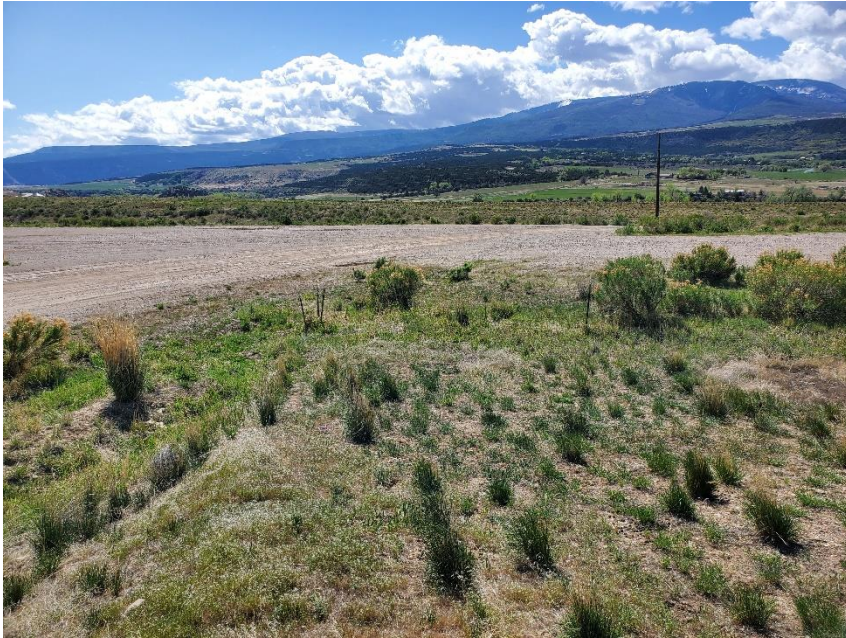
Photo 5: See comments under photo 3.

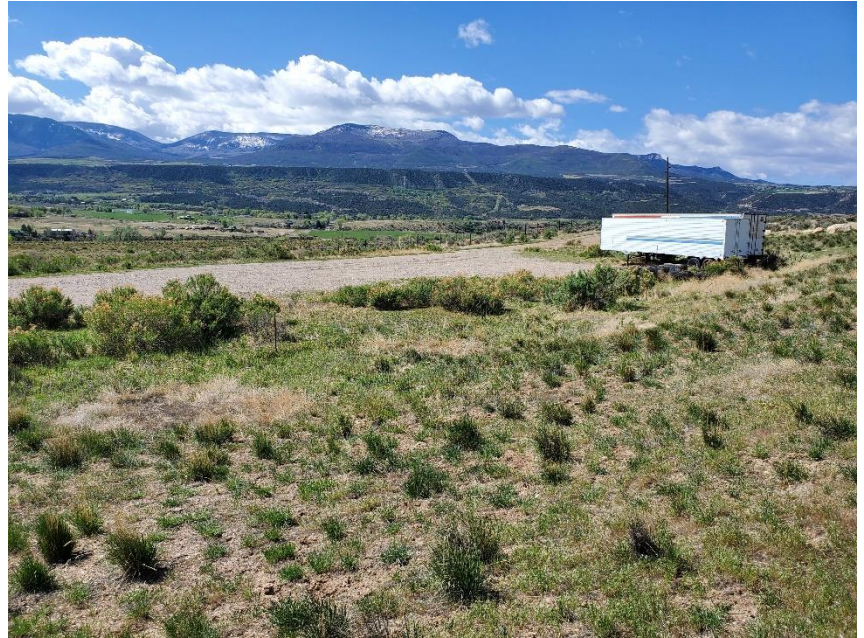
Photo 6: See comments under photo 3. Photo also shows areas on the west end of the Location not needed for production where equipment/vehicles/supplies not necessary for use on the lease is being stored. Areas require reclamation pursuant to Rule 1003.b.

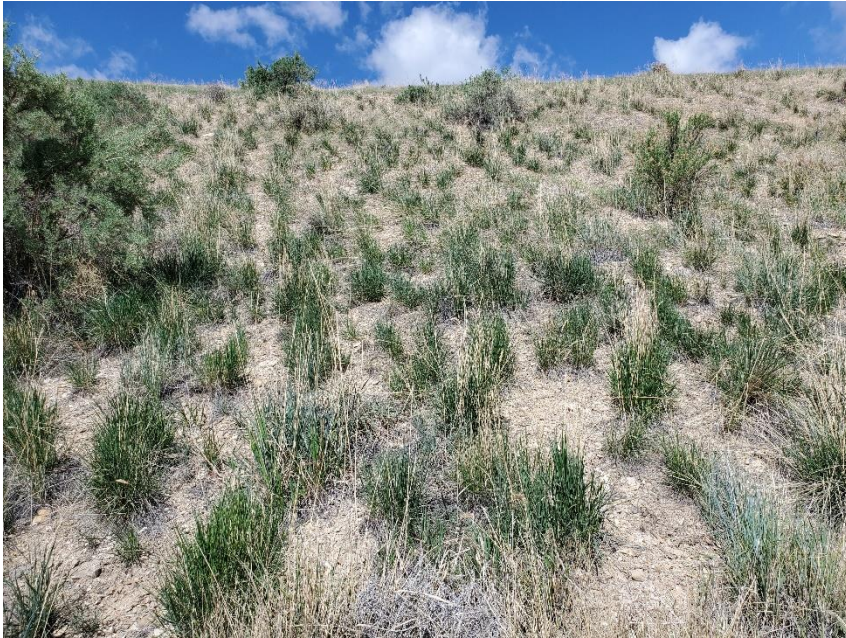
Photo 7: Photo taken from the slopes on the north end of the Location. Photo shows desirable vegetative establishment on the interim areas.

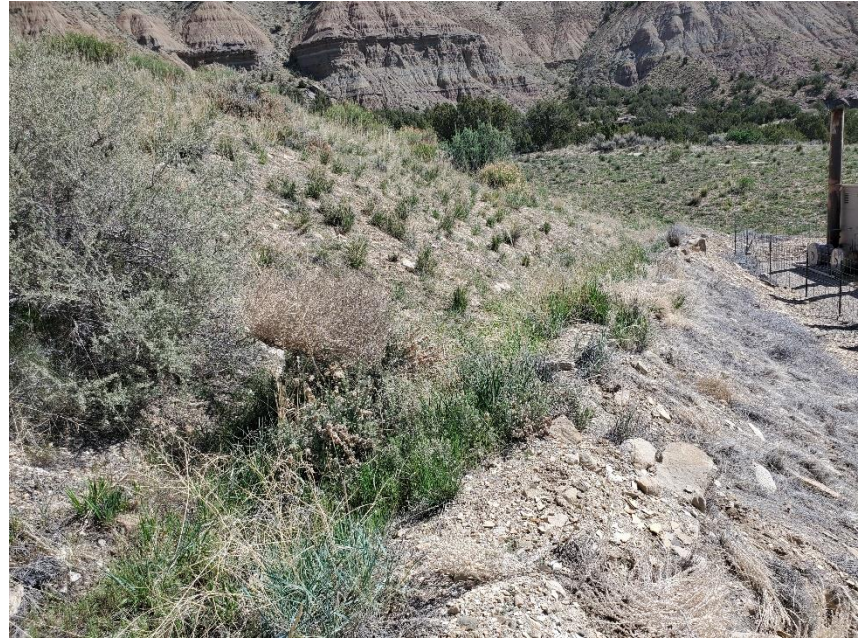
Photo 8: See comments under photo 7. Photo also shows stormwater diversion ditch.

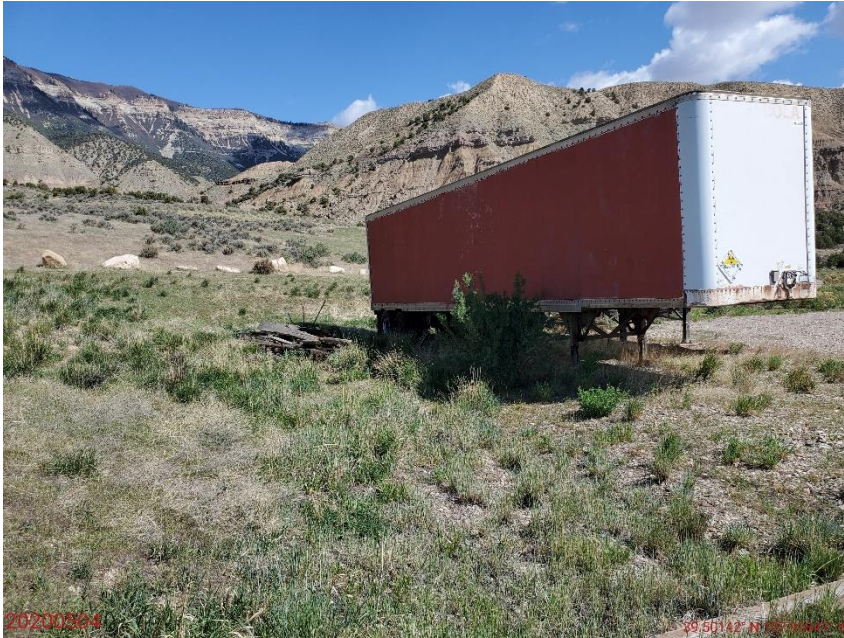
Photo 9: Photo taken from the west end of the Location, facing northeast. Photo shows areas not needed for production, where equipment/vehicles/supplies not necessary for use on the lease is being stored.

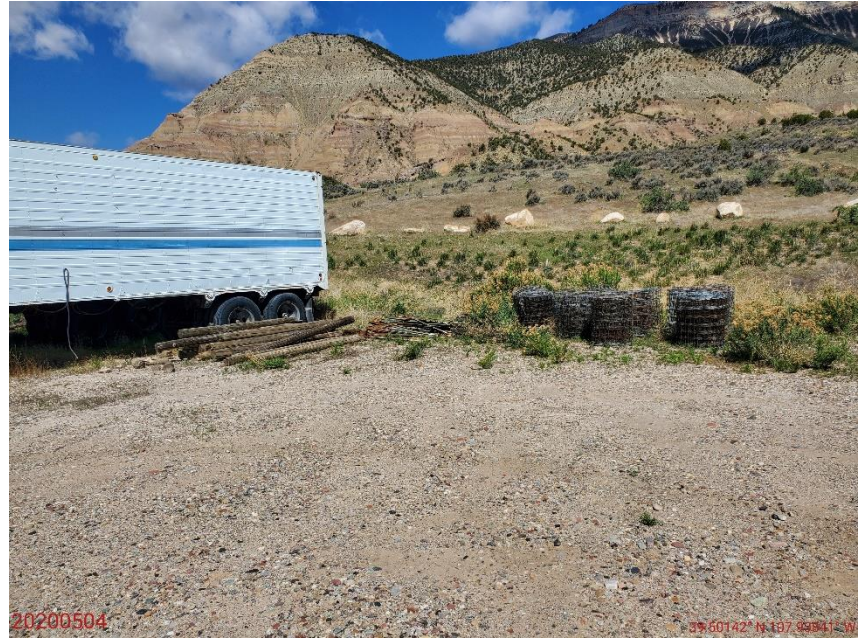
Photo 10: Photo taken from the west end of the Location, facing northwest. See comments under photo 9.
