Final Reclamation Inspection

Operator: NOBLE ENERGY INC - #100322

Location ID: 322664

Inspection Photos
Location Name: WILLMAN-H #41-16
Location ID: 322664

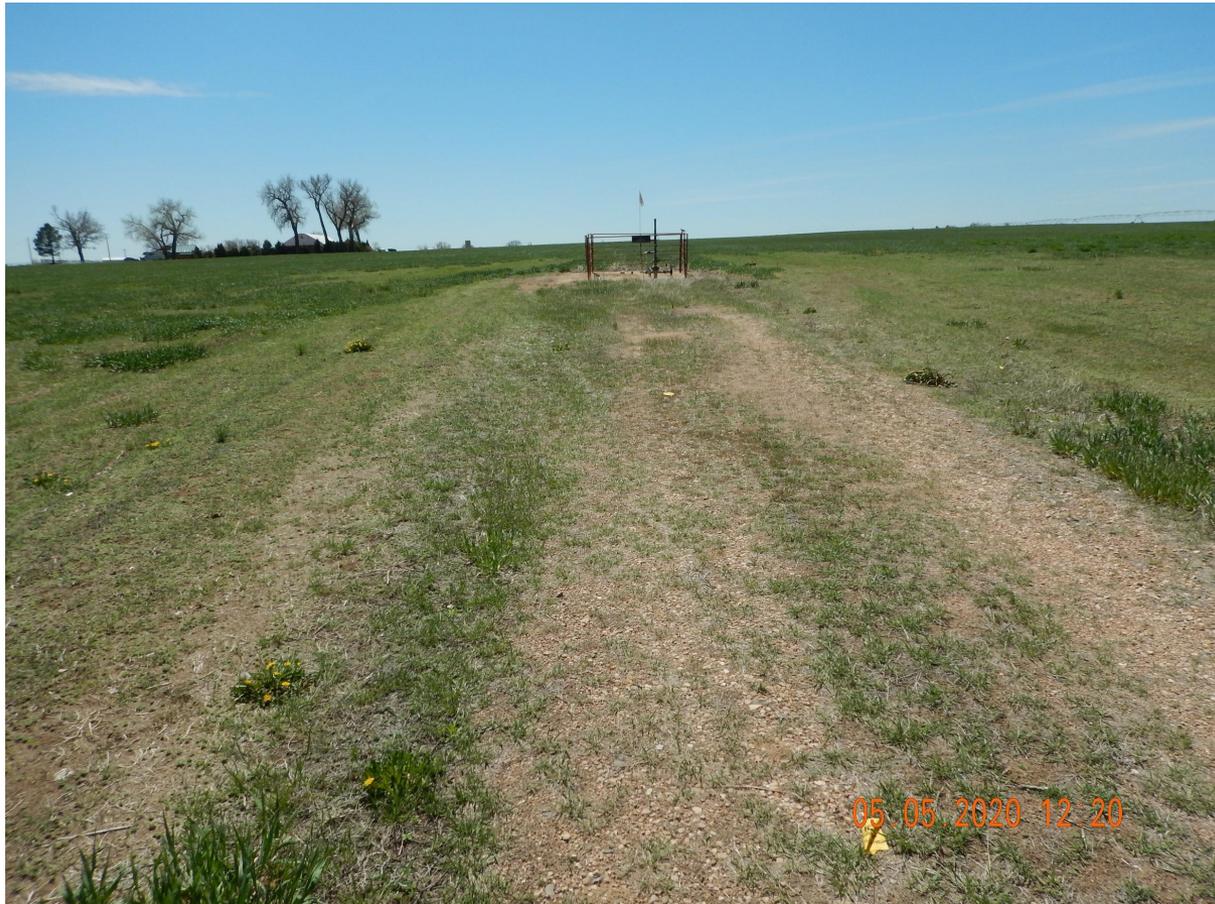
Photo 1. Photo taken north of the well location, facing South. Photo illustrates a TA well which is part of a variance waiving the requirements for a MIT. Photo also illustrates much of the low growing vegetation is that of Kochia- see Photo 3.

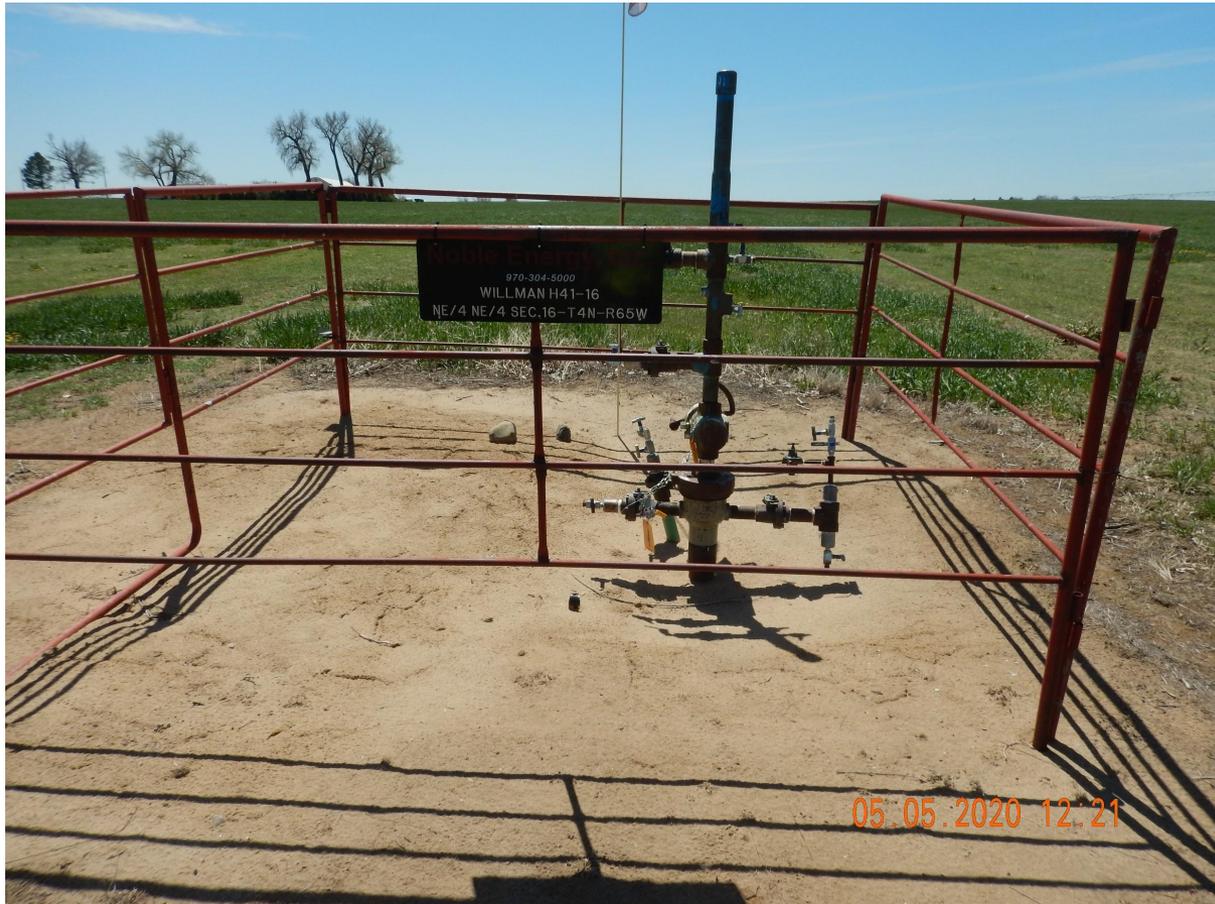
Photo 2. Photo taken of the TA well, facing South. Photo illustrates the TA well appears to be locked out and tagged per the variance.

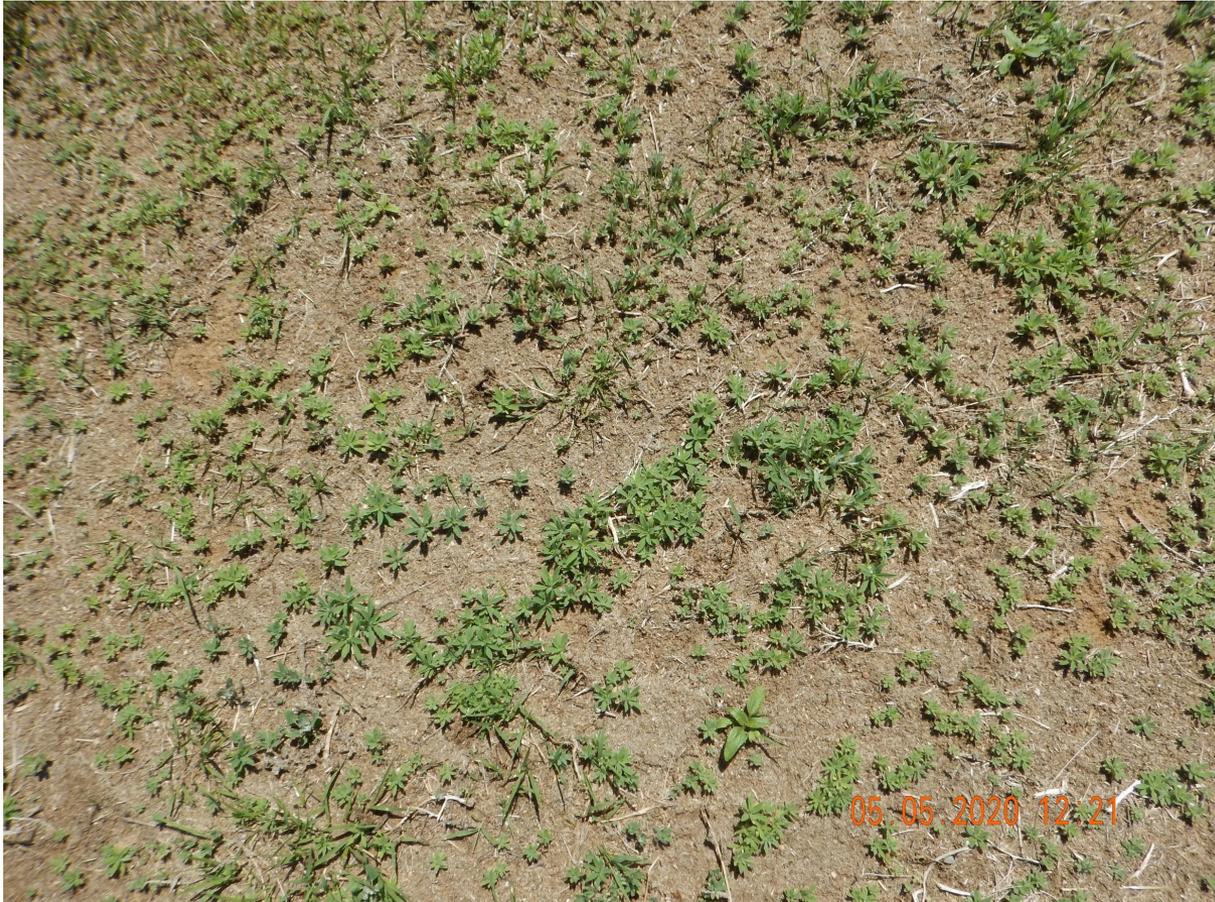
Photo 3. Close-up photo taken from around the well. Photo illustrates Kochia rosettes that will have to be managed in the future.

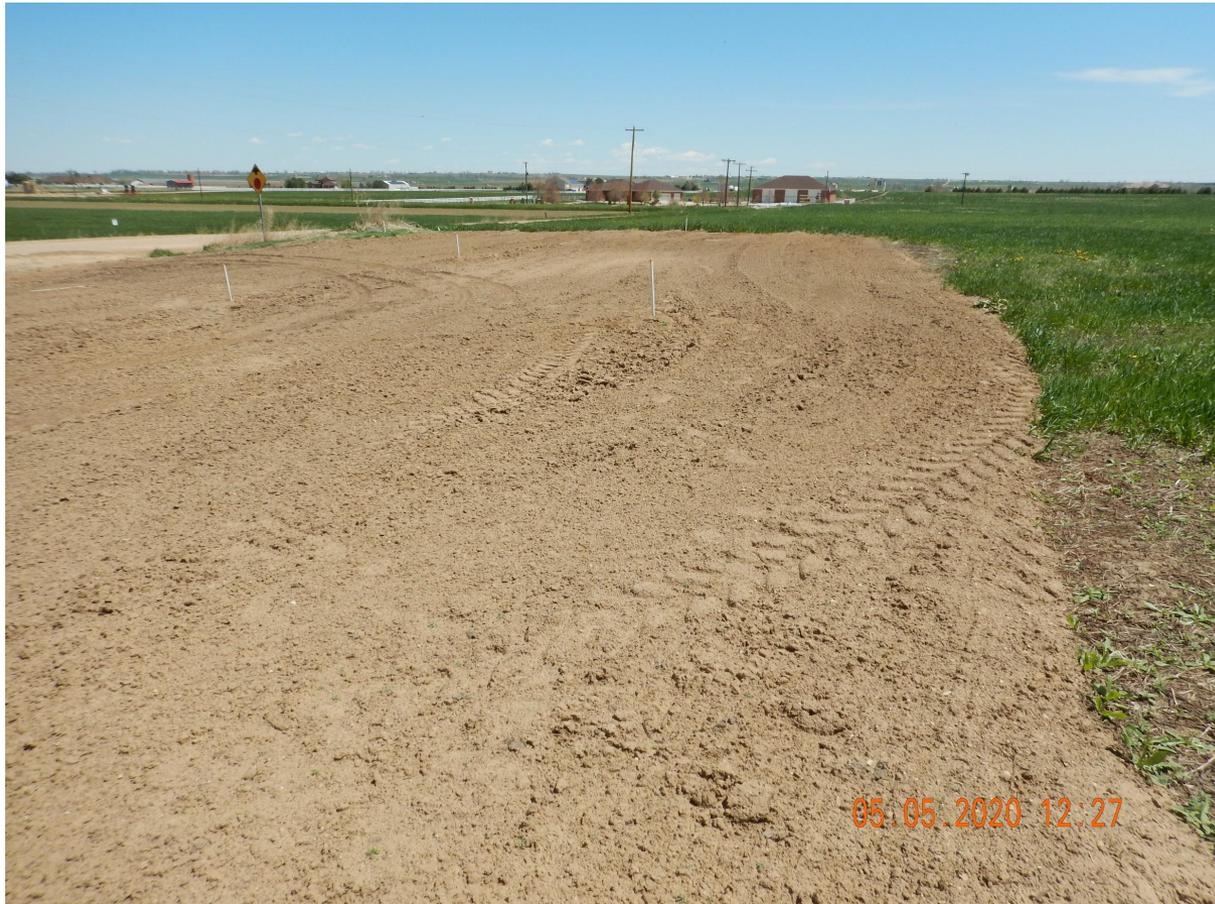
Photo 4. Photo taken from the associated offsite tank battery, facing East. Photo illustrates Operator has performed some of the final reclamation requirements (i.e., remove gravel). However, there was very little germination of desirable species; therefore, it does not appear the tank battery has been seeded. Also, there is an active remediation.

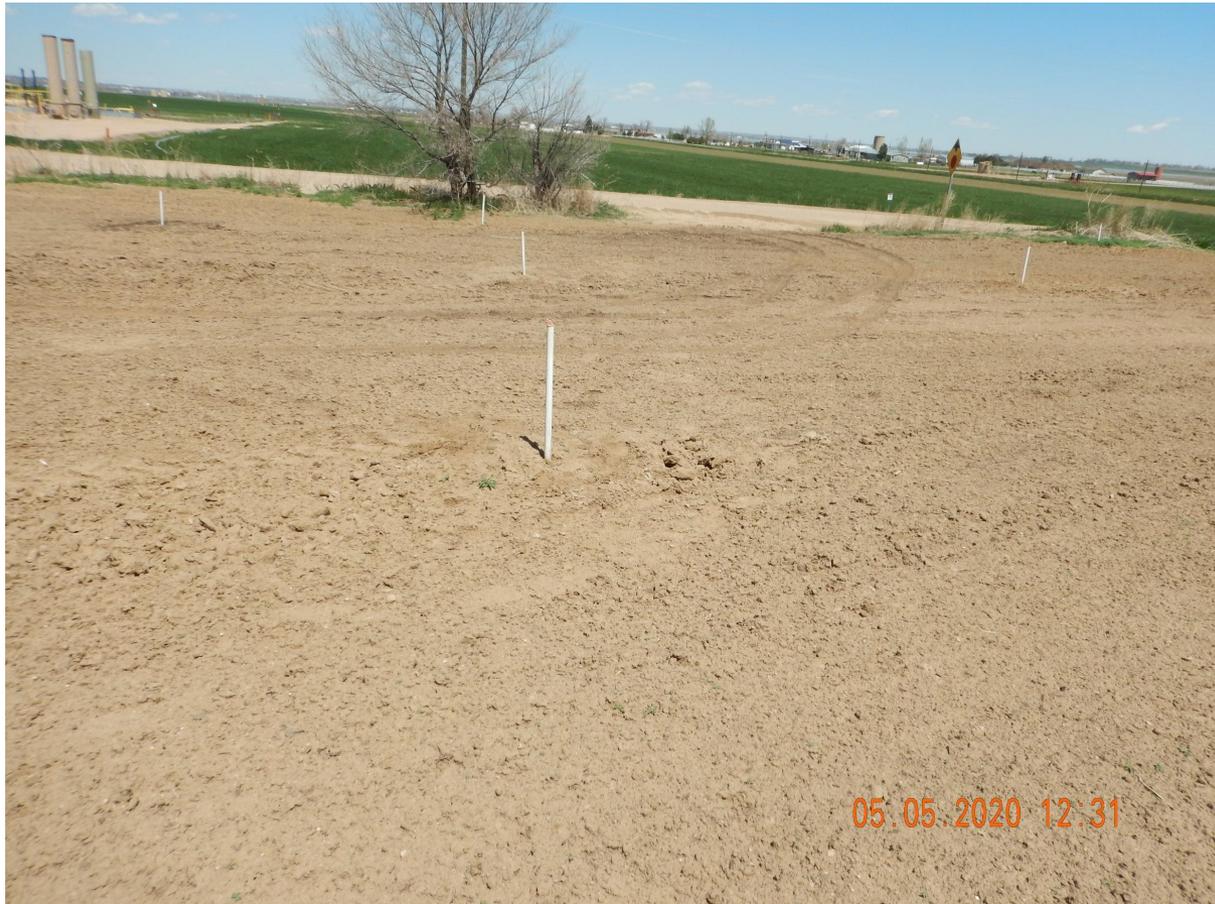
Photo 5. Photo taken from the associated offsite tank battery, facing North. Photo illustrates vehicle traffic. Operator should consider temporarily fencing off the area as this is not stabilized and to help promote successful vegetation establishment to stabilize the area.
