Inspection Photos
Operator: BP America
API#: 067-07546
Date: 5/5/2020

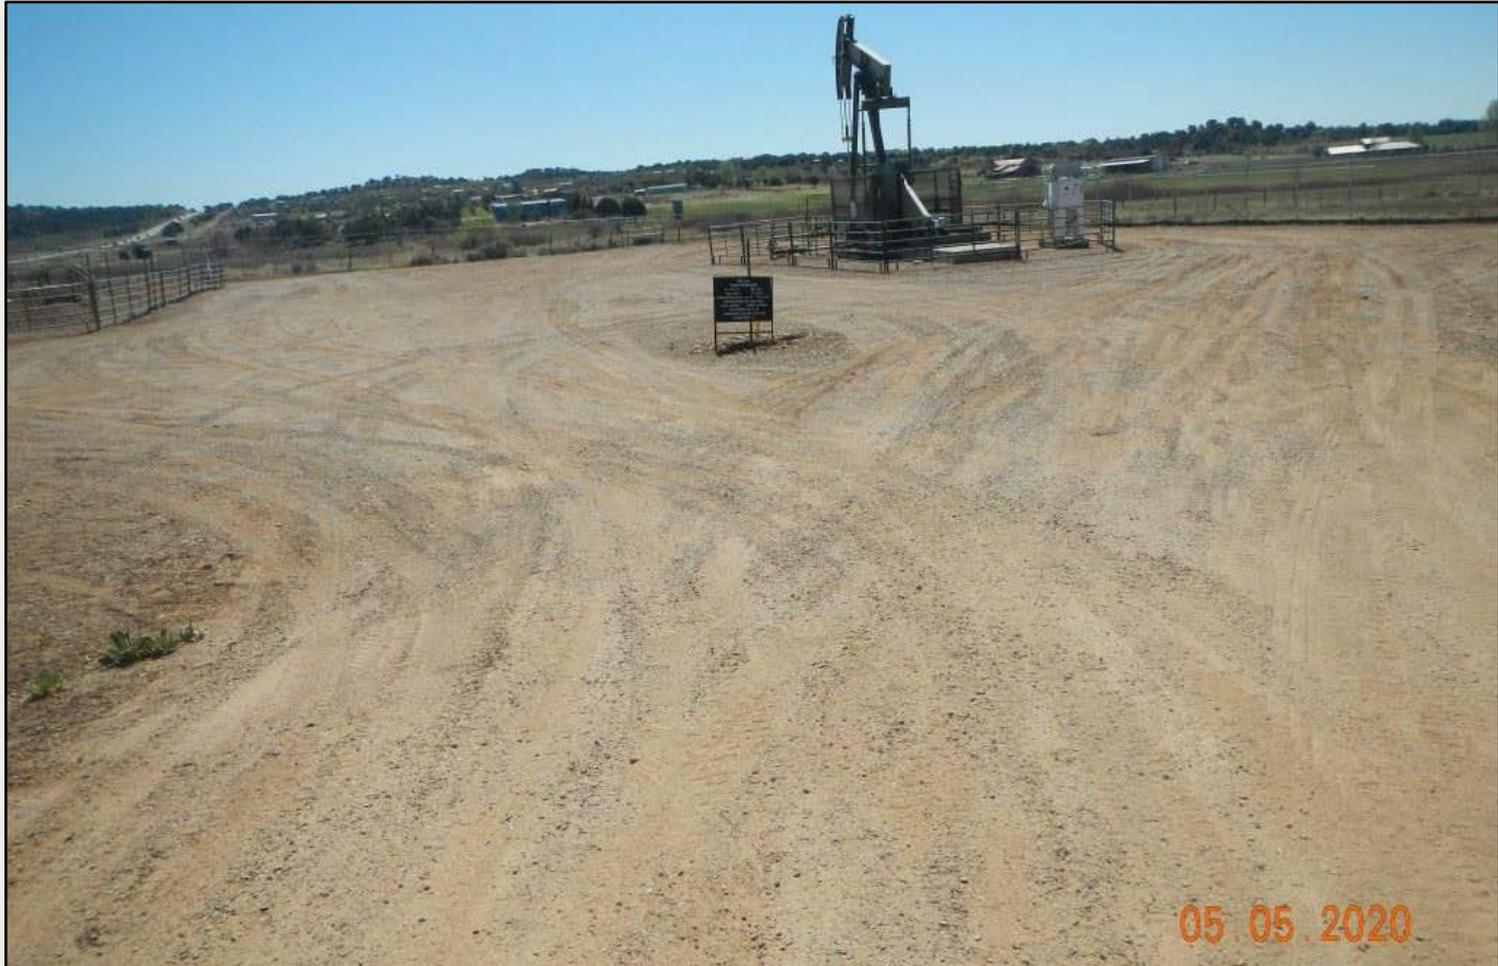
Photo 1. View of the project area from the well pad entrance facing center.

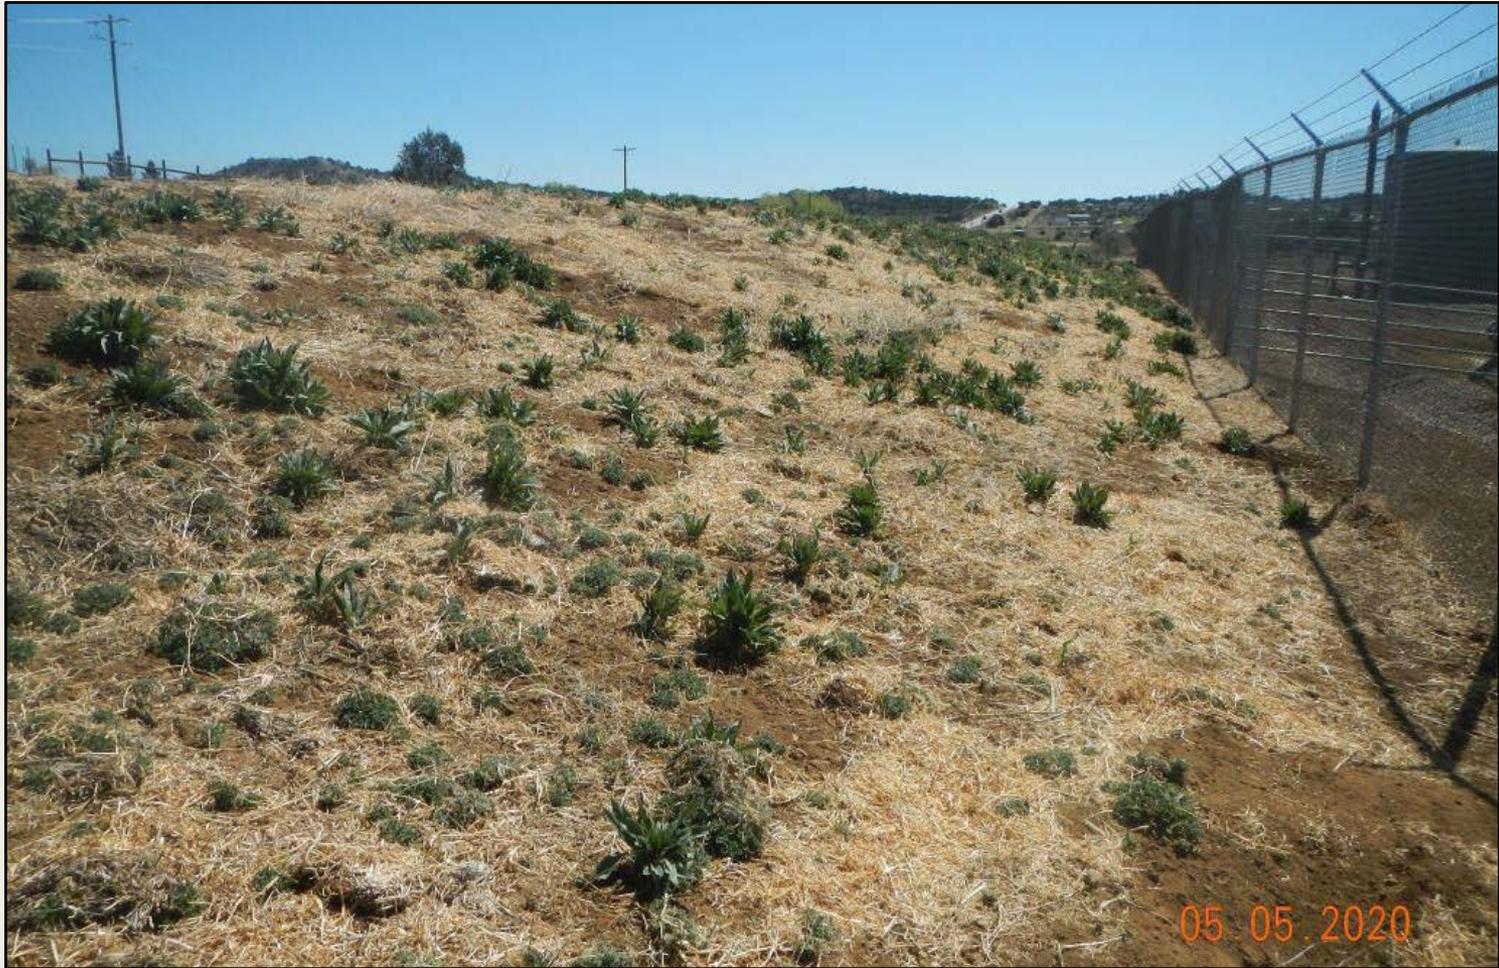
Photo 2. View of the northern project area from the northwestern corner facing eastward. Cut-slope appears to be seeded and straw mulch observed on slope. Dense houndstongue weeds present.

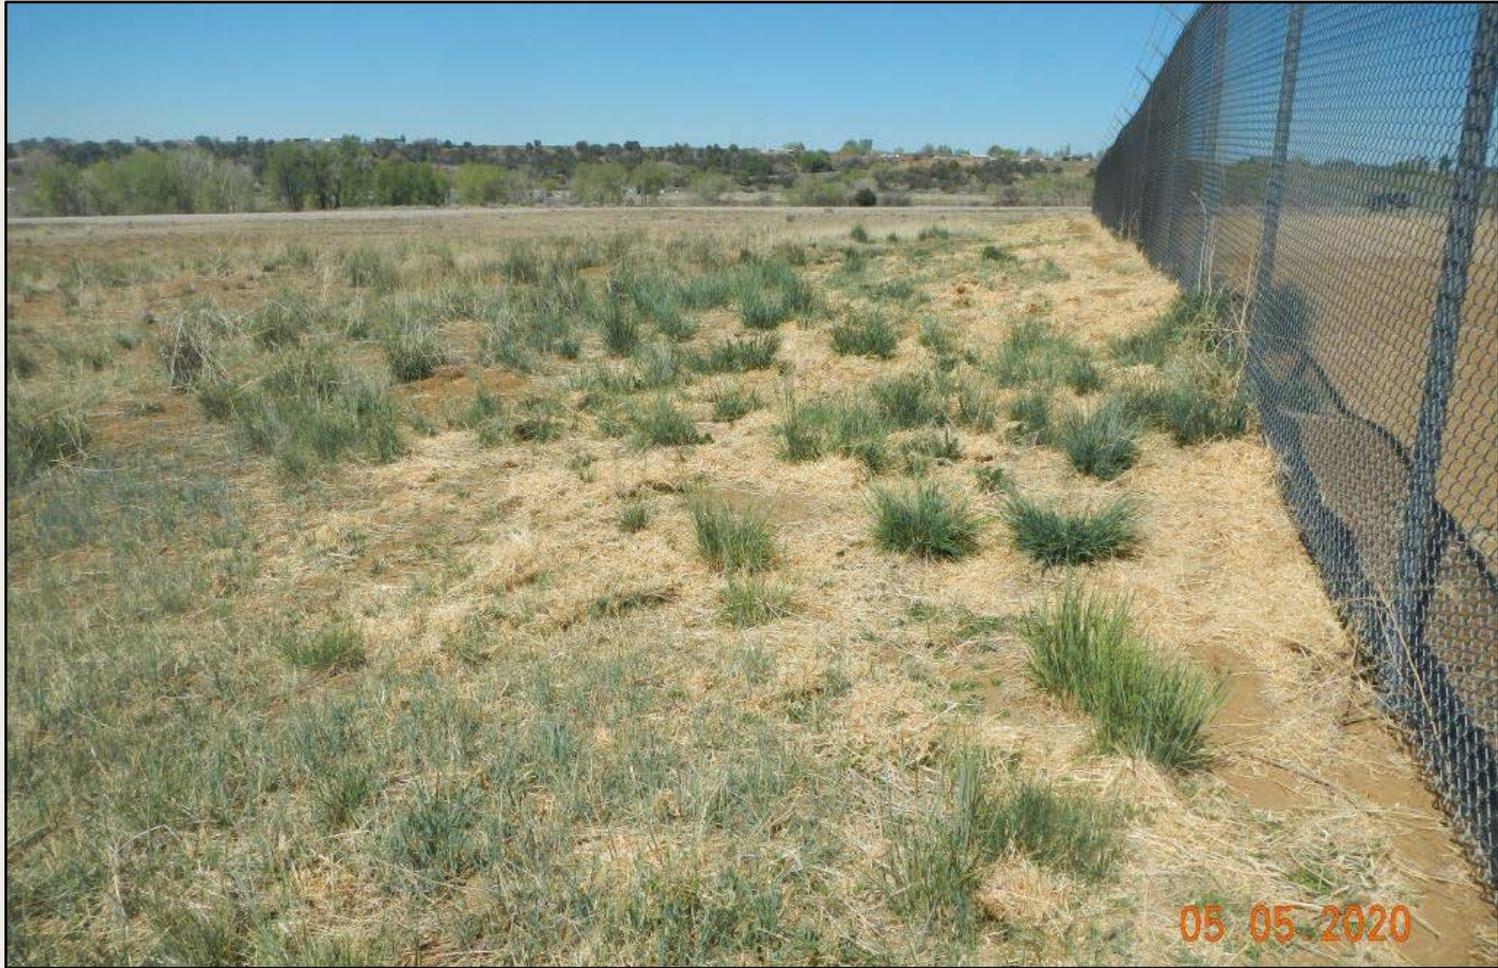
Photo 3. View of the southern project area from the southeastern edge facing westward. Grasses appear to be progressing here with straw mulch present and seedlings observed.

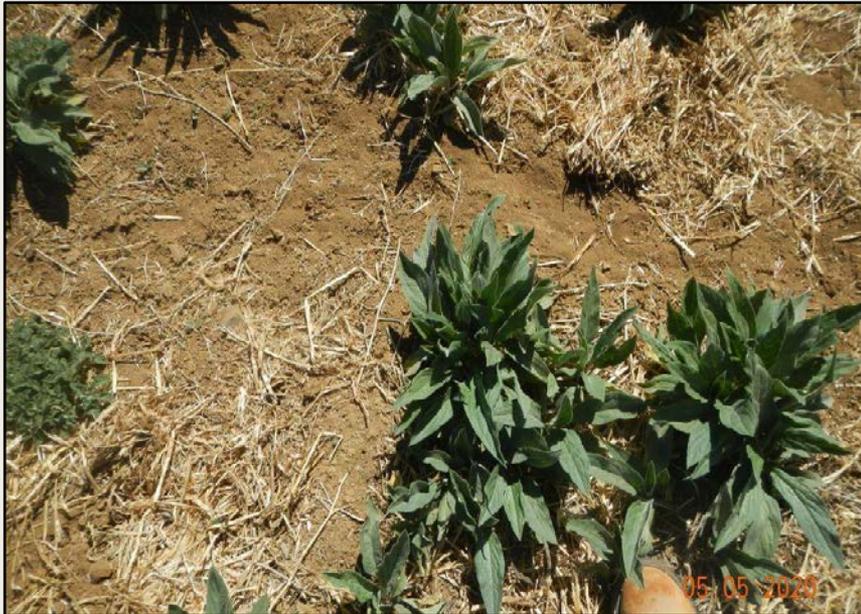
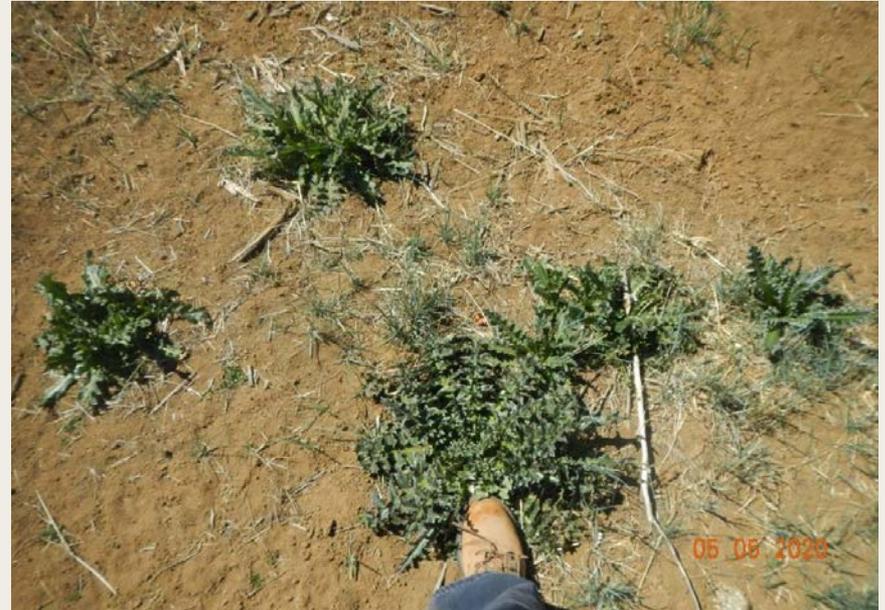
Photos 4/5. View of houndstongue and musk thistles observed within the project area, respectively from left and right. Approximately 500 houndstongue and 50 musk thistles present.

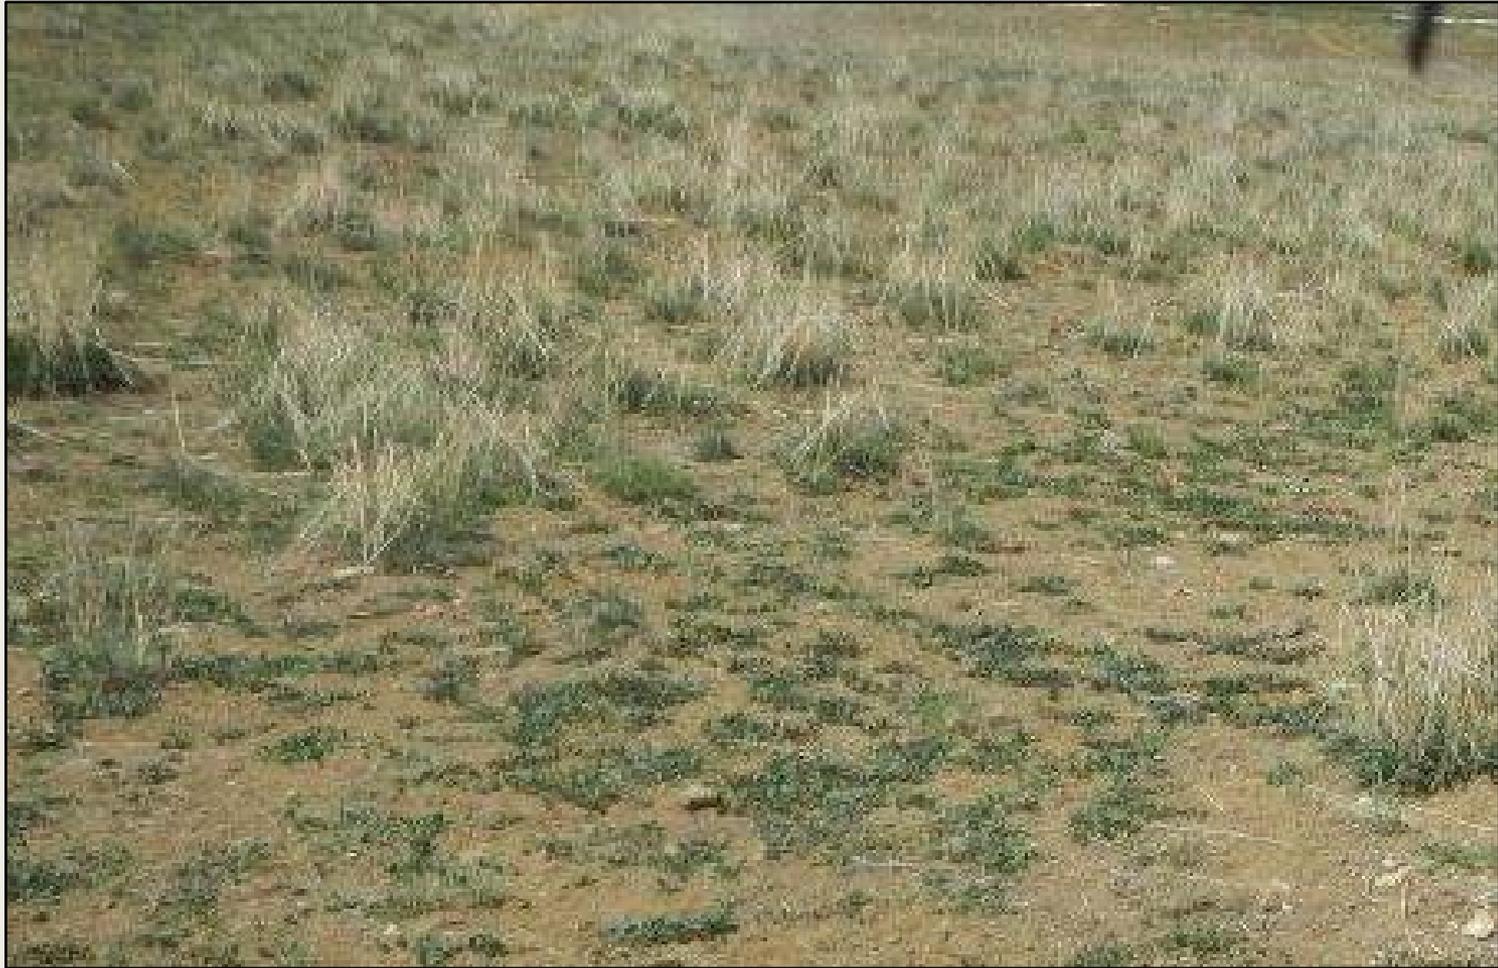
Photo 6. View of reference area open grass field, comprised of intermediate wheatgrass.
