Inspection Photos

API: 055-06256

Operator: PETROGLYPH OPERATING CO

Inspection Date: 5/4/2020

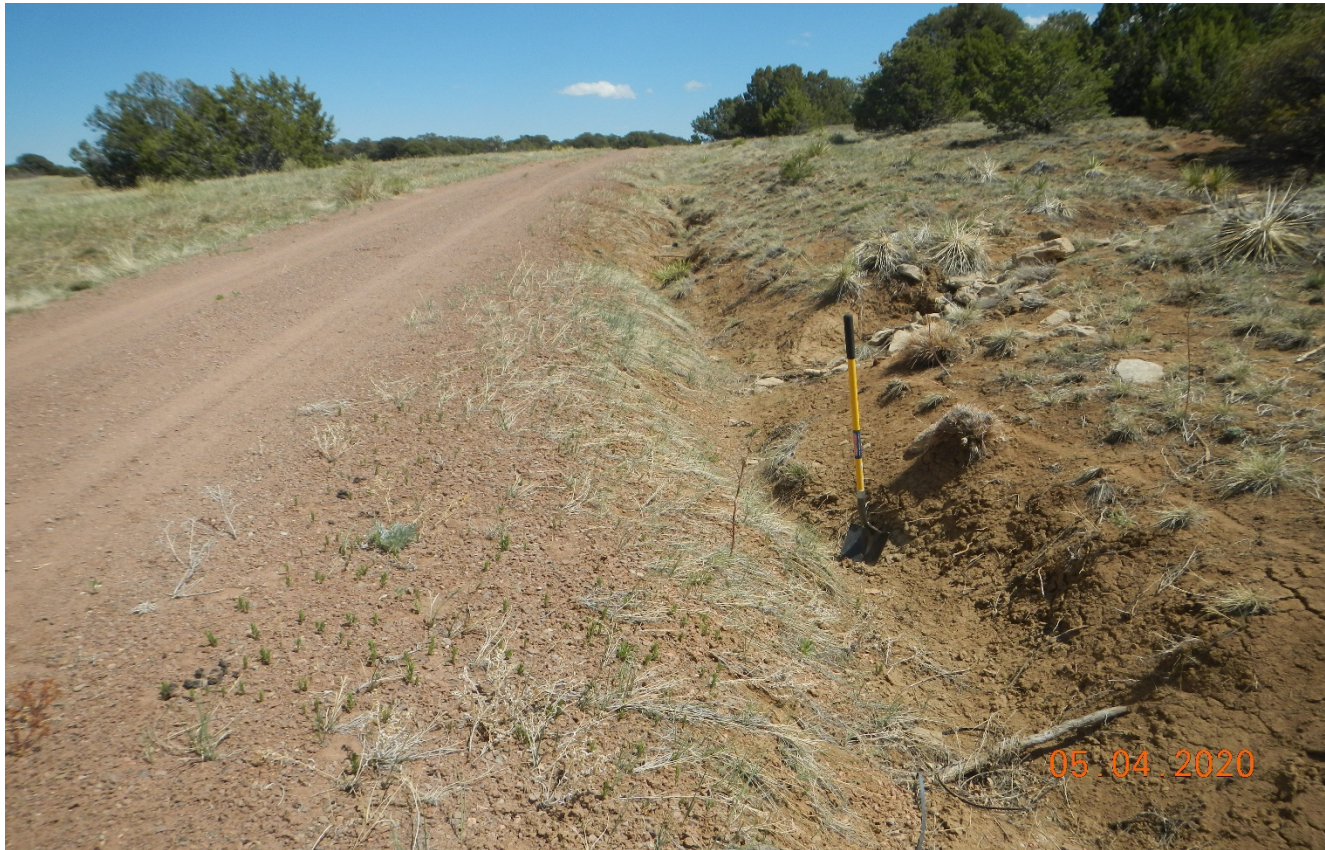
Photo 1. Facing east along the main access road just past the location. There is erosion along the road at Lat/Long:37.54165,-104.82527.

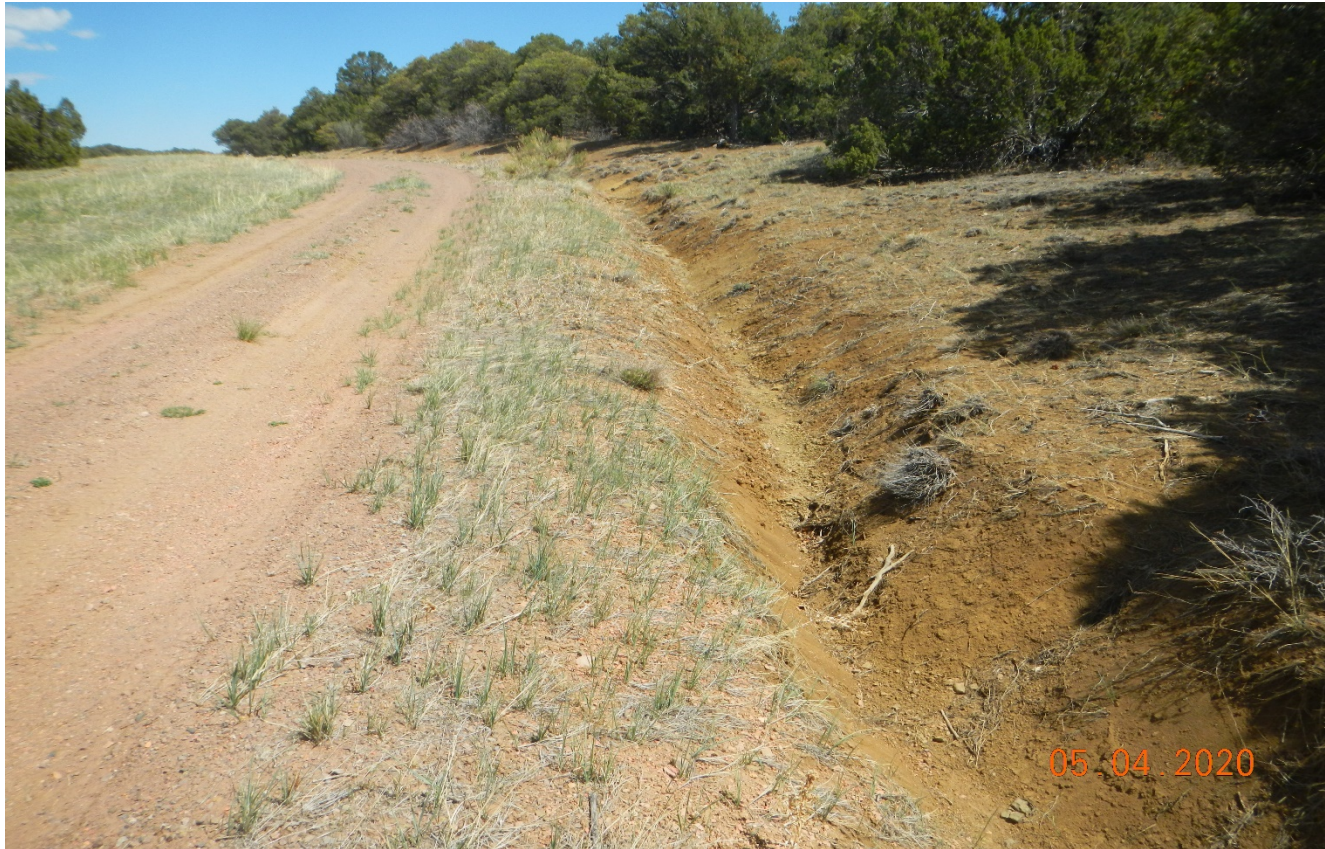
Photo 2. Additional BMP's along the road just past the location to prevent erosion along the road side.

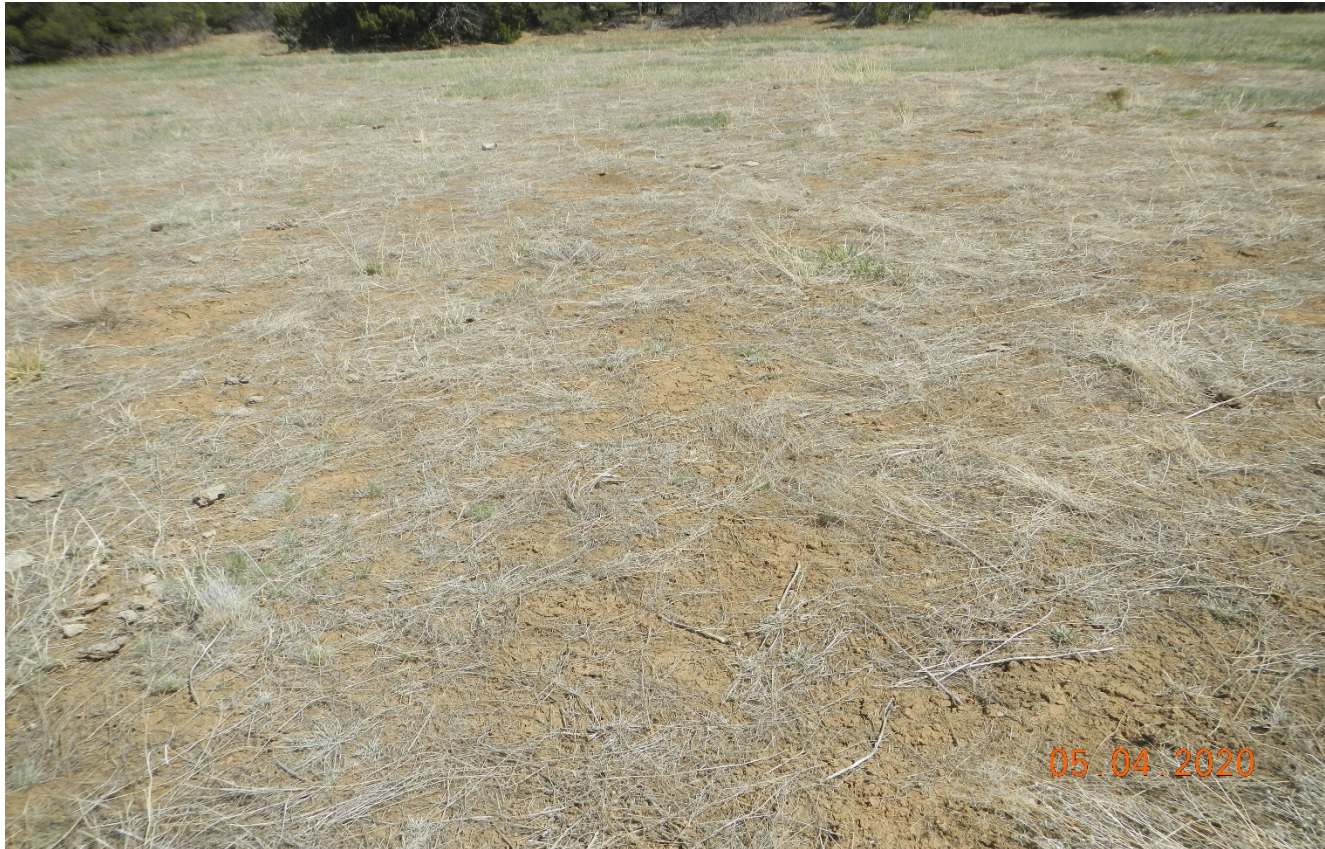
Photo 5. Facing east at south side of the location. There was mostly vegetative debris from last years growth. There was minimal growth from this year in this area.

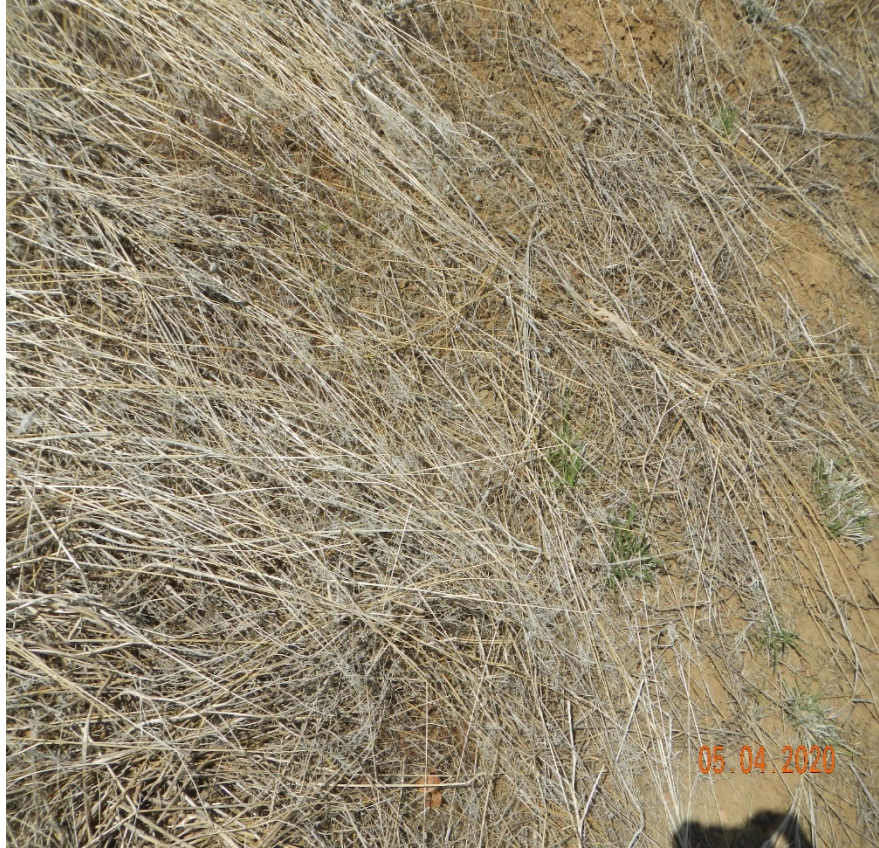
Photo 6. View of ground cover. There was minimal new growth observed. Some of the vegetation from last years growth appears to be Sand dropseed and Cheat grass.

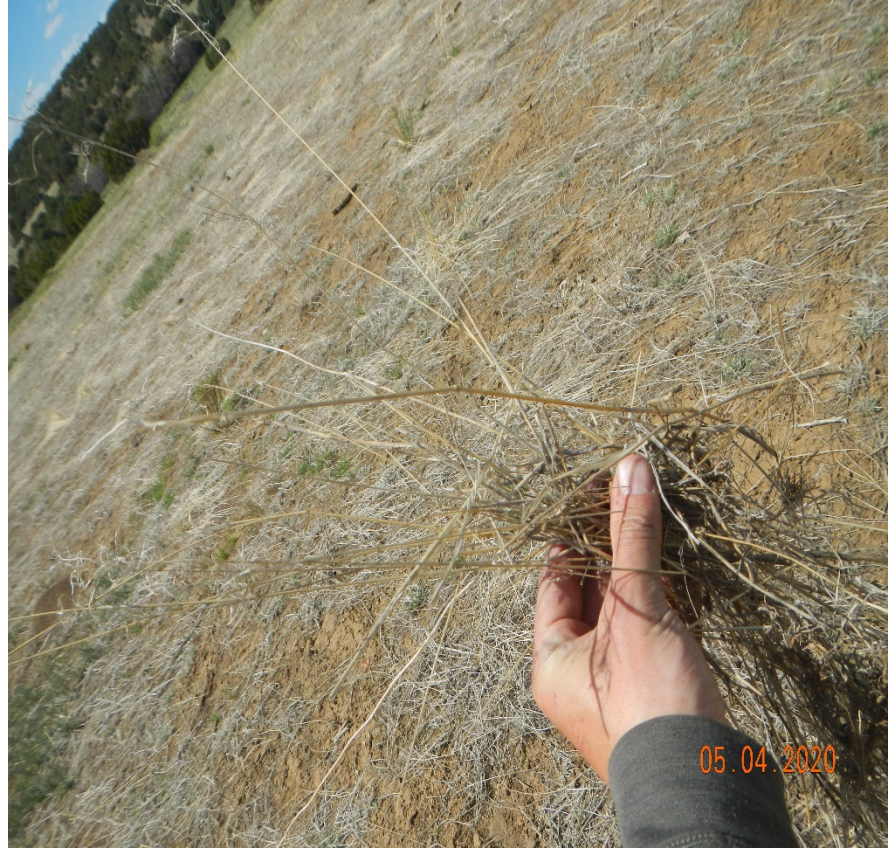
Photo 7. Some of last years vegetation appears to be Cheat grass.

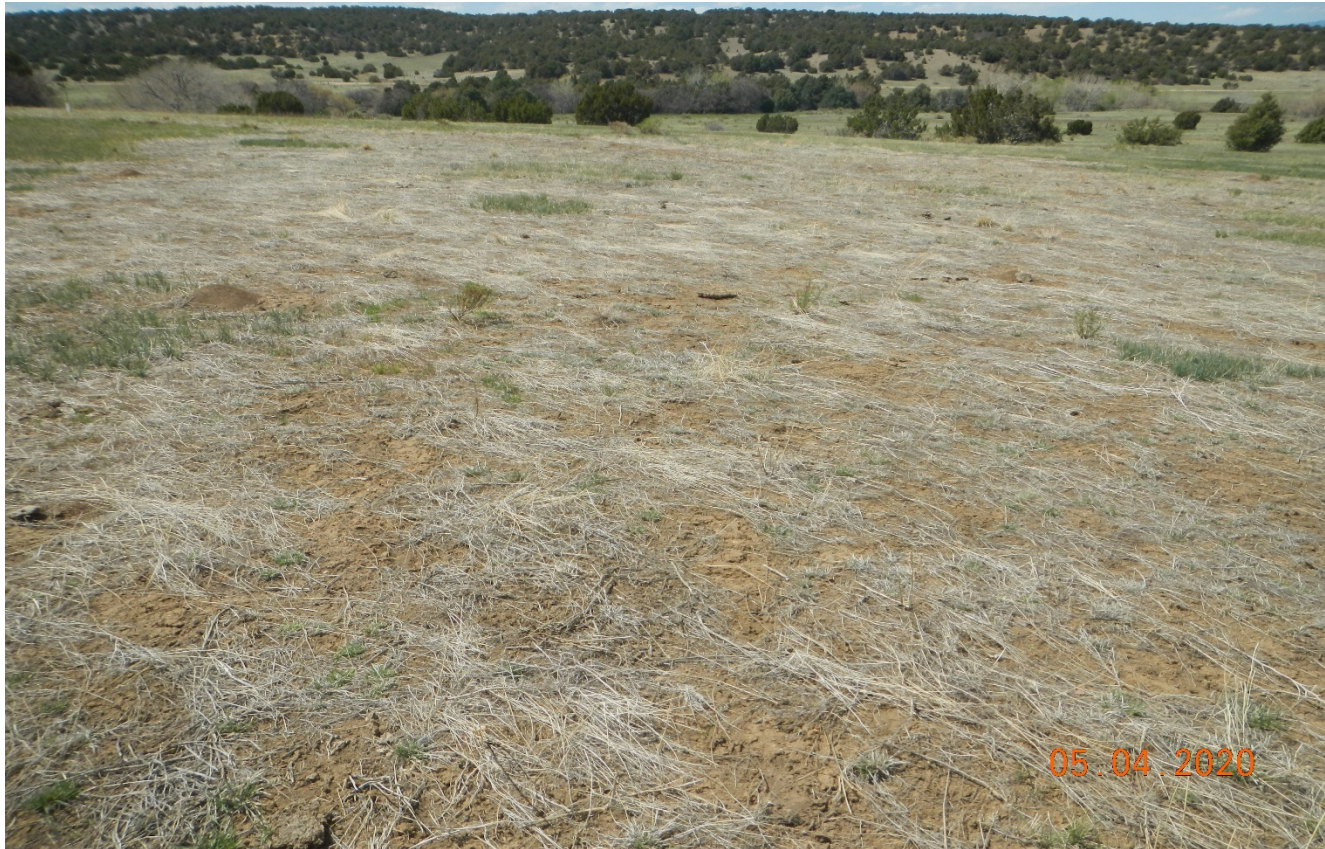
Photo 8. Facing west toward the location. There is minimal growth of vegetation from this year. This area needs additional reseeding.

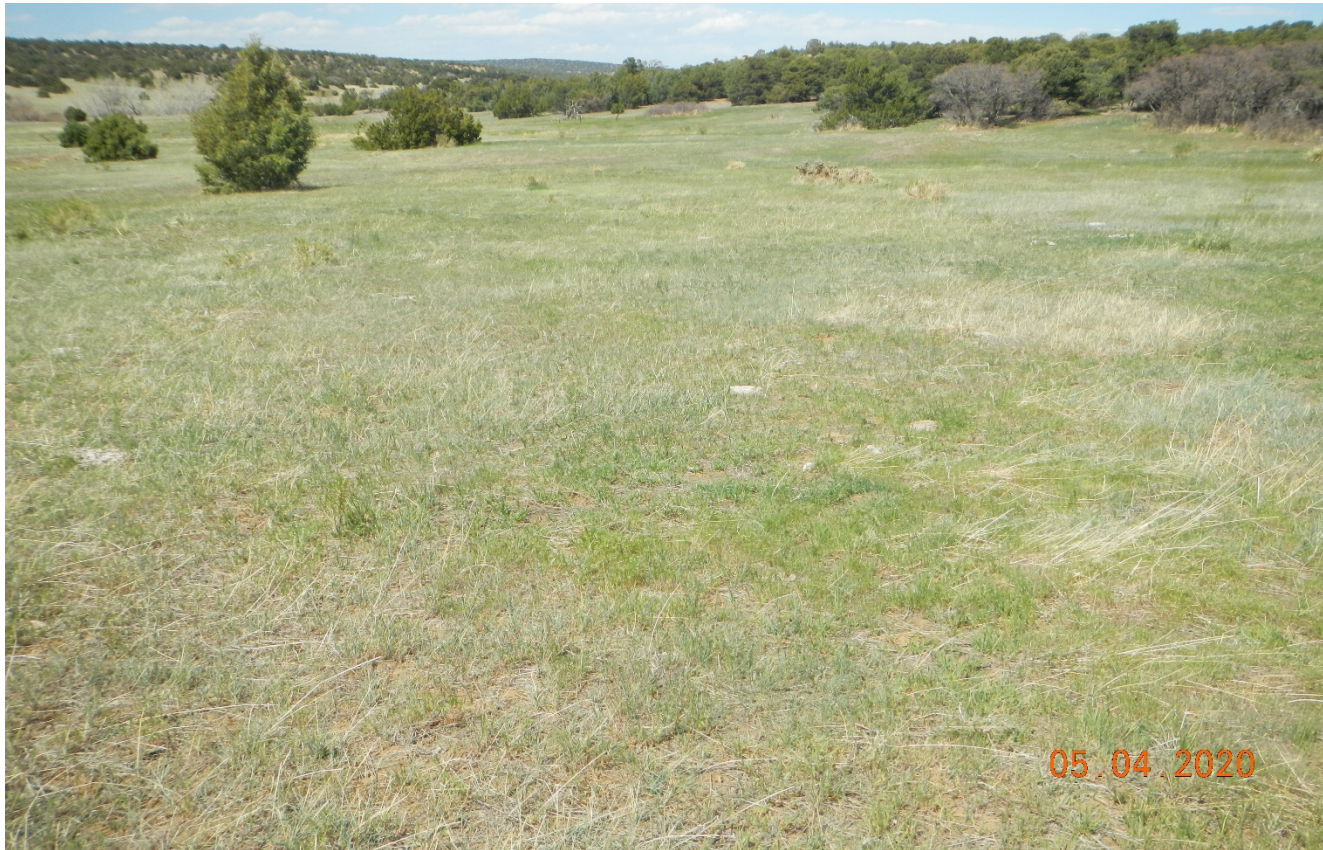
Photo 10. Facing northwest toward the surrounding undisturbed reference area. Vegetation consists of Pinion Juniper woodland and Blue grama, Western wheat grassland.
