Inspection Photos  
Operator: BP America  
API#: 067-08745  
Date: 5/8/2020

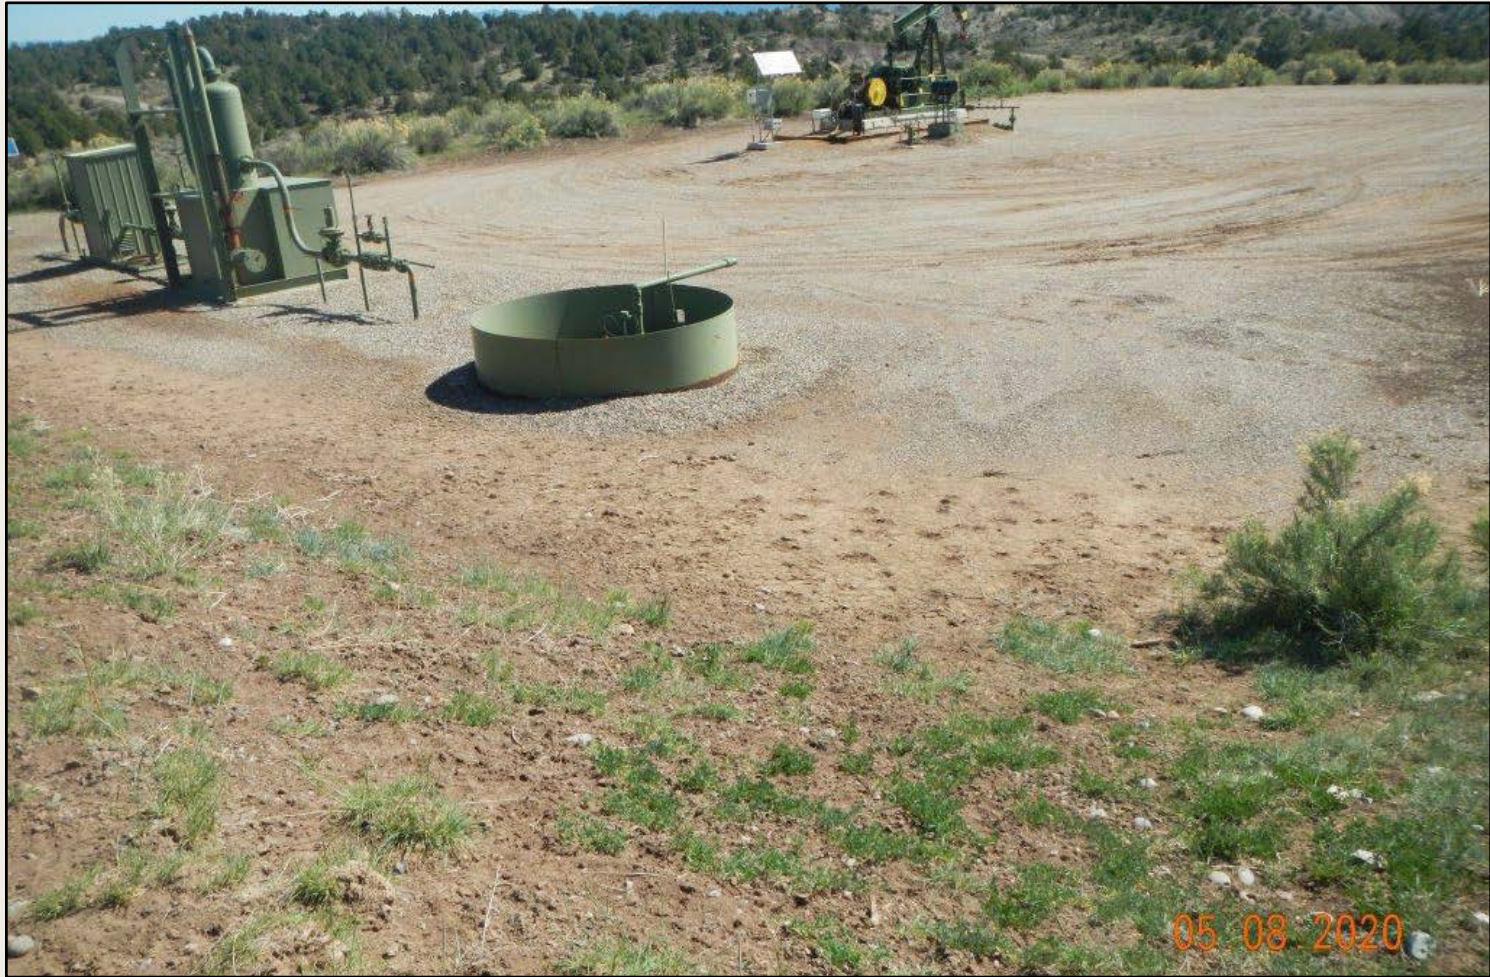
Photo 1. View of the northern well pad from the southwestern corner facing center.

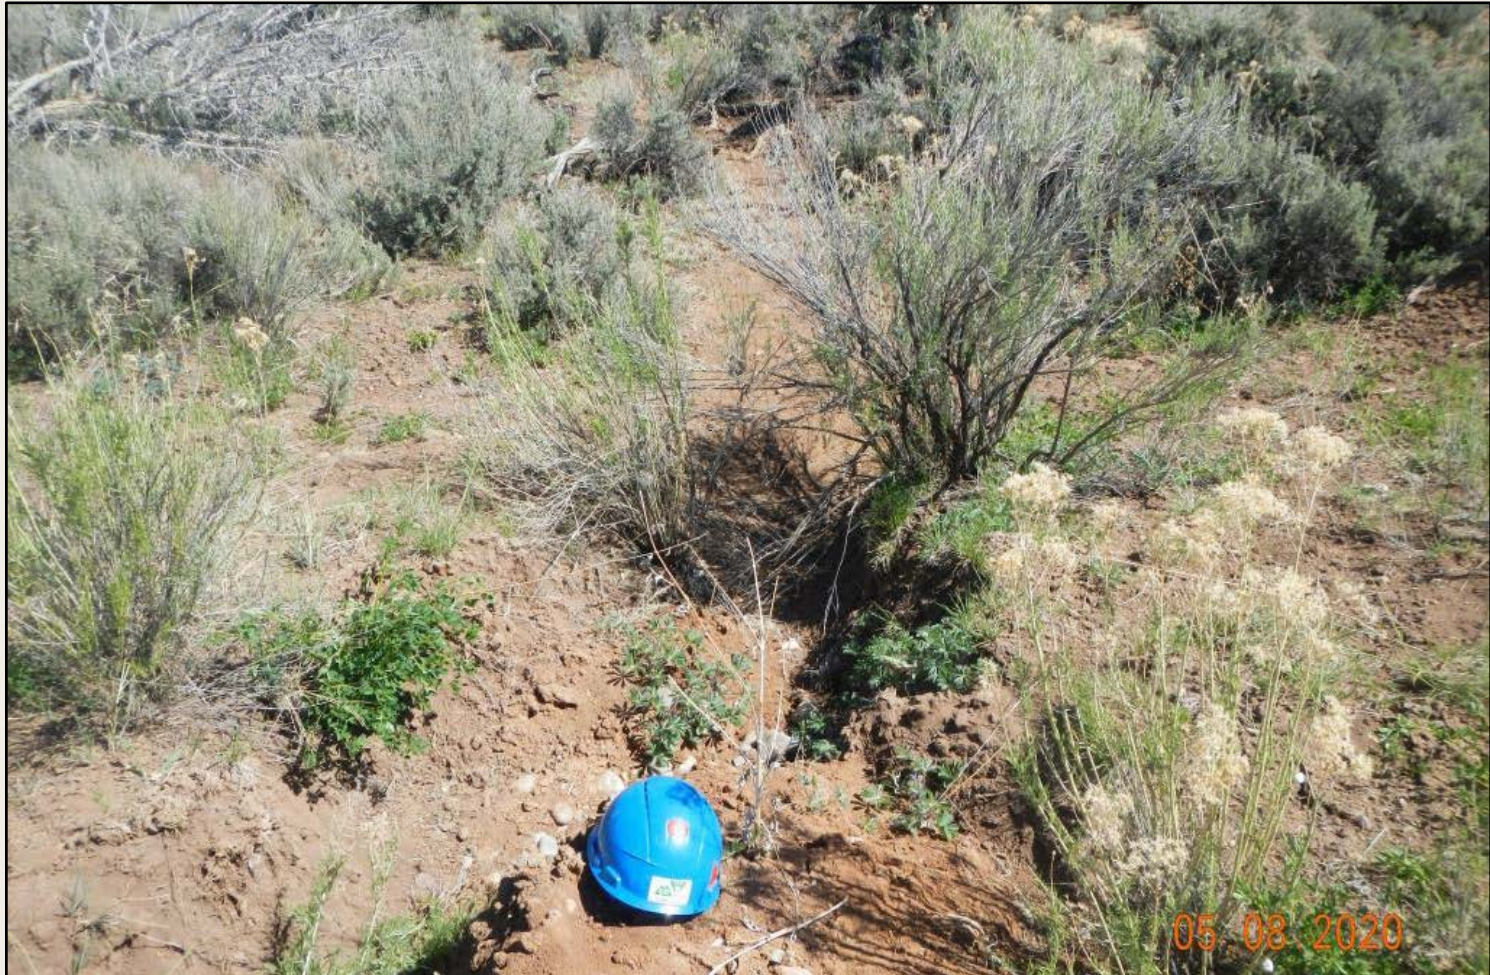
Photo 2. View of erosional channel approximately 2 feet wide and deep forming within the northwestern corner of the project area.

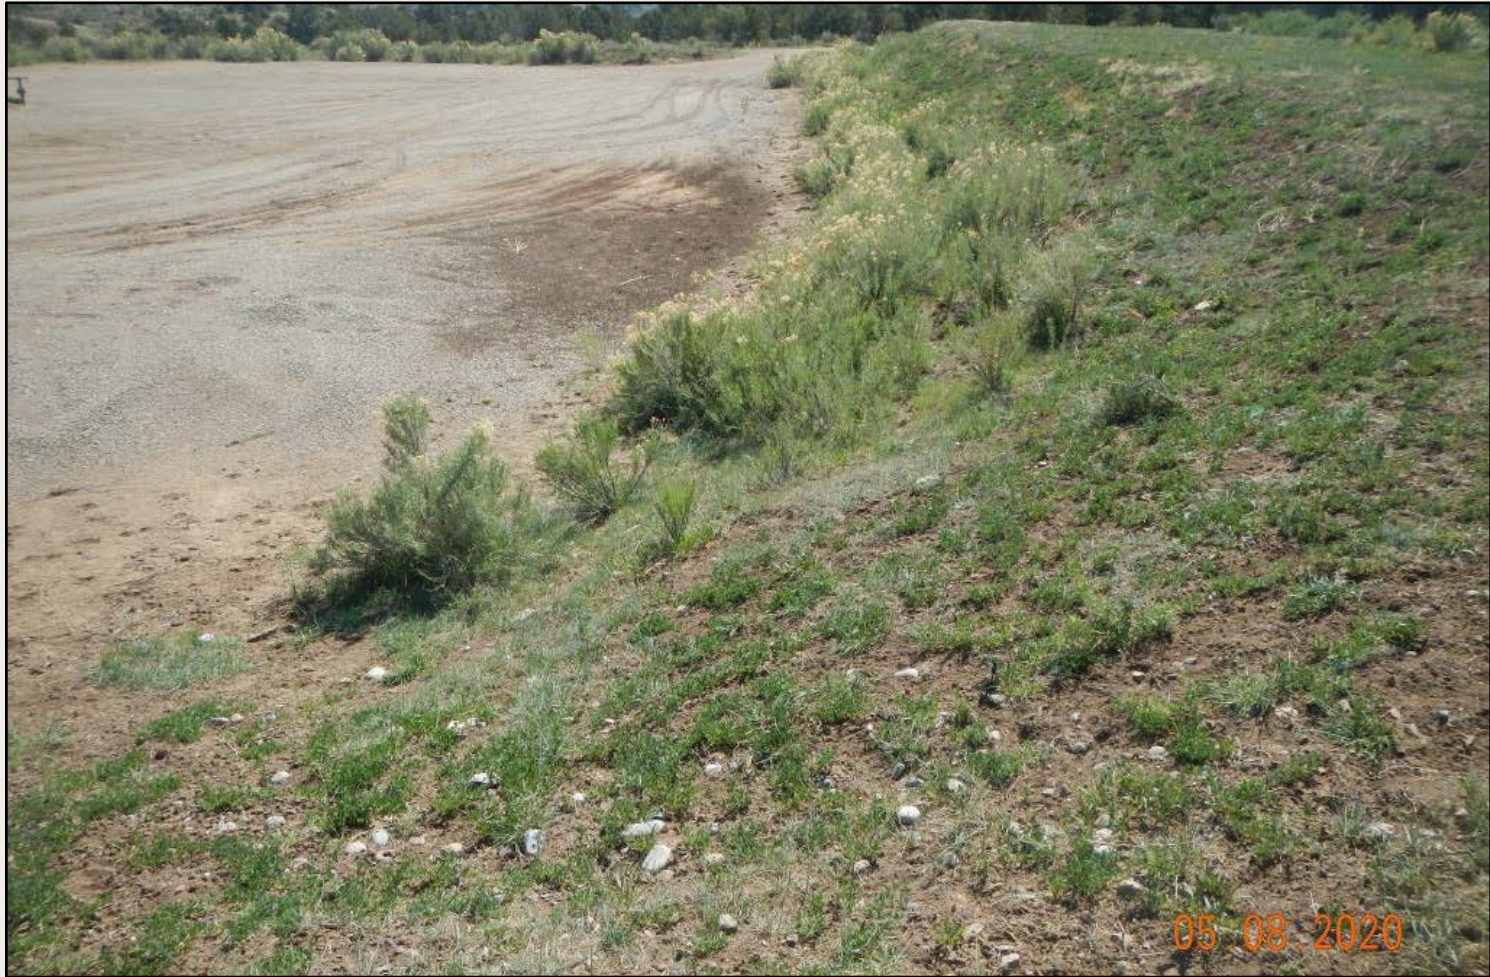
Photo 3. View of the central fill slope from the southwestern corner facing eastward. Revegetation is progressing with rubber rabbitbrush and grasses such as western wheatgrass.

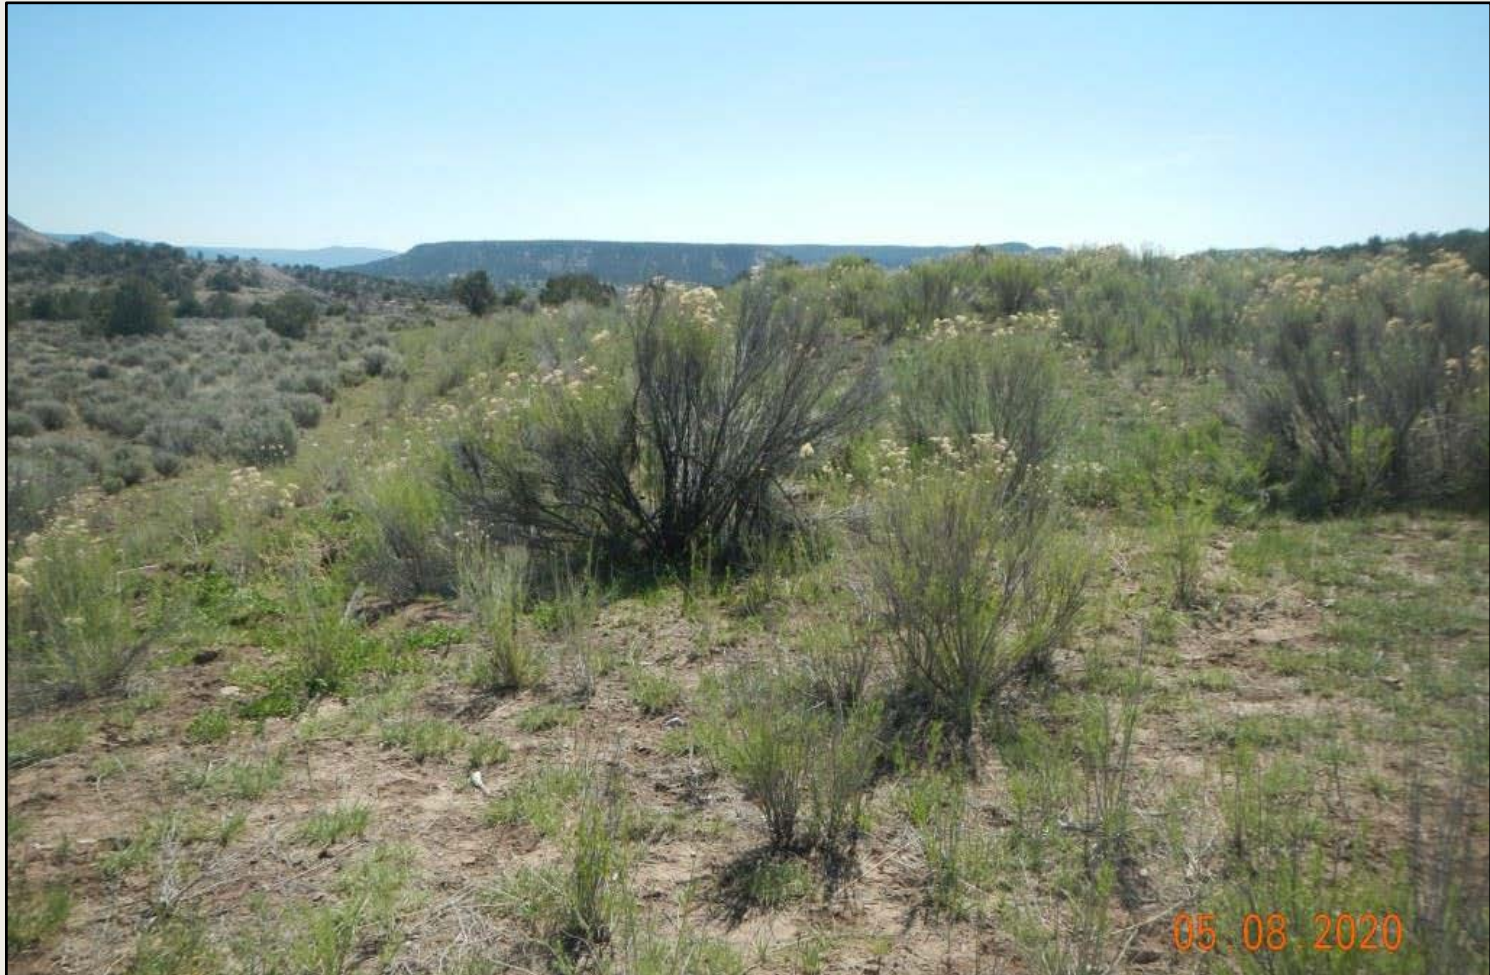
Photo 4. View of the northern fill slope from the northwestern corner facing eastward.
